# GODDARD SPACE FLIGHT CENTER

## Test Lab Report Summary

<i>Report Number:</i>	Q10155DPA	<i>Project:</i>	SWIFT
<i>Part Type:</i>	Microcircuit	<i>System:</i>	BAT
<i>Part Number:</i>	CMP402FS	<i>Initiated Date:</i>	05/01/2001
<i>Date Code:</i>	0010	<i>Report Date:</i>	08/02/2001
<i>Manufacturer:</i>	Analog Devices	<i>Investigator:</i>	C. Greenwell (562)
<i>Generic Number:</i>	CMP402	<i>Requester:</i>	B. Meinhold (562)
<i>Purchase Spec:</i>	Commercial	<i>Approval / Date:</i>

### Step 2: DESTRUCTIVE PHYSICAL ANALYSIS

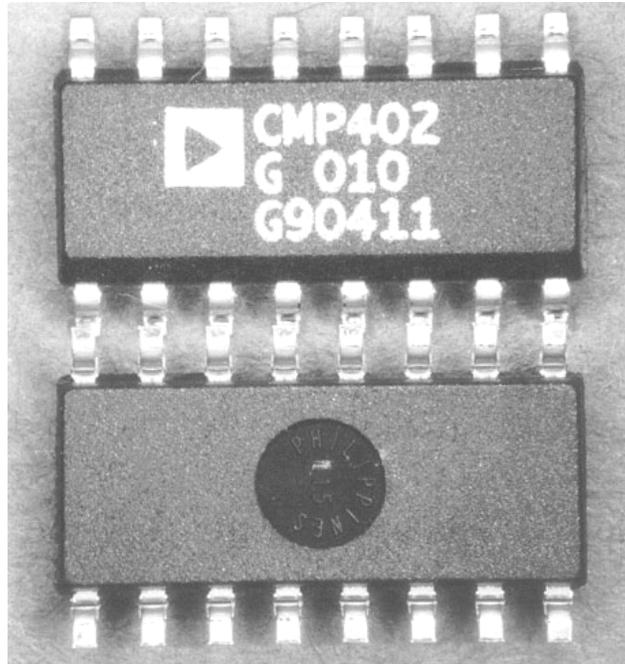
Figure 1. External top and bottom views of the CMP402FS devices. Each device had a unique three character alphanumeric code embossed on the bottom side that was used for reference designations during this analysis. 8X

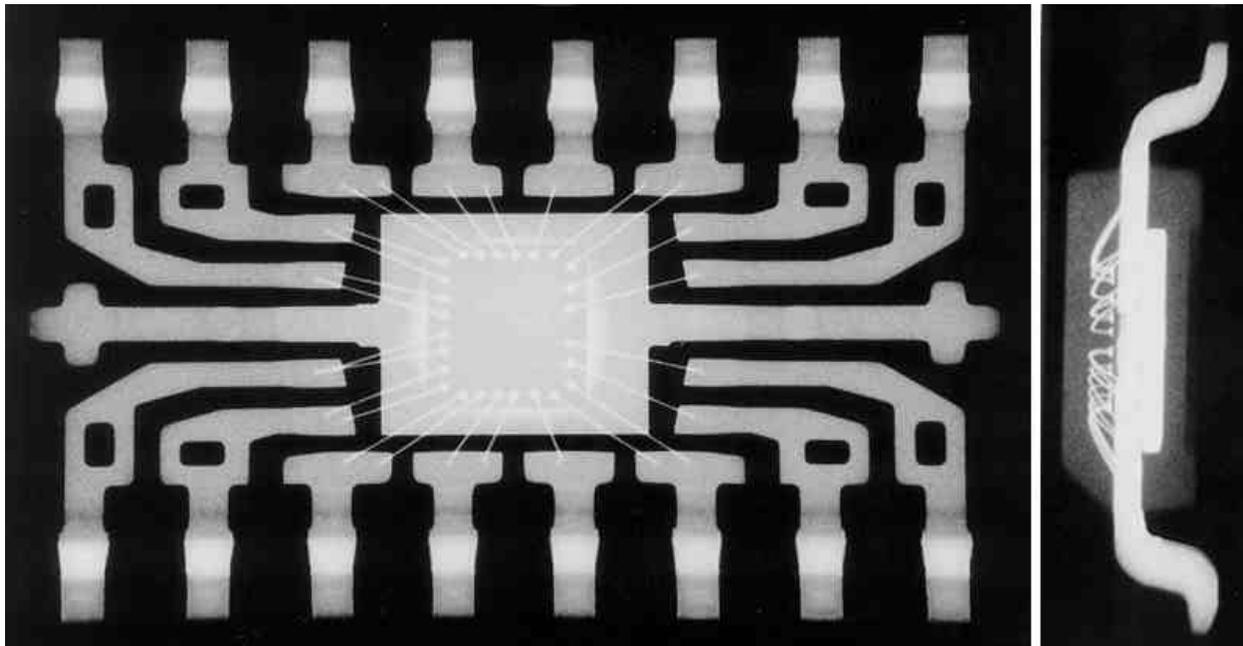
Figure 2. Top and side view radiographic images. 14X

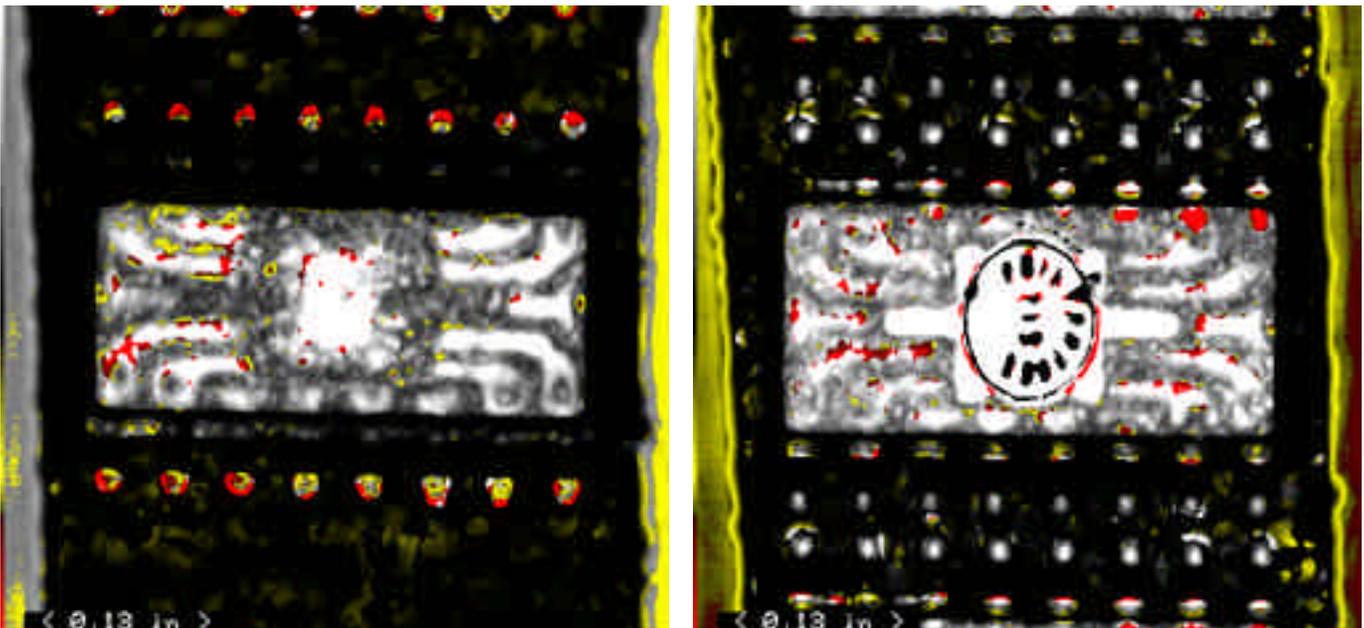
Figure 4. Top (left) and bottom C-SAM images of SN I15. Minor delaminations are delineated in red.

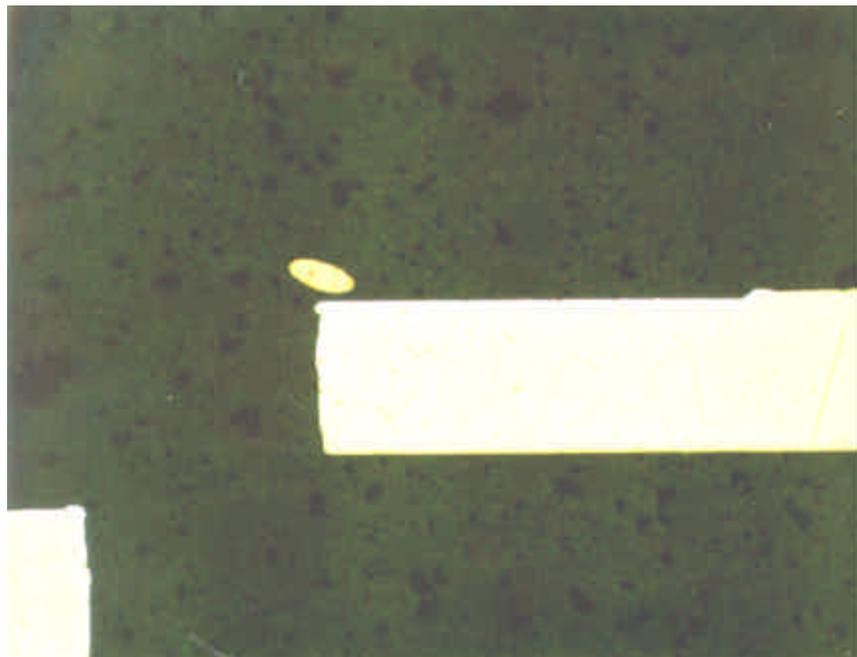
Figure 8. Cross-section image of SN I15. No delaminations or anomalies were observed, consistent with the C-SAM inspection results.  $\approx 200X$ .

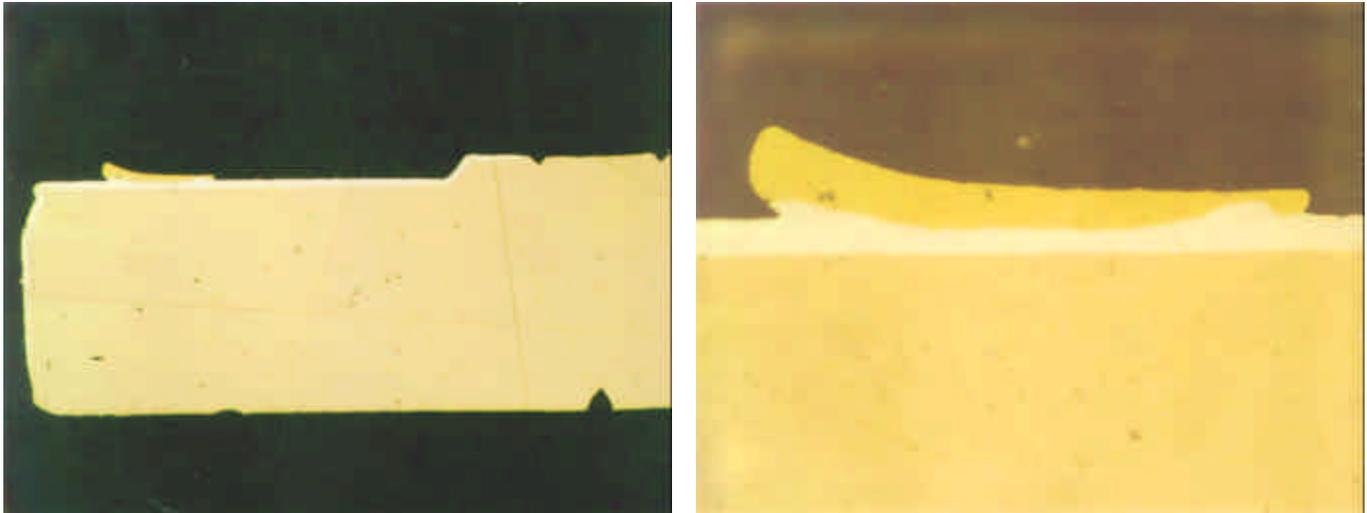
Figure 9. Cross-section images of SN J19. No delaminations or anomalies were observed. Left  $\approx$  200X, right  $\approx$  1000X.

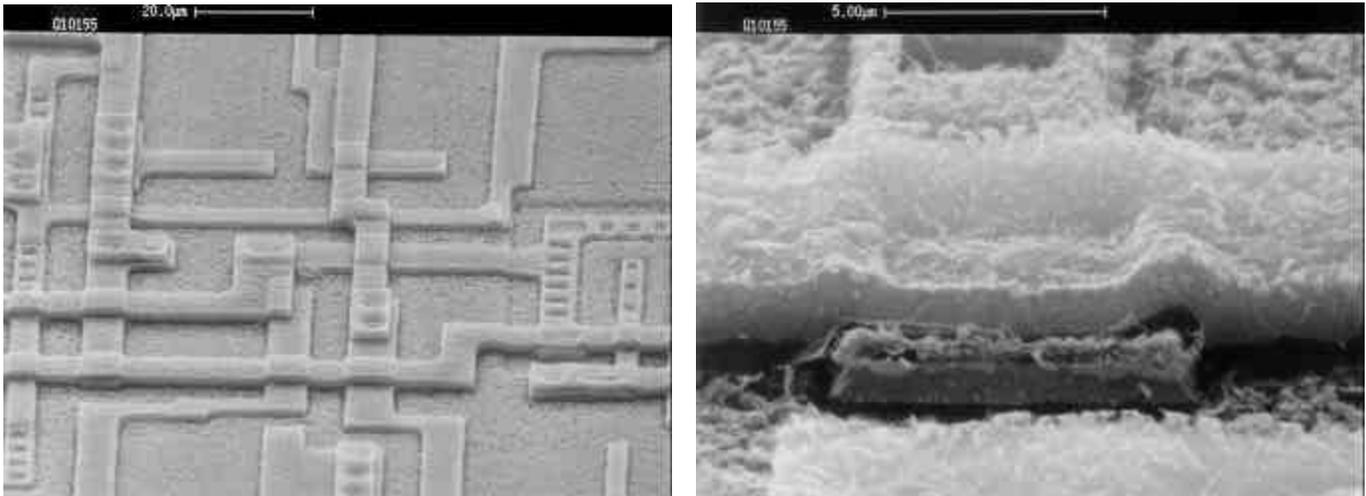
Figure 13. SEM micrographs of SN I13. The metallization has excellent step coverage. The deprocessing pickled the silicon and left artifact on the surfaces.
