Thermo-Mechanical Characterization of Motorola MMA1201P Accelerometer Test Report

**MOTOROLA MMA 1201P ACCELEROMETERS FAILURE
AND CONSTRUCTION ANALYSIS REPORT**

Motorola Accelerometers (MMA1201P) Failure and Construction Analysis Report

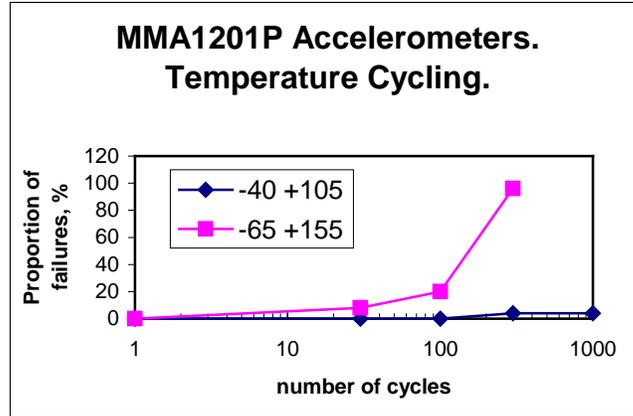
Figure 1. Temperature cycling test results showing proportion of Failures (%) versus number of cycles

Table 1. Temperature cycling results showing proportion of failures (%) out of 25 samples tested.

Number of Cycles	Temperature interval	
	-40 +105°C	-65 +155°C
0	0	0
30	0	8
100	0	20
300	4	96
1000	4

Test results showed no failures during low TC range testing till 100 cycles, and 4 % parts failing post 300 – 1000 TC electrical tests. During extended range TC testing, 8 % parts failed post 30 TC electricals and 96 % parts failed post 300 electricals. Mechanical shock testing showed no failures till 16 MS, and 16 – 20 % failures from 130 – 10,000 MS. These parts are not recommended for use in rugged environment and space flight applications.

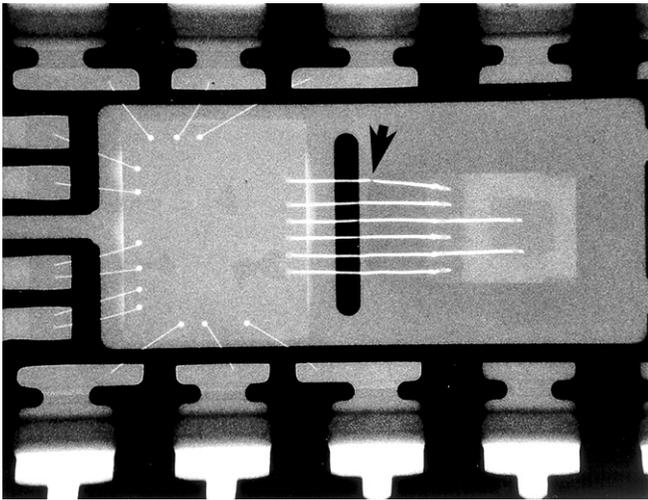
Careful examination of the x-ray images under magnification revealed that some of the internal wires on the parts receiving temperature-cycle testing appeared to be broken near the edge of an internal cavity. These wires were also kinked on one end, near an internal bonding pad on the sensor. The portion of the wires remaining inside the plastic encapsulation had a nominal, undamaged appearance.

Figure 3. X-ray view of accelerometer reveals that it is a hybrid device. A large microcircuit at left is wire-bonded to the lead-frame. Internal wires bridge to the sensor. Arrow indicates defect seen better in Figure 4. 10X

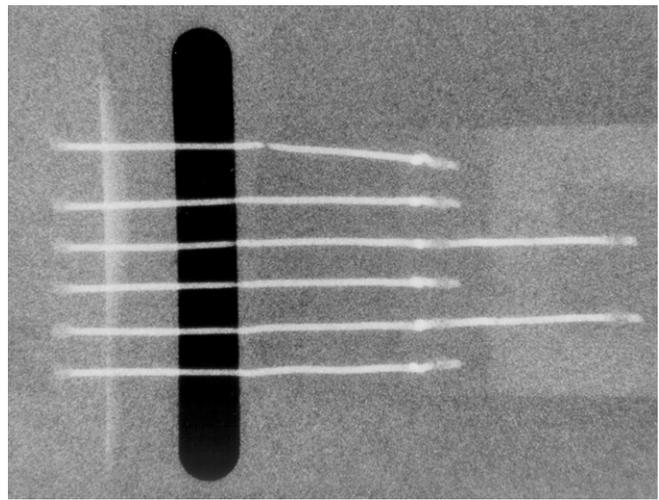
The nature of the damage suggested that the silicone had shrunk and expanded under multiple temperature cycles and, while doing so, the silicone had pulled anisotropically on the gold wires, leaving them damaged after testing. Multiple temperature cycles caused the wires to kink and break at the bond pads, and caused Poisson necking at the silicone/plastic interface. A gap was also seen between the silicon and the plastic, indicating lack of adhesion between the plastic and the silicone.

Figure 4. Close examination of the bridging wires inside the part reveals an apparent break in the top wire in this photo. The large, faint shadow over the sensor indicates the cavity filled with silicone. Note that wire break occurs near the interface of the plastic and the silicone. SN76 failed under temperature-cycle testing. 25X

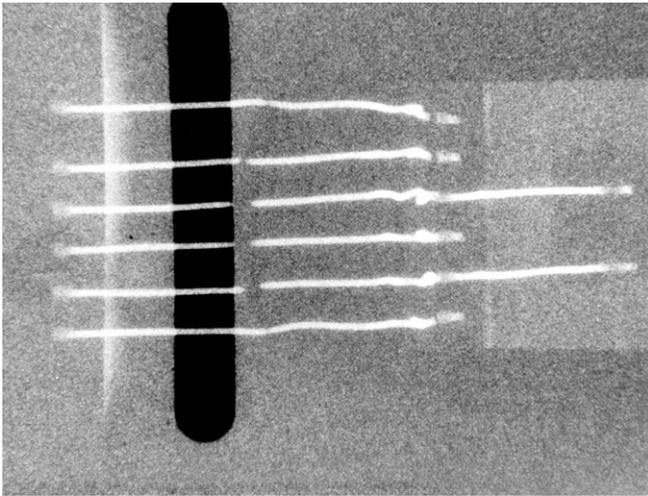
Figure 5. A similar, but more severe problem was noted on SN78, which also underwent temperature-cycle testing. Many of the above wires are broken. All of the wires appear wavy or kinked on the right. 25X

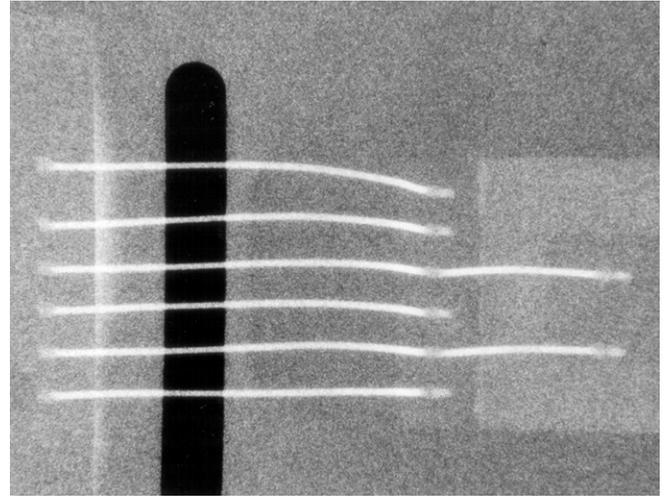
In comparison, x-rays did not reveal any damage to the wires of the parts subjected to shock testing. Nor was there any evidence of wire damage in the x-rays of the untested parts submitted for construction analysis.

Figure 6. A second group of accelerometers failed due to shock. This representative device x-ray shows no evidence of wire breakage or kinking. 25X

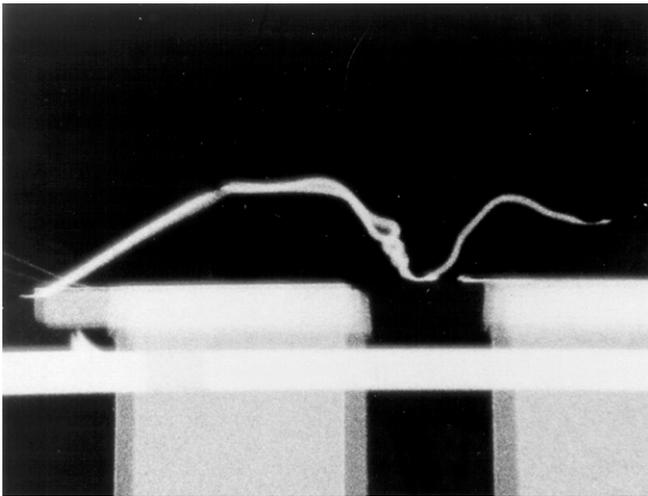
Figure 7. The bridging wires are seen in side view in this x-ray of SN78. Most of the wires broke at a common location near the edge of the cavity. Note that on the left of the break the wire is smooth; on the right it is kinked. 25X

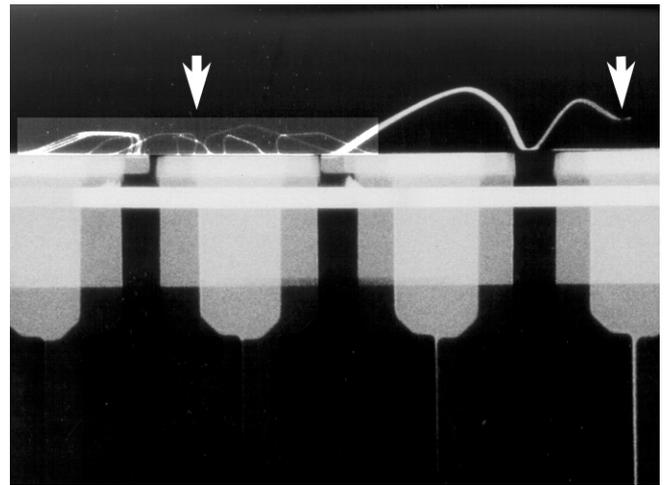
Figure 8. SN264 failed due to shock. Notice that the wires are not damaged. The arrow on the left points to an enhanced region showing the lead dress of the wires bonded between the lead frame and the microcircuit. Arrow on the right indicates where the wires attach to the top of the sensor, which cannot be seen in this x-ray. 25X

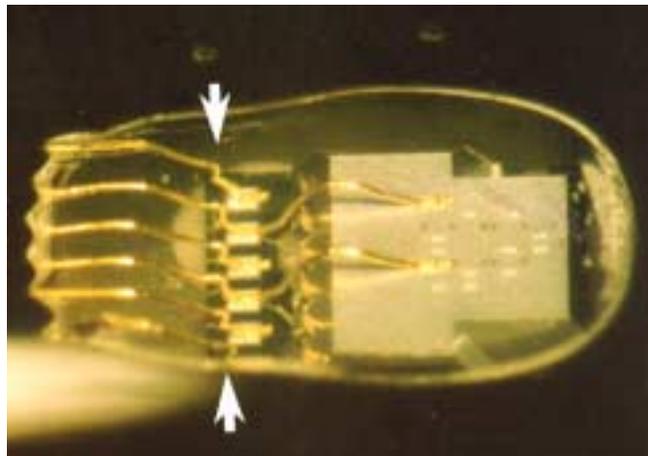
Mechanical lapping was used to remove the top surface of the plastic encapsulation and reveal the wires underneath. It was found that the internal cavity was filled with a clear polymer, possibly a silicone material, through which the wires could be partially inspected once the plastic encapsulation had been removed. The parts were inspected optically in both top-down and side views. In the group of parts subjected to temperature-cycle testing, it was determined that many wires were severely kinked at the bonding pads. Closer inspection suggested that the breakage had also occurred at the bond heel. In addition, some of the wires were confirmed to be broken or damaged near the silicone/plastic interface, where evidence of neck-down was also found, as if the damaging process had been interrupted prior to breakage.

Figure 10. The SN76 sensor is seen on the right, under two wire bonds. The plastic encapsulant was lapped off in this method of deprocessing, revealing clear silicone underneath. Note that gold wires between arrows are kinked.

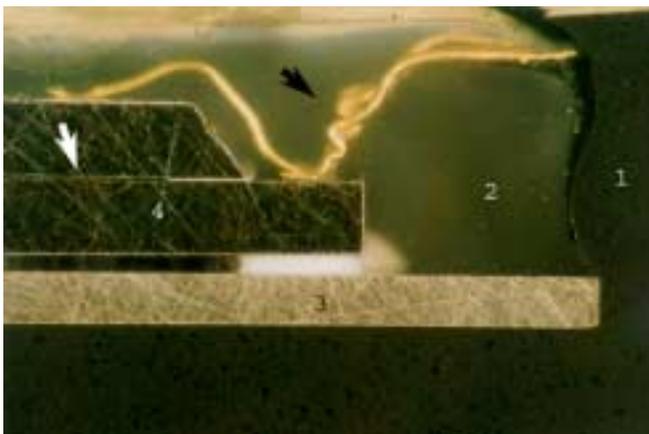
Figure 11. This side view of sensor and wires reveals construction of SN76. (1) Plastic encapsulant. (2) Silicone inside cavity. (3) Lead frame. (4) Sensor. Note that sensor has a two-part construction, with a space in between as indicated by the white arrow. Black arrow points at kinked wires. 32X

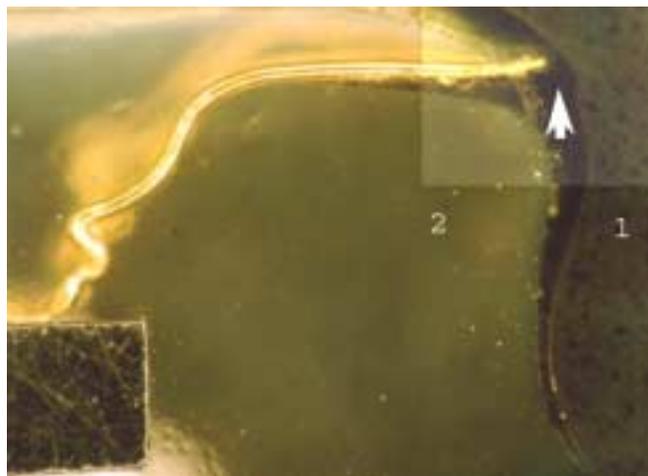
Figure 12. Close-up view of wires in Figure 11, showing severe kinking. Note that a space exists between the plastic (1) and the silicone (2). Enhanced corner of photograph highlights the gap and shows that the wire is slightly tapered at its end, and broken, as the wire does not extend to the plastic. 64X

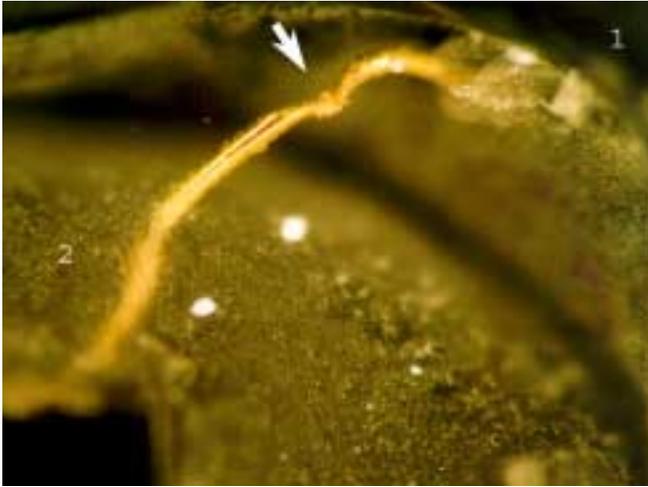
Figure 13. The gap between the plastic (1) and silicone (2) is seen in this view of SN77. Arrow points to a wire region inside the gap which exhibits necking. 64X

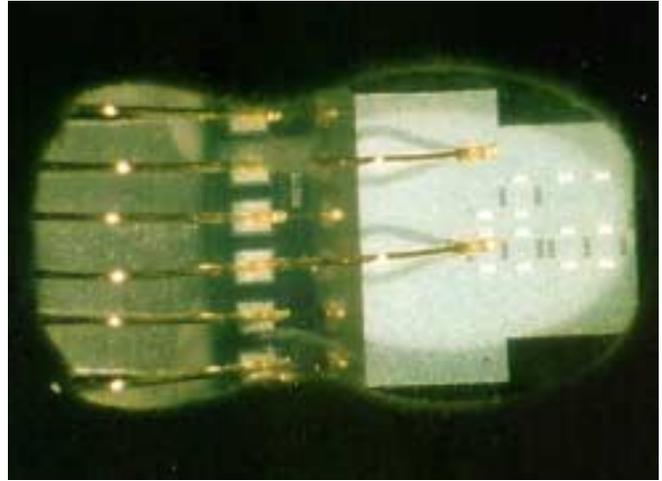
Figure 14. Another view of a part which did not experience temperature-cycling. SN262 failed shock testing. Observe that the wires are continuous and smooth, with no evidence of breakage or kinking. 16X

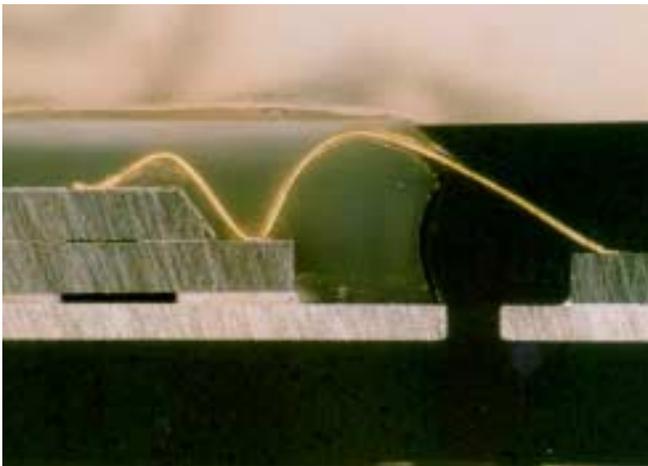
Figure 15. A side view of SN262 indicates the wires are in excellent condition, unlike the parts that experienced temperature-cycle testing. 16X

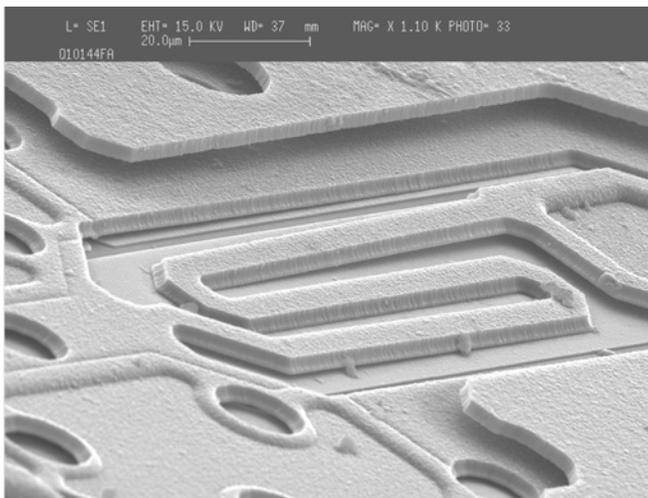
Figure 27. Note that the lower level of silicon appears to be elevated at the left end, behind the resistor, while also being down at the right side, creating a gentle slope. It is not understood if this is an artifact of the manufacturer's etching process, or necessary for the device operation. 1100X

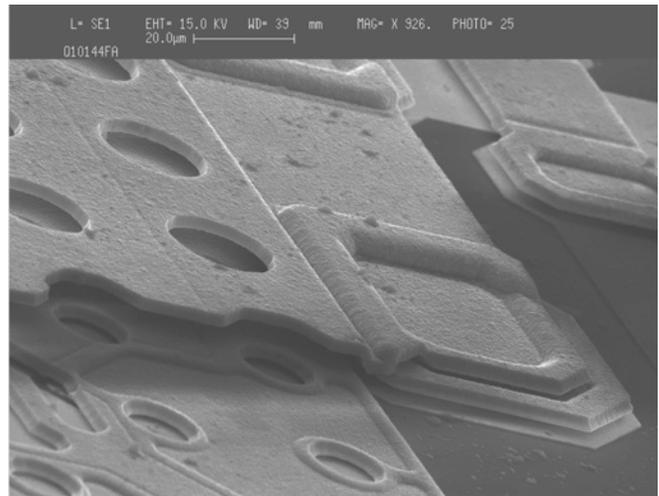
While the cause of failure for the shock-tested parts has not yet been determined, it is suspected that shock in the z-axis direction may have caused damage to the unsupported silicon membrane.

Figure 30. A high angle view of a corner where membrane appears to be suspended. It is suspected that shock in the z-axis may have damaged the membrane of the parts exposed to shock testing. 926X
