GODDARD SPACE FLIGHT CENTER

Test Lab Report Summary

<i>Report Number:</i>	Q10173DPA	<i>Project:</i>	SWIFT
<i>Part Type:</i>	Microcircuit	<i>System:</i>	BAT
<i>Part Number:</i>	OP420GS	<i>Initiated Date:</i>	05/01/2001
<i>Date Code:</i>	9940	<i>Report Date:</i>	08/14/2001
<i>Manufacturer:</i>	Analog Devices	<i>Investigator:</i>	C. Greenwell (562)
<i>Generic Number:</i>	OP420	<i>Requester:</i>	B. Meinhold (562)
<i>Purchase Spec:</i>	Commercial	<i>Approval / Date:</i>

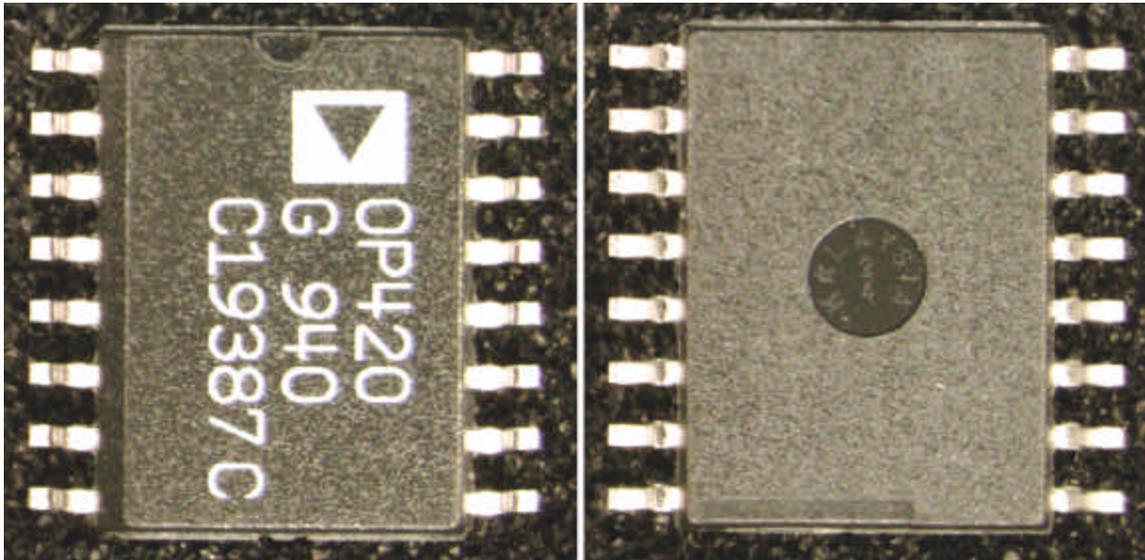
Figure 1. External top and bottom views of the OP420GS devices. Each device had a unique two character numeric code that was used for reference designations during this analysis. 6X

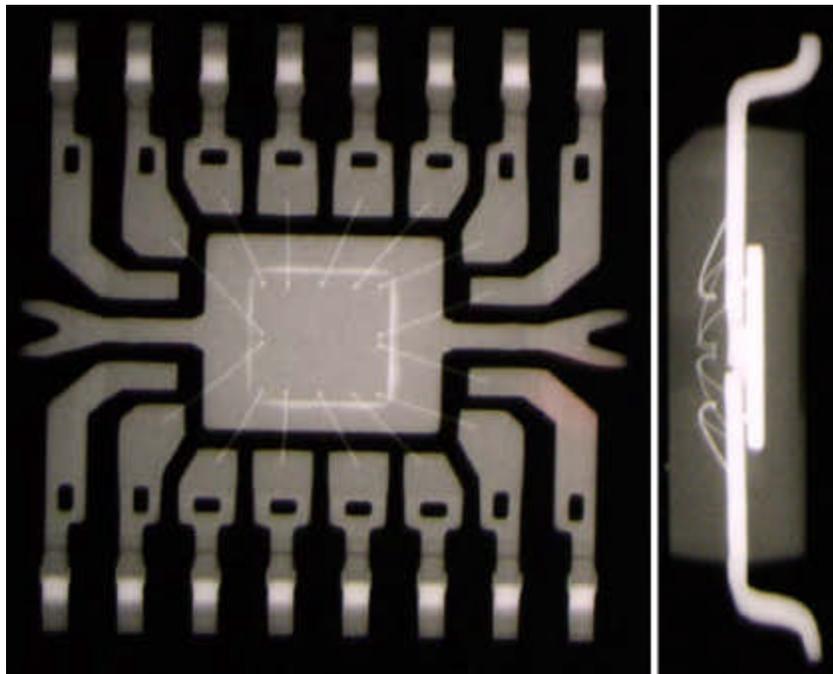
Figure 2. Top and side view radiographic images. 8X

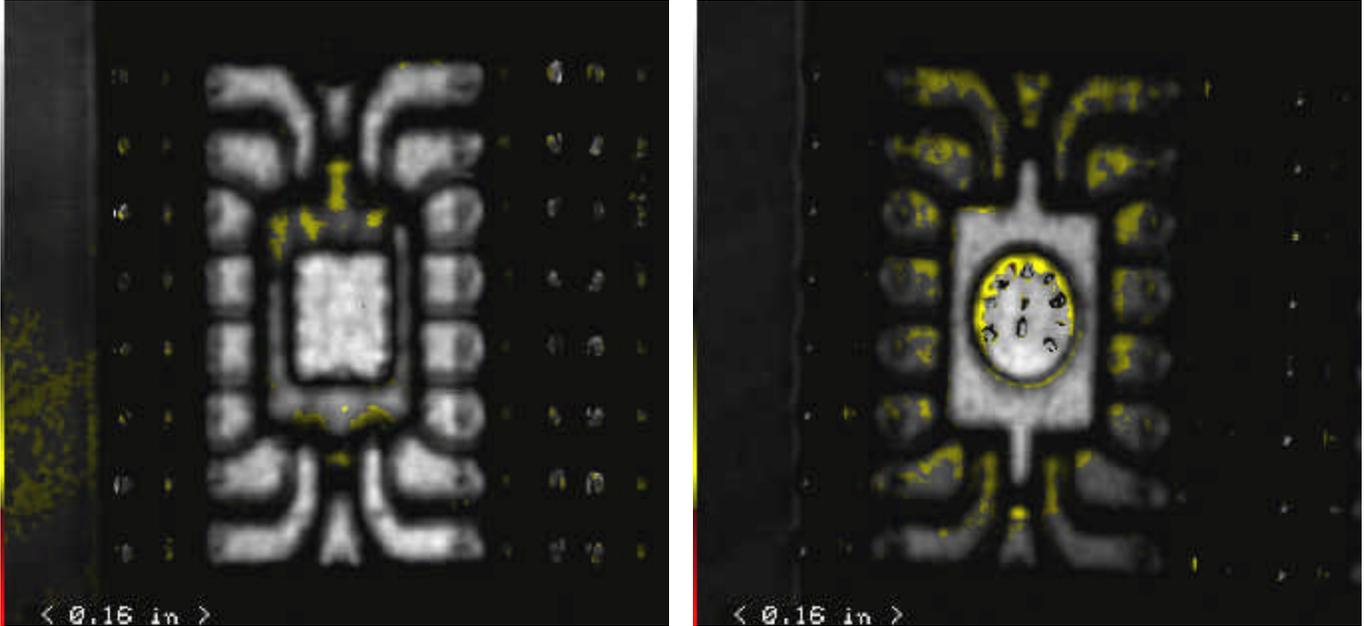
Figure 3. Top (left) and bottom C-SAM images of SN 18. Yellow areas are artifact of the tool settings.

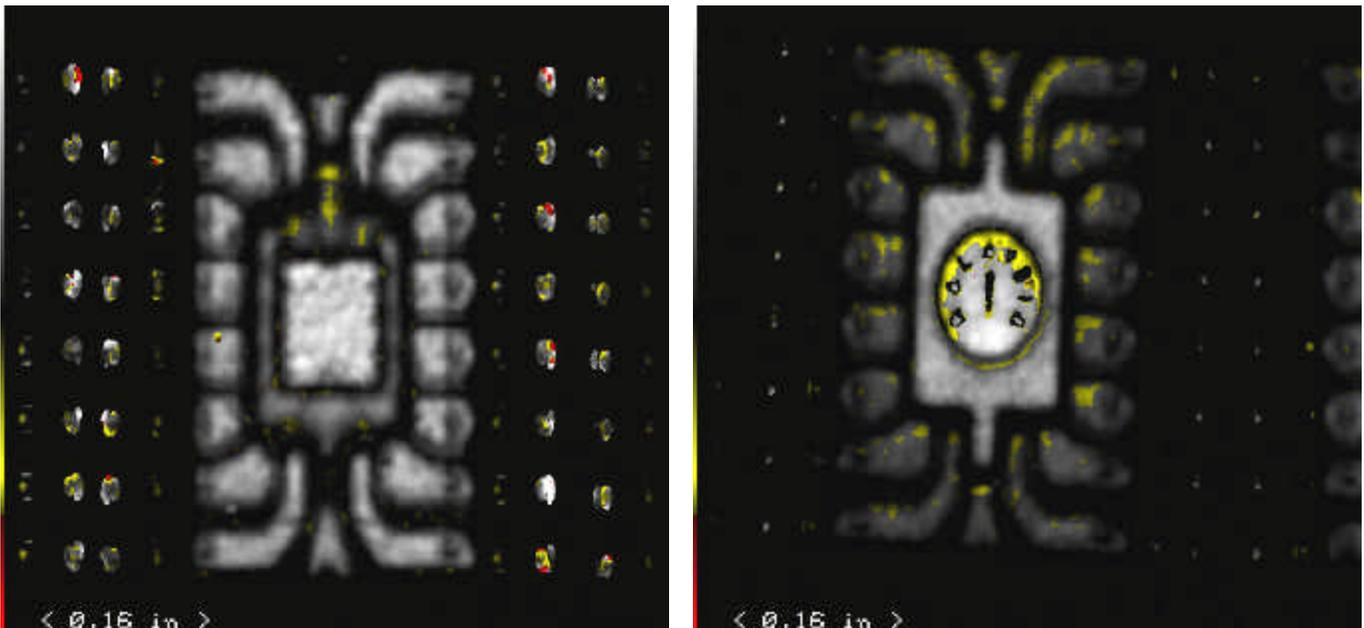
Figure 4. Top (left) and bottom C-SAM images of SN 21.

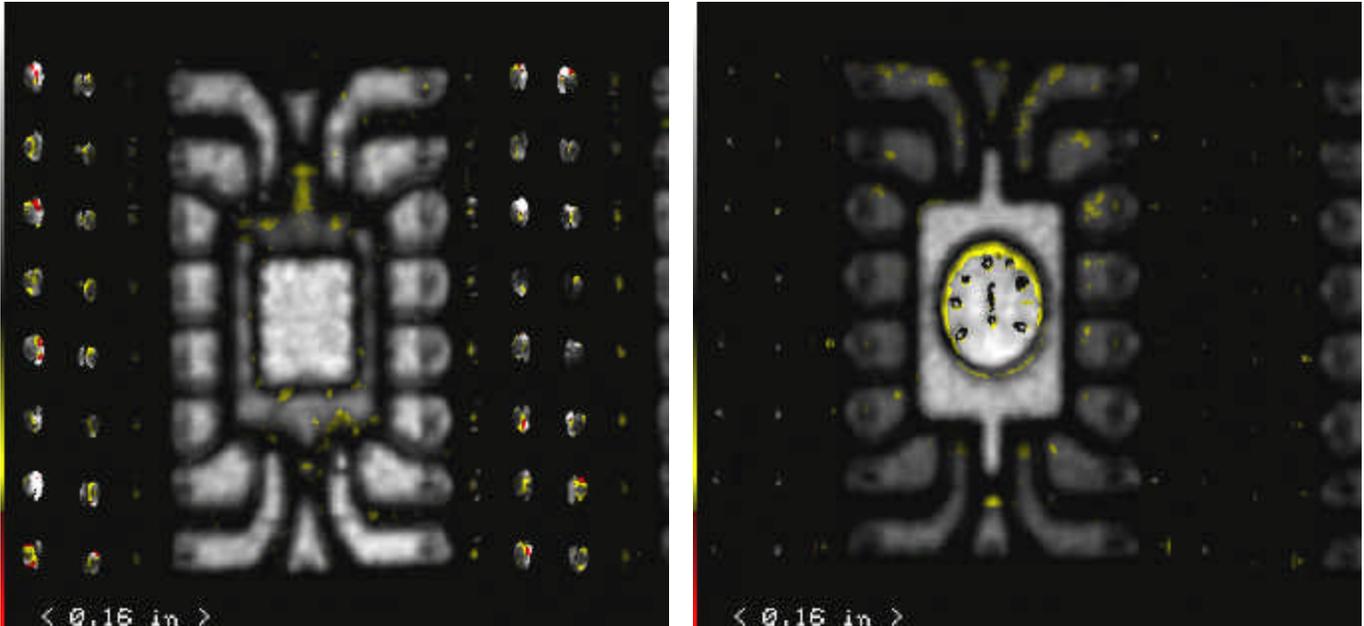
Figure 5. Top (left) and bottom C-SAM images of SN 24.

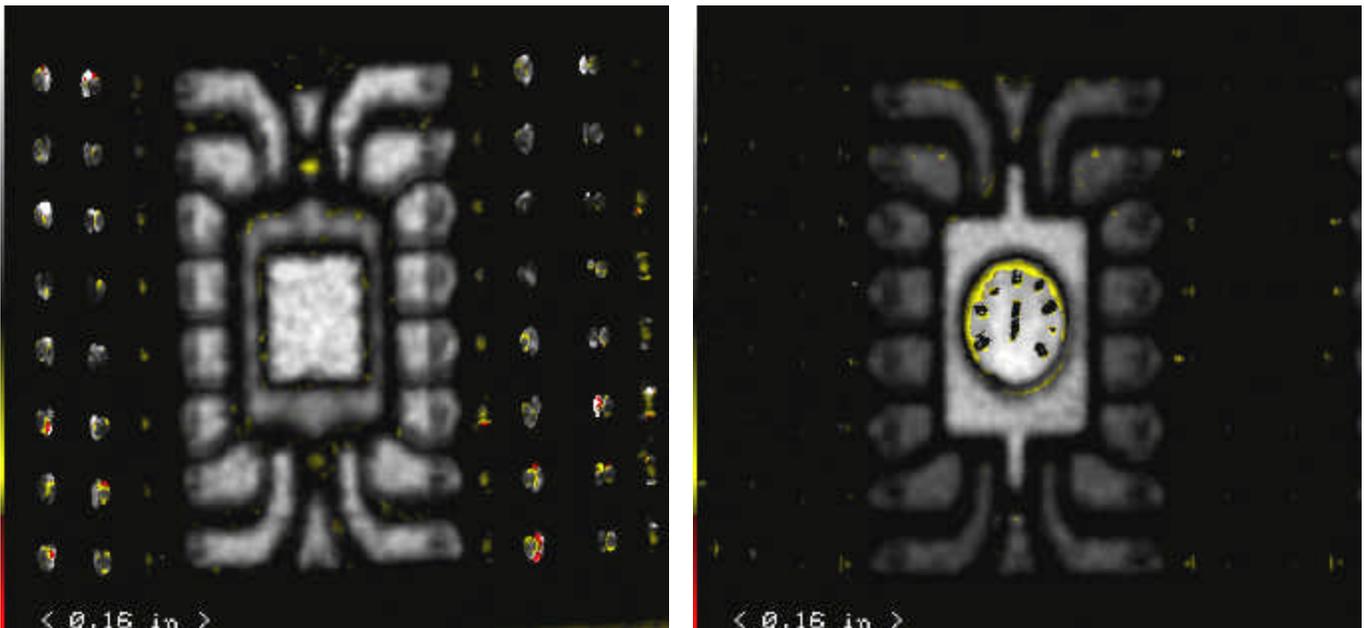
Figure 6. Top (left) and bottom C-SAM images of SN 27.

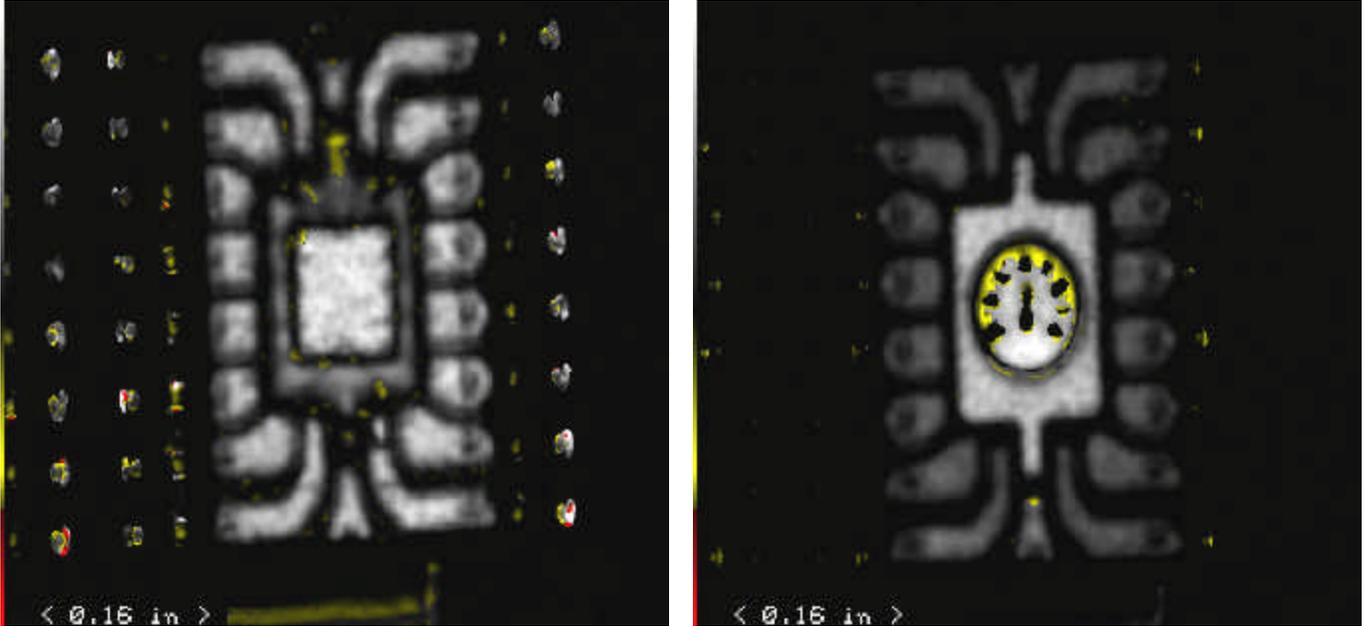
Figure 7. Top (left) and bottom C-SAM images of SN 30.

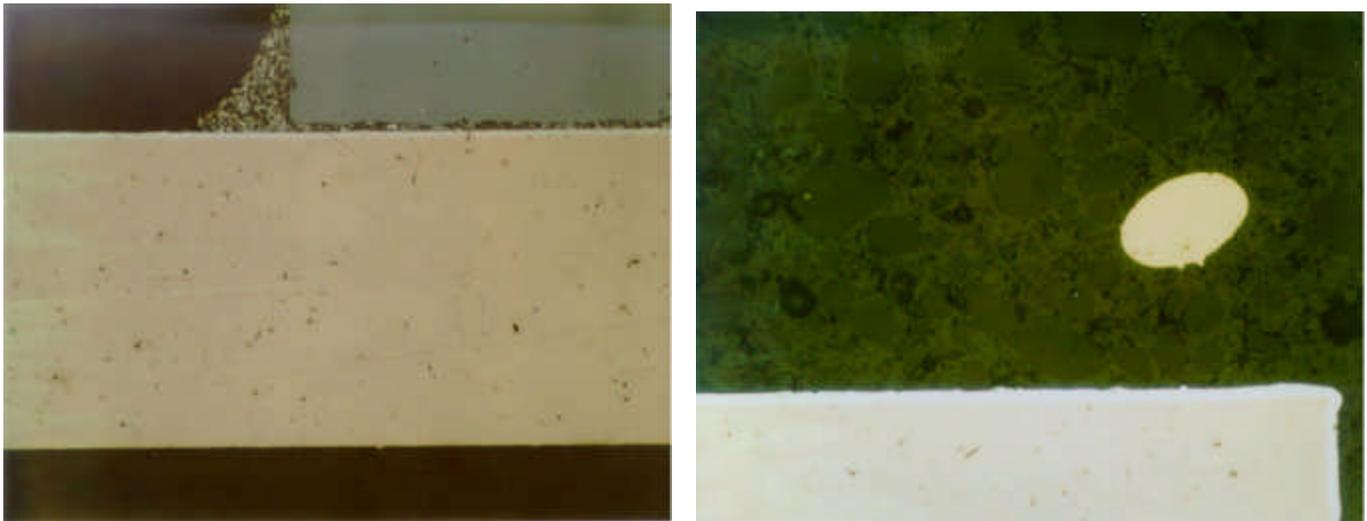
Figure 8. Cross-section images of SN 18. Left \approx 200X; right \approx 200X.

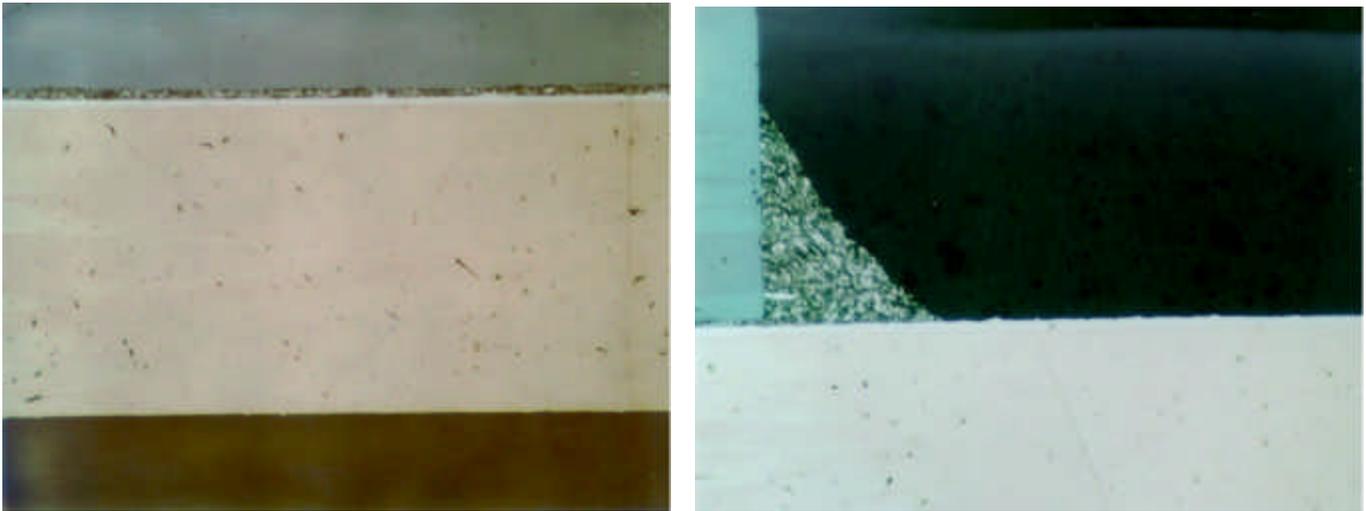
Figure 9. Cross-section images of SN 21. Both images $\approx 200X$.

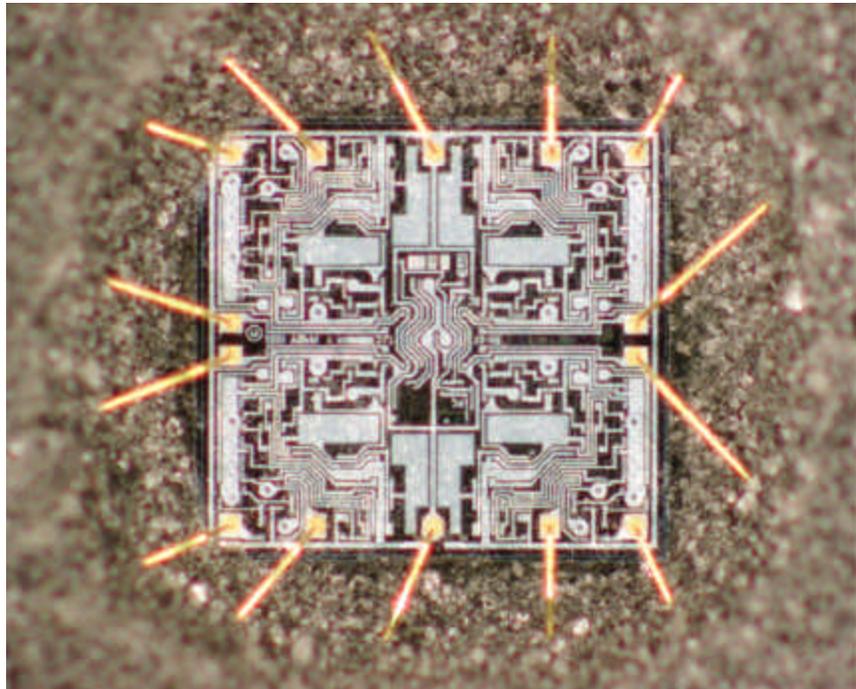
Figure 10. Internal view of SN 24 prepared for internal inspection. $\approx 20X$

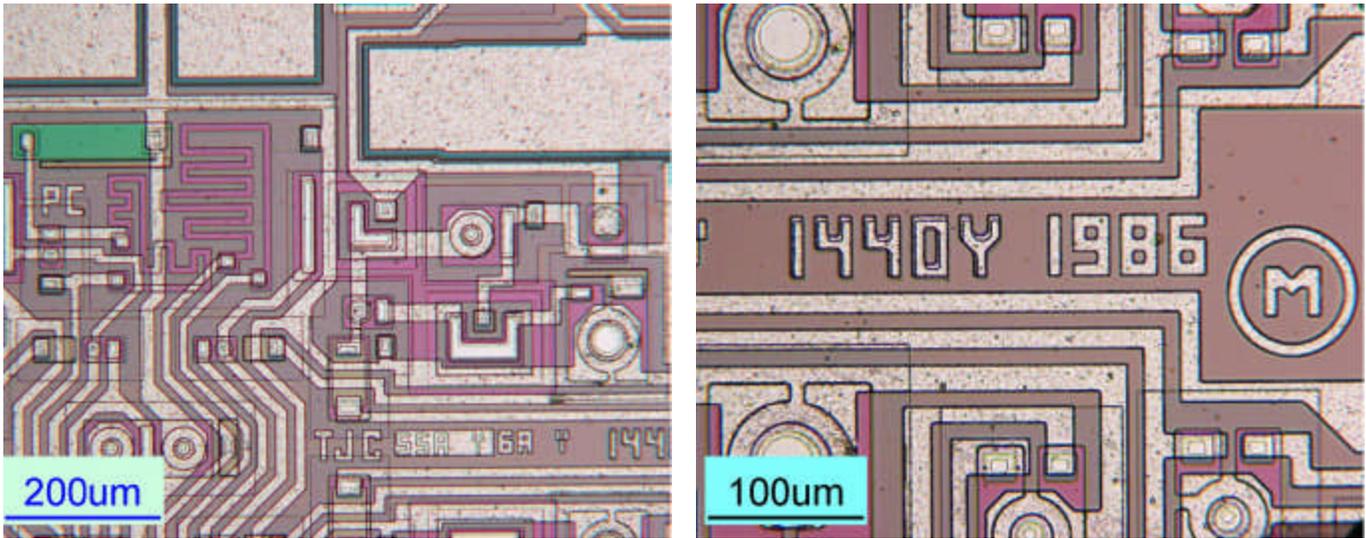
Figure 11. Optical micrograph images show general die features on SN 24.

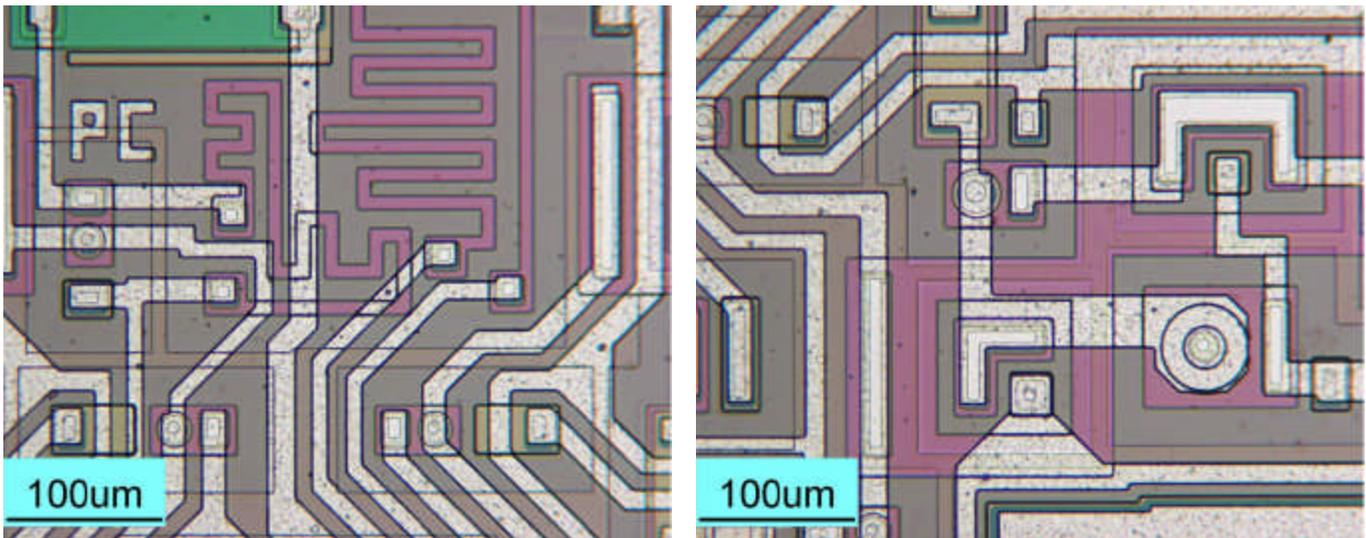
Figure 12. Optical micrograph images show general die features on SN 27.

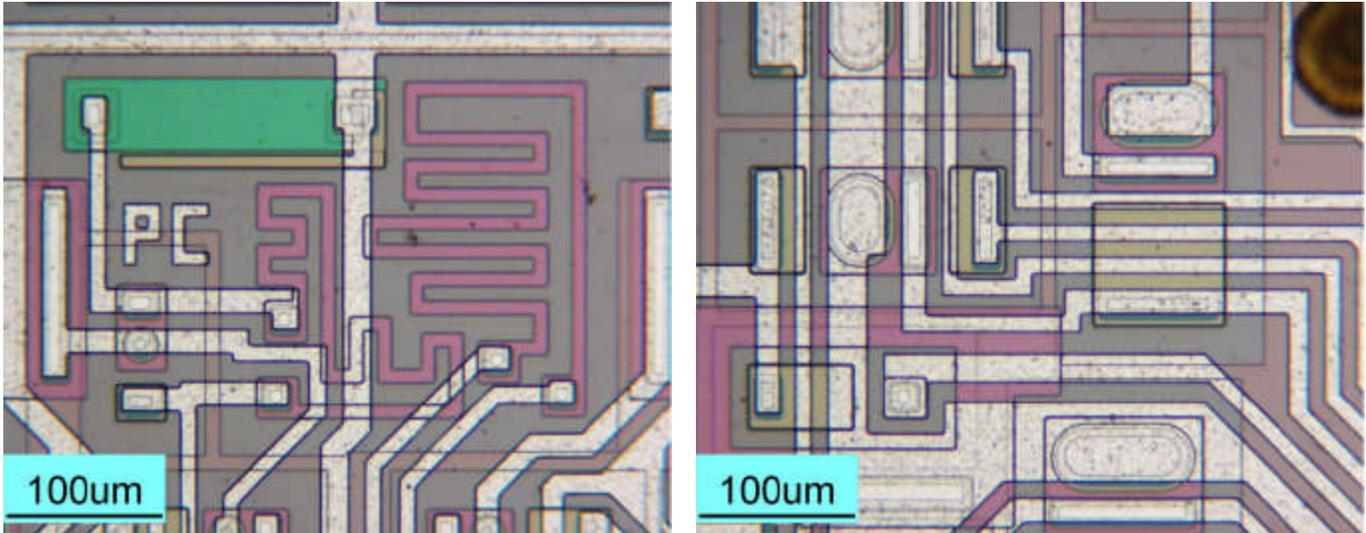
Figure 13. Optical micrograph images show general die features on SN 30.

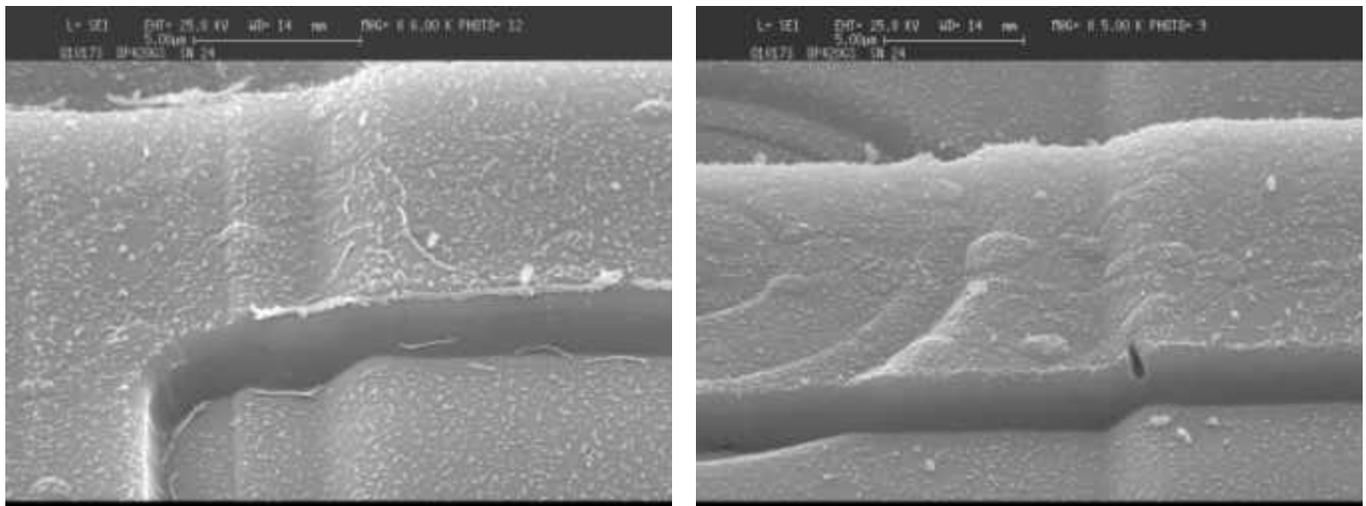
Figure 14. SEM micrographs of SN 24 show excellent step coverage.

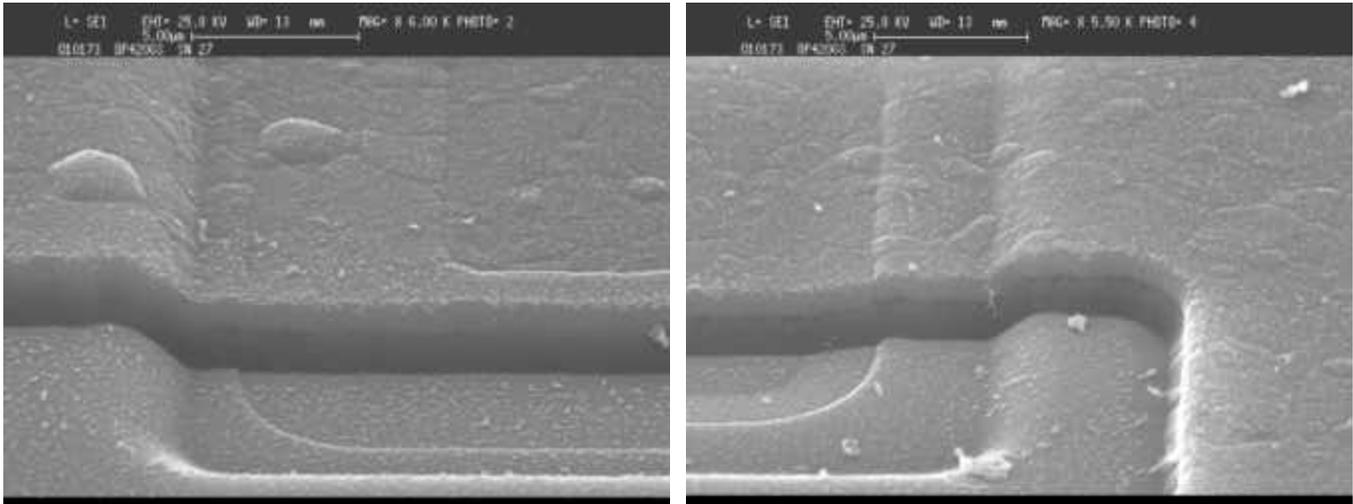
Figure 15. SEM micrographs of SN 27 show excellent step coverage.

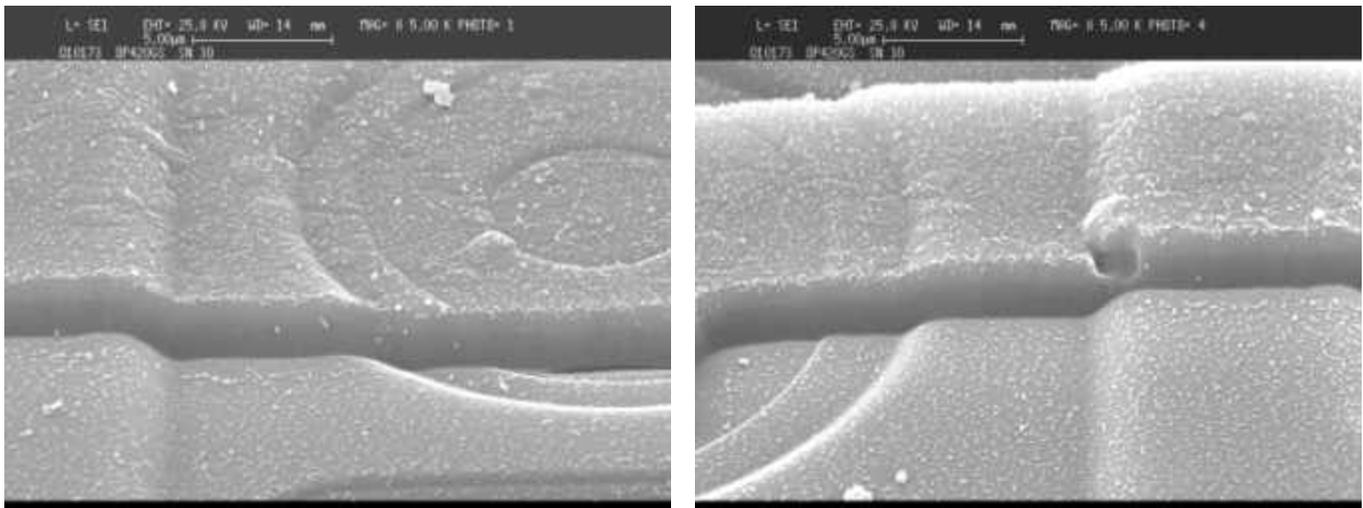
Figure 16. SEM micrographs of SN 30 show excellent step coverage. A minor 'mouse-bite' defect is visible in the right image.
