GODDARD SPACE FLIGHT CENTER

Evaluation Report

Microcircuit (15)
Mfr.: IDT
P/N: 49C465
D/C: 9832

Project
EO-1
System
Parts testing
Requester
Bruce Meinhold (562)
Initiated Date
08/25/98
Investigator
A.Teverovsky (300.1)

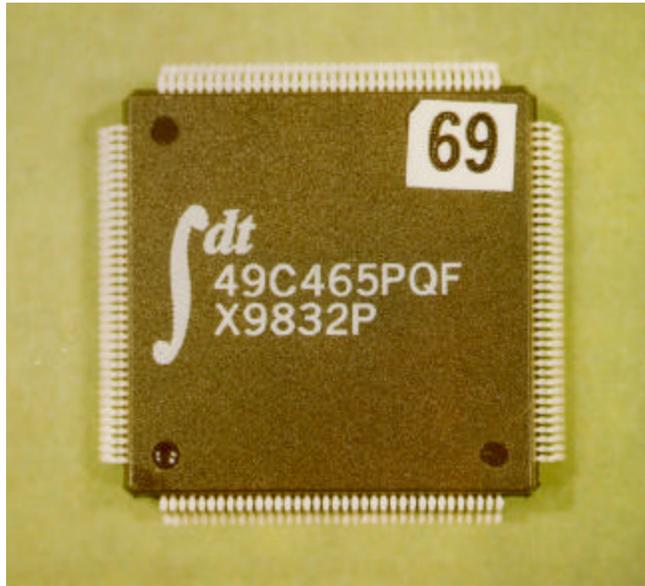
Figure 1. An overall view of the microcircuit.

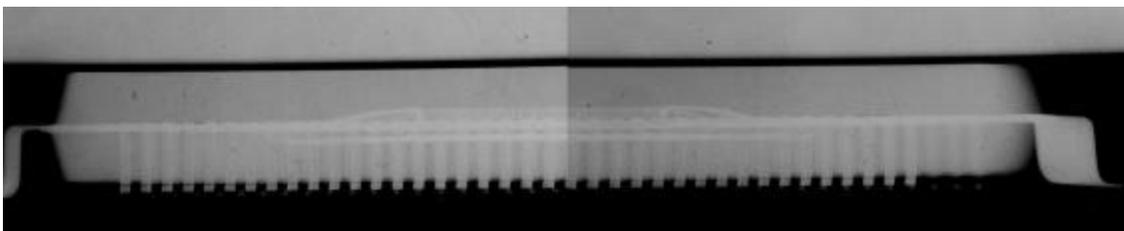
Figure 2. Side X-ray view of the package. (6X)

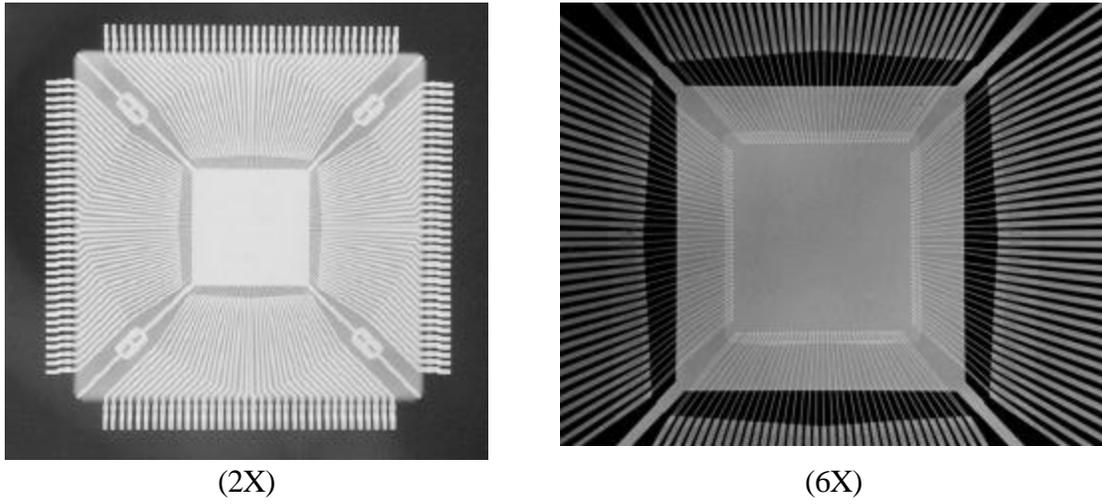
No package warping, cracks, voids, or foreign inclusions in the plastic encapsulant were found. No gaps were found between the leads entry and the molding compound. Radiographic examination showed adequate wire bond dressing. The die-paddle support bars had lead lock holes which enhanced a bond between the molding compound and the lead frame and increased moisture resistance of the part.

Figure 3. Top X-ray views of the microcircuit. Note good wire dressing.

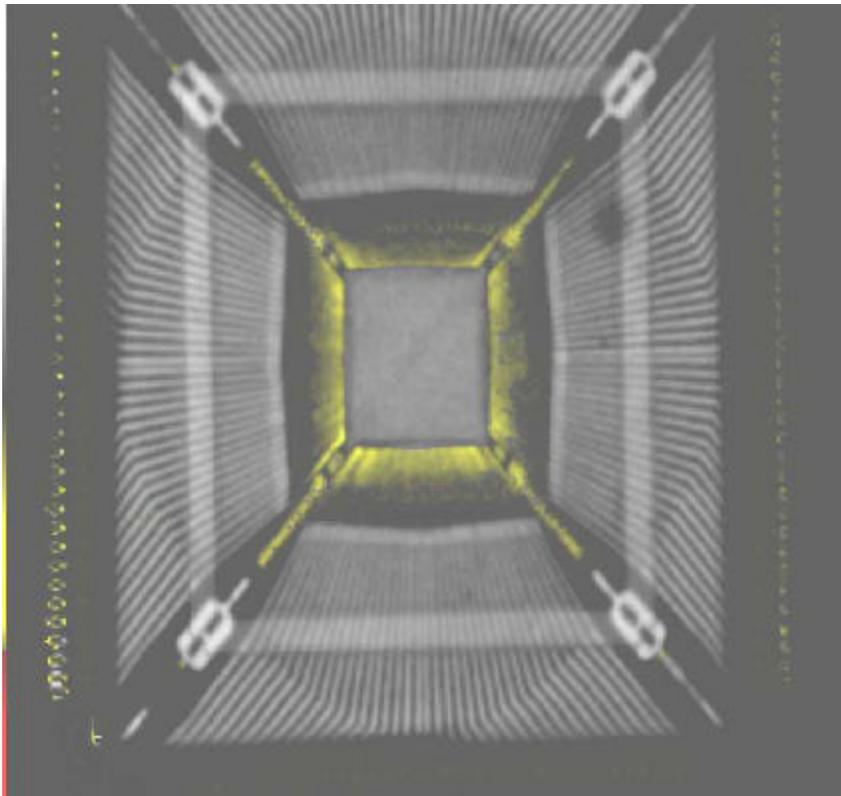
Figure 4. Typical acoustic image of the part. Top view, SN 78.

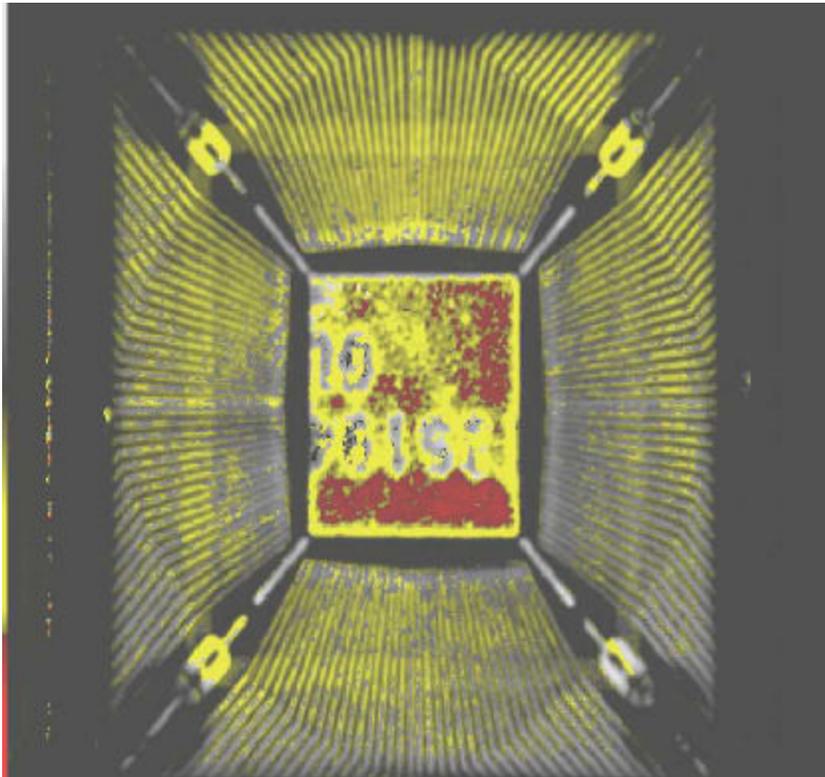
Top and bottom sides of all parts were examined using an acoustic microscope (C-SAM mode with a 30 MHz transducer). All parts had similar acoustic images. Typical images are shown in Figures 4 and 5. No abnormalities at the die-molding compound interface were noticed. Following analysis showed that a square frame on the lead frame was a polymer (most likely Kapton) tape used to support internal part of the leads. Red colors at the bottom view of the die paddle acoustic image indicate delamination at the die paddle-molding compound interface.

This delamination, which was confirmed by acoustic microscopy and cross sectioning, is considered an indication of possible popcorning problem.

Figure 5. Typical acoustic image of the part. Bottom view, SN 81. Red color indicates delamination.

A chemically roughened lead frame would adhere better to molding compound and reduce the risk of popcorning.

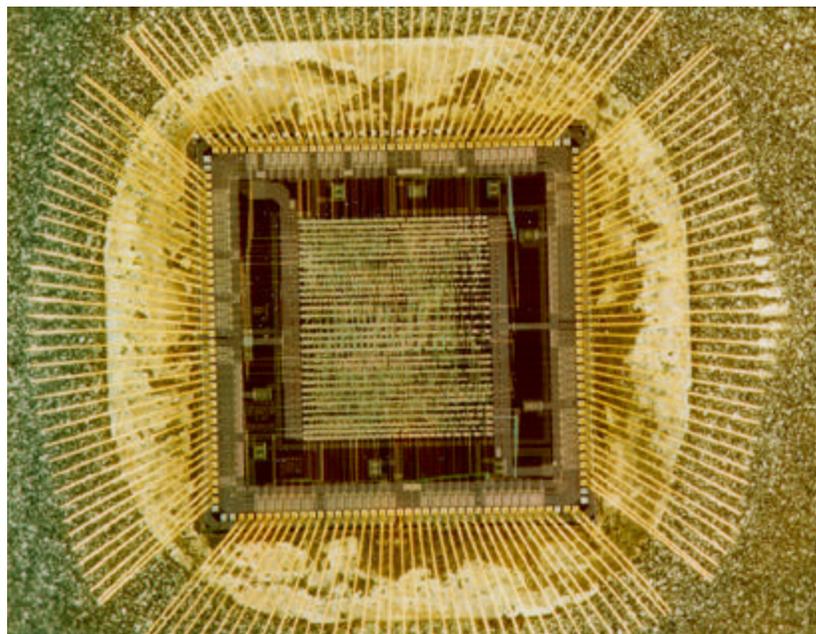
Figure 6. Overall view of the microcircuit after decapsulation, SN 79. (8X)

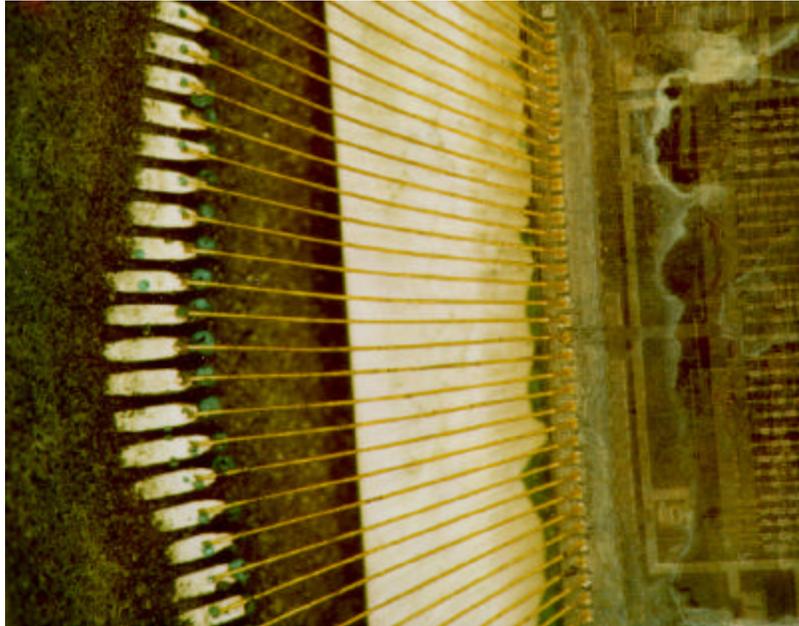
Figure 7. Close up internal view showing products of the acid attack on exposed copper leads, SN 77. (16X)

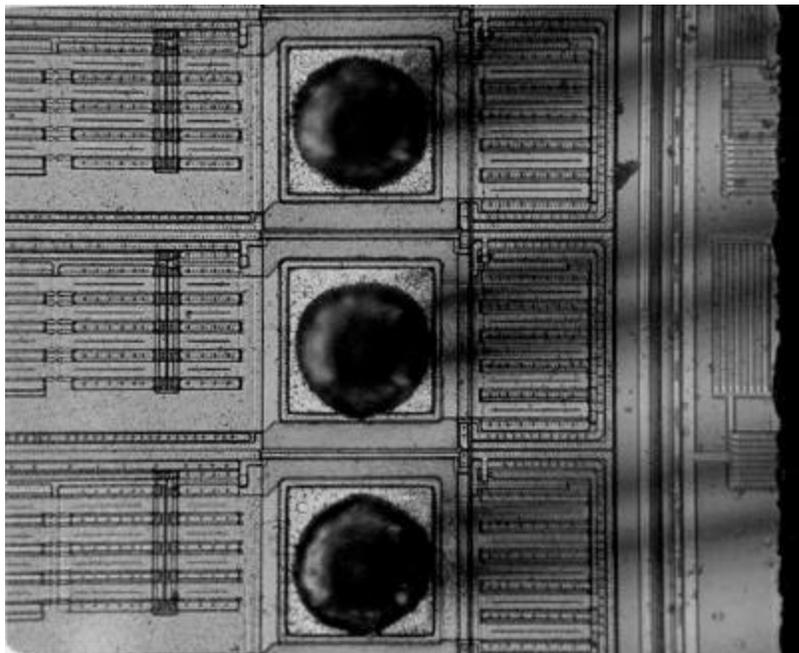
Figure 8. Optical internal view showing typical ball bond alignment, SN 80 (200X)

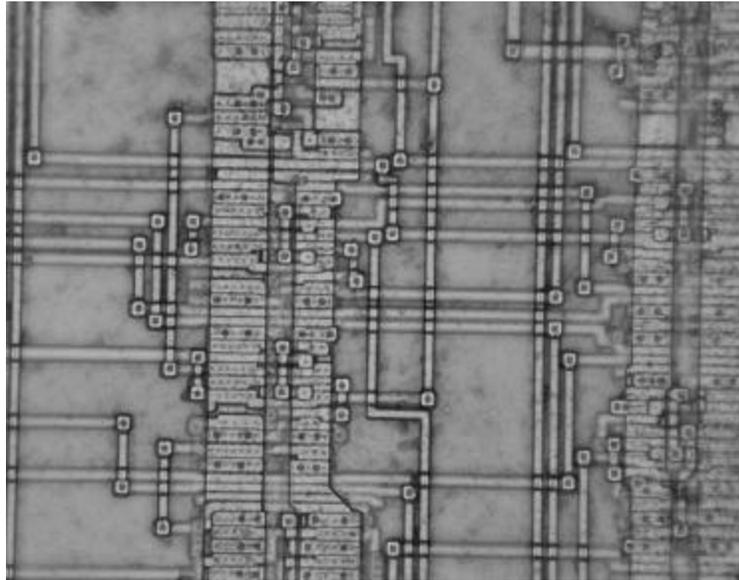
Figure 9. Optical view of the die metalization showing good patterning, SN 81. (500X)

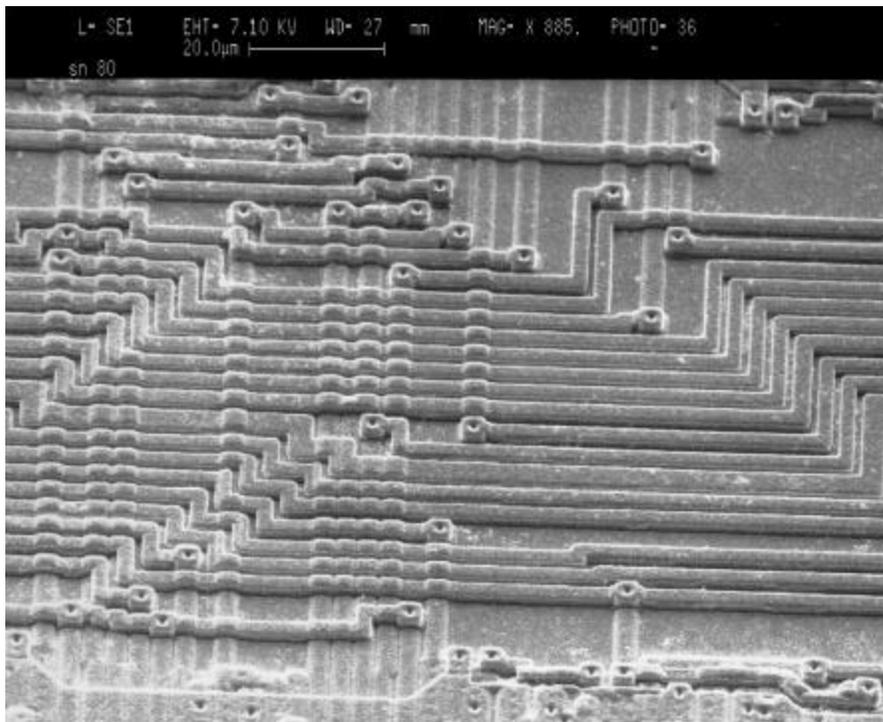
Figure 10. Typical SEM view of the die glassivation showing adequate coverage of the metallization.

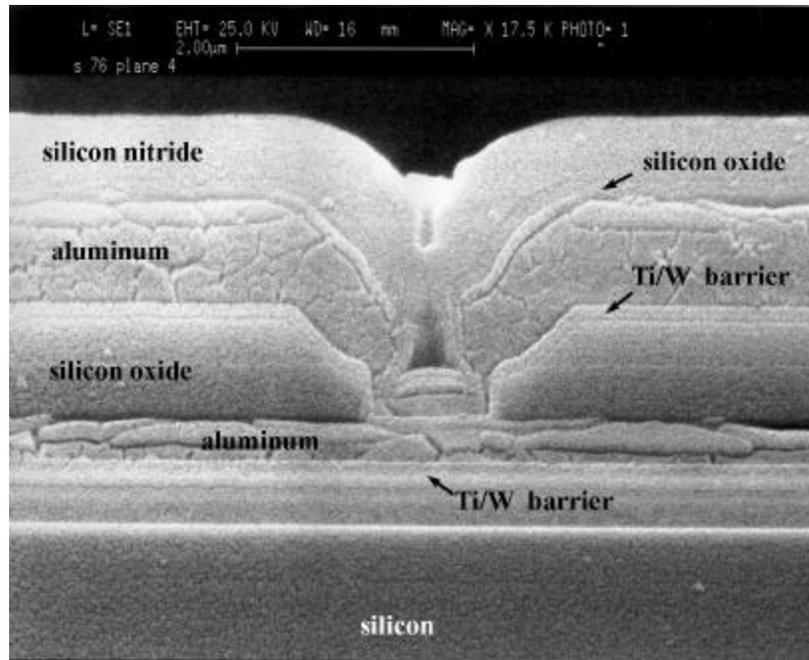
Bonds and glassivation in sample SNs 79 and 80 were inspected using a SEM. No glassivation defects were found (see Figure 10). Energy-dispersive X-ray microanalysis (EDX) indicated that the glassivation was composed of a nitride film. Cross section of the die (SN 76) revealed (see Figure 11) that the glassivation consisted of two layers: the first, most likely, was a silicon dioxide layer (approximately 0.15 μm) and the second was a silicon nitride/(oxynitride) film of approximately 0.7 μm of thickness.

Figure 11. SEM view of the die cross section indicating features of the die technology.

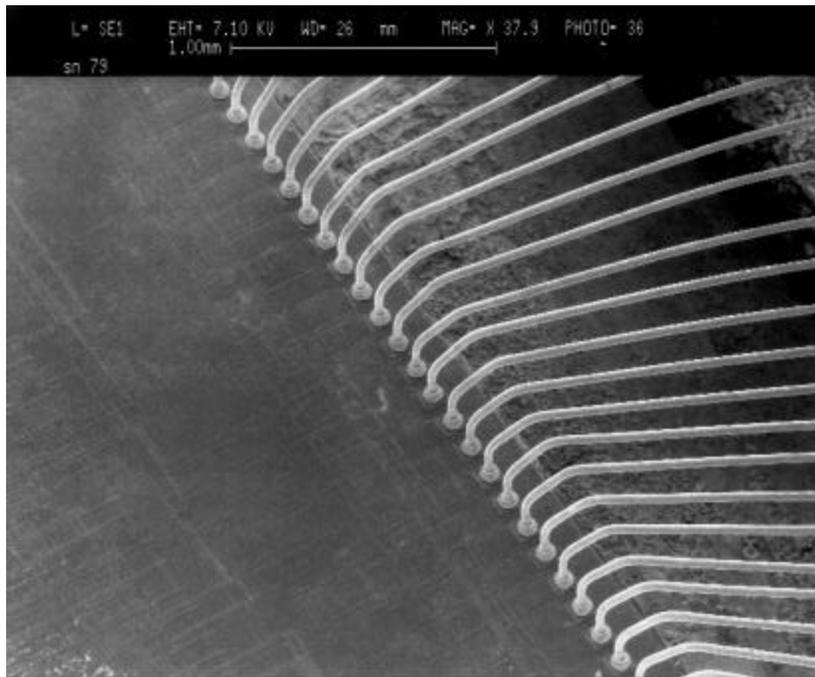
Figure 12. Typical SEM view of wire bond alignment and dressing.

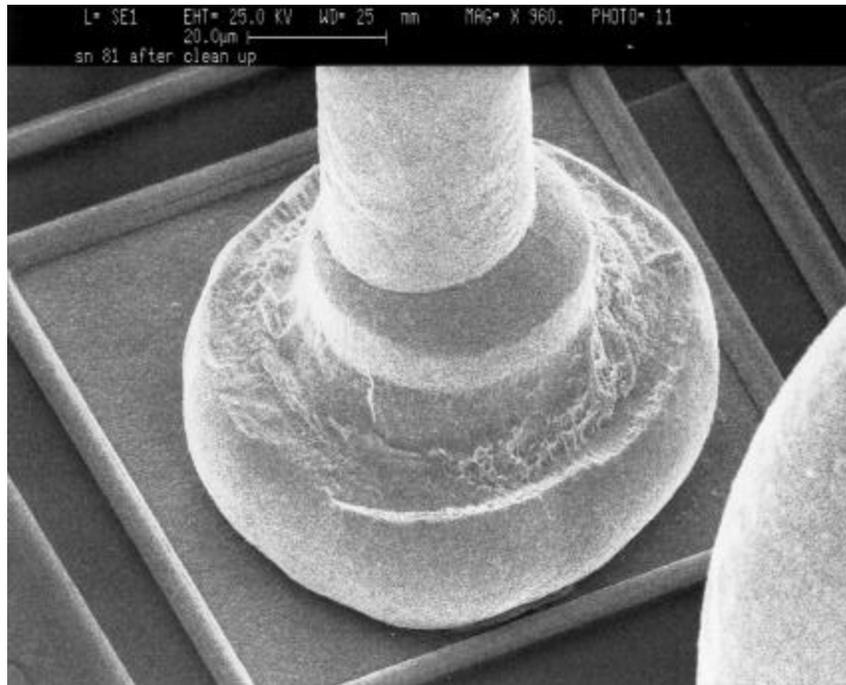
Figure 13. Typical SEM view of a wire ball bonding showing good deformation and placement.

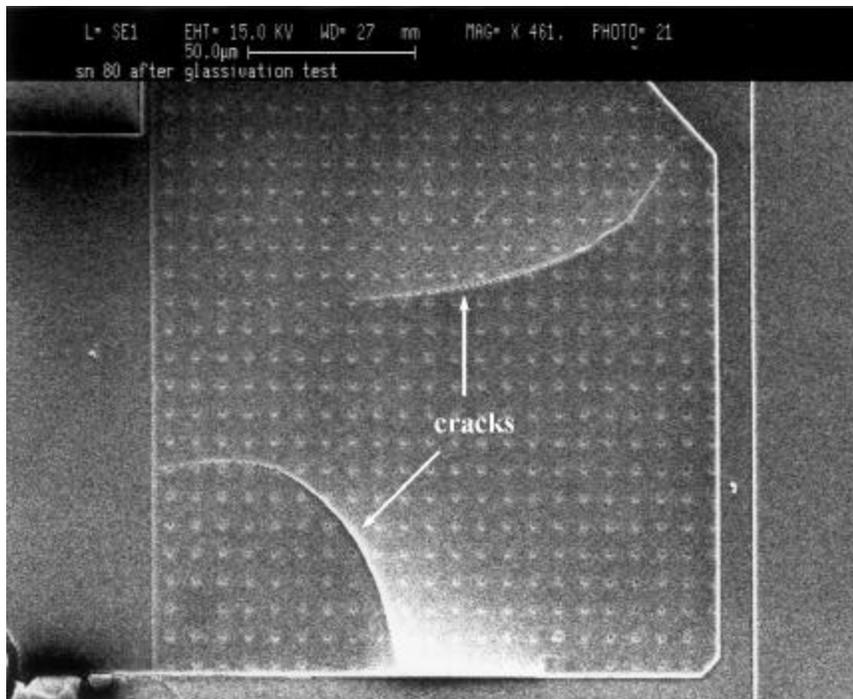
This examination was performed on samples SN 79 and SN 80 per MIL-STD-883D, Method 2021, "Glassivation layer integrity". The test involved a high power optical examination after the die was subjected to an aluminum etch. Multiple sites of aluminum corrosion were observed on both samples, mostly at the periphery of the dice. Figures 14 and 15 give typical SEM views of the failed sites. As no similar defects in the nitride films were seen before the glassivation integrity test, most likely they were created by a chemical attack on the aluminum metallization. Fine preexisting cracks (or pores) allowed acid attack on aluminum resulting in corrosion. Aluminum corrosion products have approximately three times the volume of pure aluminum, thus resulting in a swelling of the nitride film and widening of the cracks.

The defects in glassivation were mostly found along the metallization lines at the periphery of the die. This can be explained by increased shearing stresses at the die edge. These stresses (caused by molding compound-die CTE mismatch) being applied to the glassivation “bumps” (along metallization lines) may have caused fine cracks which later developed under acid attack. A “bumpy” surface of glassivation significantly increases the possibility of crack formation. This possibility is usually minimized using a polyimide coating which enhances the interfacial integrity and provides surface planarization and stress relief. For example, a polyimide film 8 μm thick will reduce the failure rate by a factor of 3 during thermal shock test.

Rejectable defects (per MIL-STD-883, TM 2021) were observed along the periphery of the die during the glassivation integrity test. The lack of polyimide conformal coating, which is commonly used in similar parts, probably resulted in increased mechanical stresses and caused cracking of the silicon nitride glassivation layer.

Figure 14. Cracks and peeling of the silicon nitride film after glassivation integrity test.

To ensure the quality of the parts, additional analysis of their thermomechanical robustness, including SMT simulation tests and multiple thermal cycles/thermal shocks are recommended.

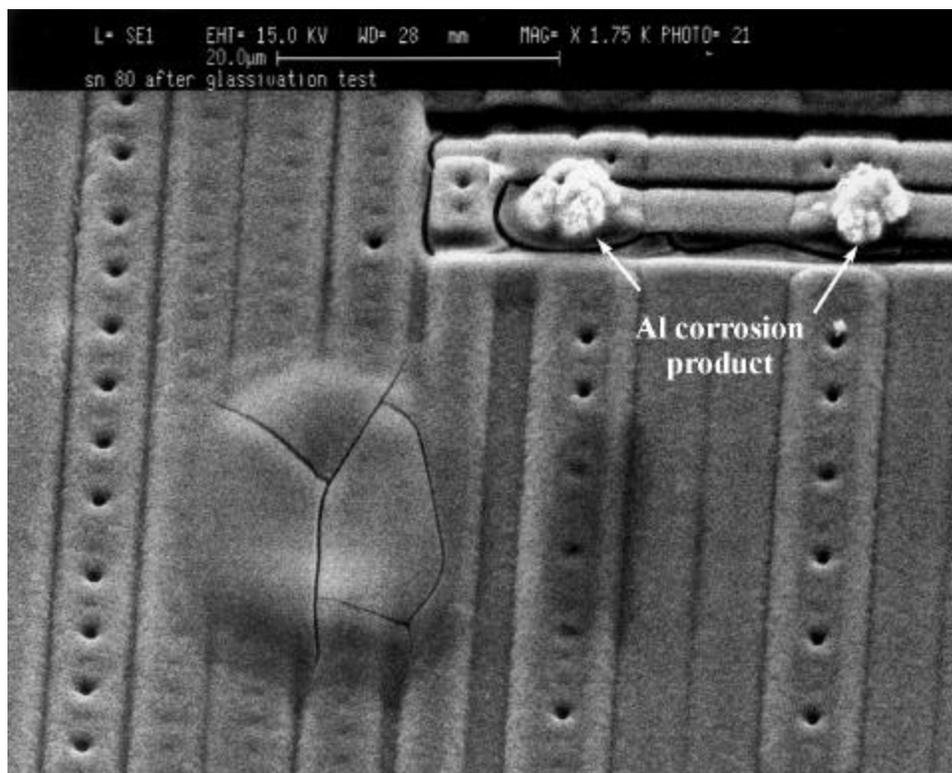
Figure 15. Typical defects revealed during the glassivation integrity test.

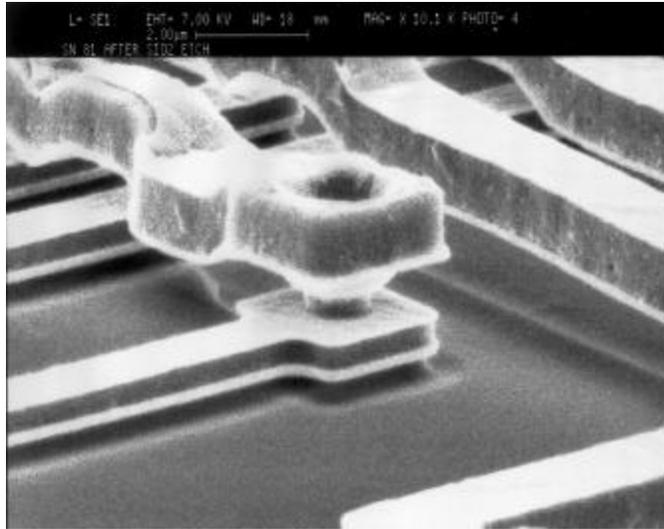
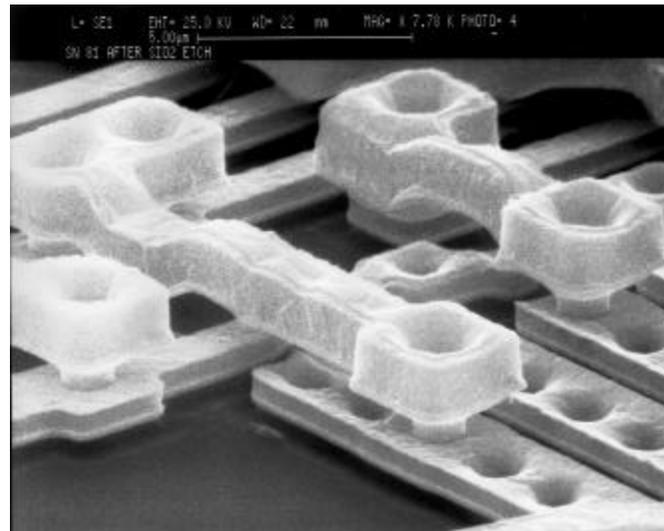
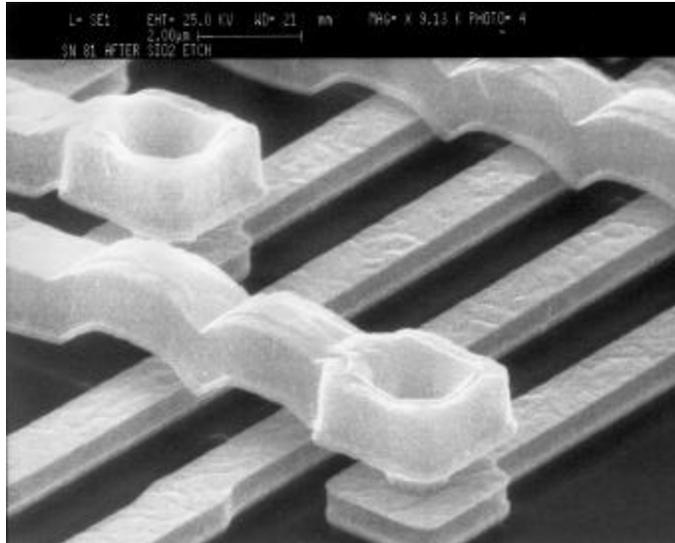
The metallization was inspected in SN 81 per MIL-STD-883D, Method 2018 after glassivation removal. No patterning problems or other defects were found in top and bottom metallization layers. Metallization is shown in Figures 16, 17, and 18. The minimum line width was 1.2 μm . EDX analysis showed that Ti/W alloy (approximately 0.1 μ of thickness) was used as a metallization barrier layer. No void or thinning problems were observed with the Ti/W layer.

Figures 16 - 18. Typical SEM views of the top and bottom metallization.

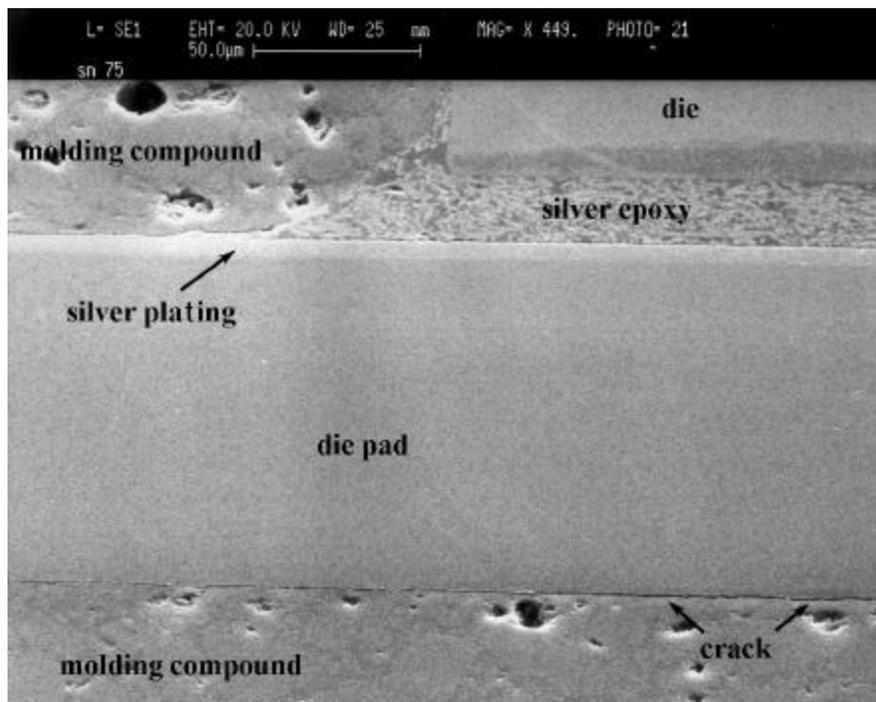
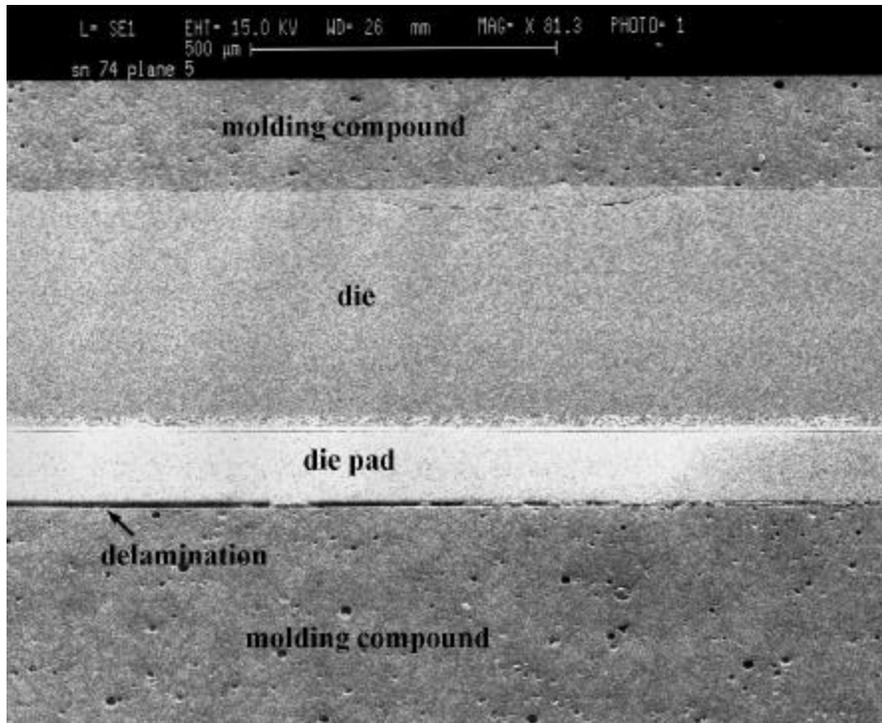
A gap between the molding compound and the back side of the die paddle was observed in both parts in the central area of the pad. The gap width gradually increased toward the center of the die

paddle reaching several micrometers of thickness (see Figures 19 and 20). The gap widened to approximately 10 μm after the part had been heated to 70 °C for half an hour, then cooled to room temperature.

of thermal expansion (CTE) for copper and molding compounds match each other better thus reducing thermomechanical stress and the possibility of delamination. Poor adhesion between the copper and the molding compound might be due to an excessive copper oxide film which usually grows during high temperature assembling processes (wire bonding and post mold curing).

Figures 19-20. SEM views of cross sections showing gaps between the die pad and molding compound.

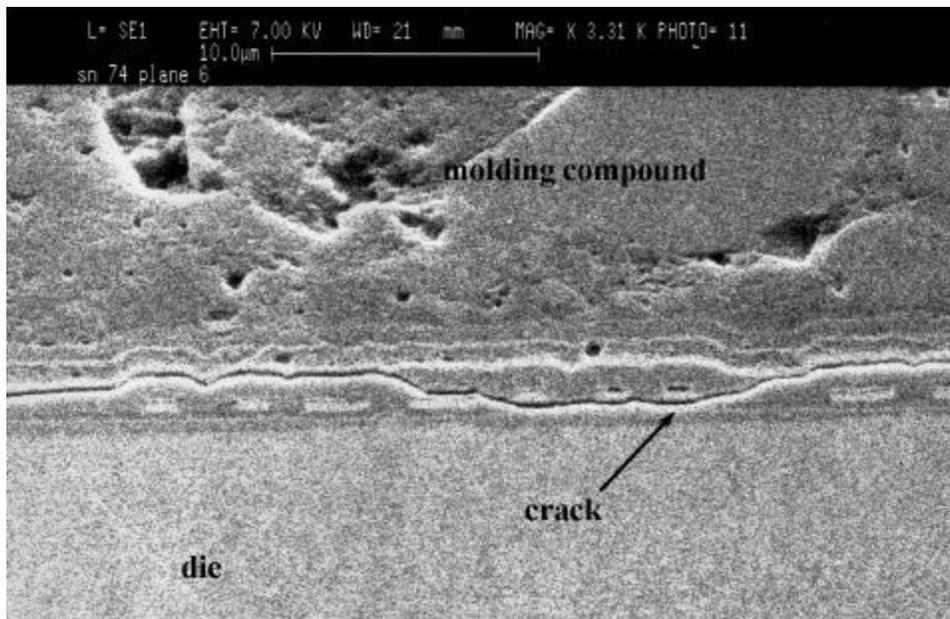
Both samples had longitudinal cracks along the silicon-oxide and/or oxide-metallization interfaces (see Figure 21). At the wire bond areas these cracks indicated cratering (see Figure 22). As no cratering was observed during the wire pull tests and no cracks were found during the bare die (SN 76) cross sectioning, these cracks were probably artifacts caused by the package cross sectioning.

It is known that the tendency to crater predominates in thin aluminum metallization. However, a hard titanium-tungsten underlayer should reduce the possibility of cratering. In this study, cratering and cracks along the die surface were revealed only when encapsulated parts were cross sectioned. These defects were not exposed during wire pull tests or cross sectioning of a bare die. One explanation assumes that the surface layers of an encapsulated silicon die are highly stressed and prone to crack formation and cratering. In that case, even minor mechanical disturbances during cross sectioning would be sufficient to cause fracturing.

Figure 21. SEM view of the crack along the die surface. Similar cracks were observed at all cross sections of the parts.

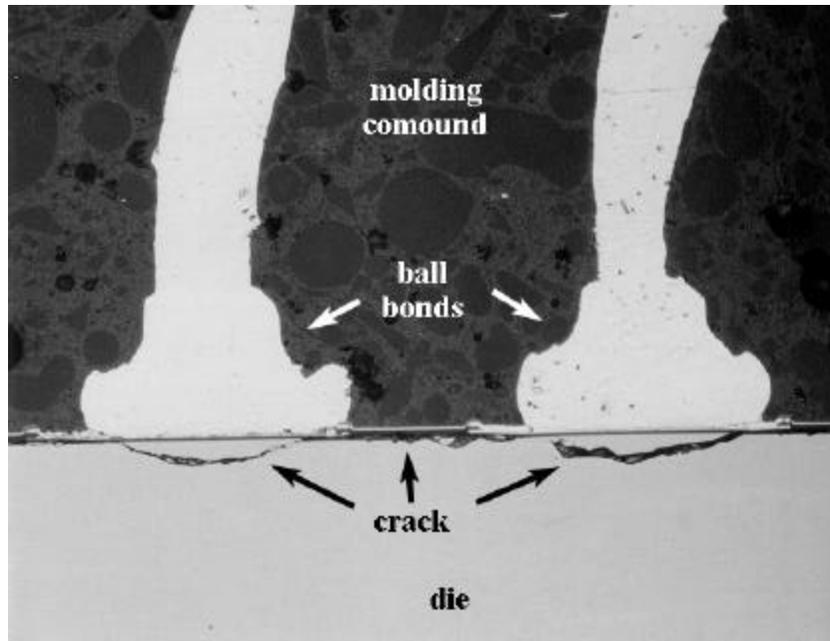
Figure 22. Optical view of the wire-to-contact pad cross section, SN 75. The cracks indicate possible cratering problems. (920X).

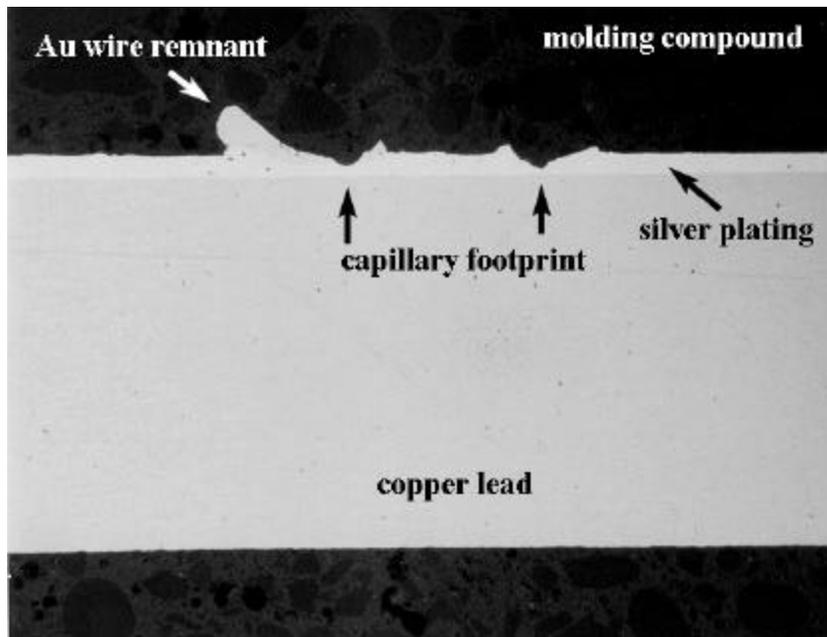
The gold wires formed adequate metallurgical contacts with the silver plating at all examined wire-to-lead frame bonds (see Figure 23).

Figure 23. Optical view of the wire-to-lead bond cross section, showing adequate deformation at stitch bonds, SN 75. (400X)

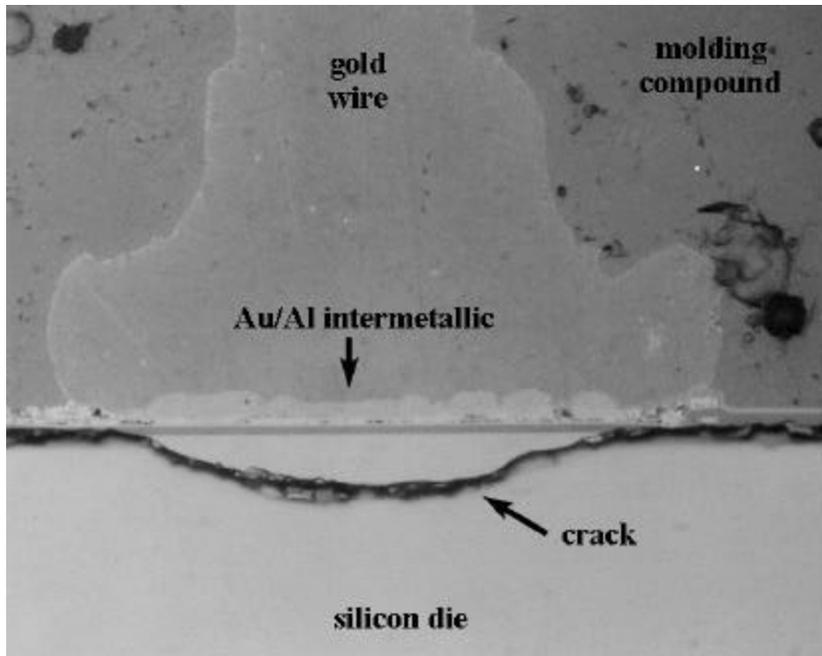
Figure 24 gives an optical view and Figure 25 gives a SEM view of typical ball bond cross sections. Aluminum metallization under the contact pads was mostly consumed during bonding forming an Au/Al intermetallic layer (of light-gray color) 2 - 3 μm thick). No Kirkendall voiding was observed.

Intermetallic formation at the ball-contact pad interface is normal and suggests a good metallurgical contact between the gold wires and aluminum metallization. Light-gray color of the intermetallic layer indicates normal low temperature Al/Au compounds. Due to a relatively thin (1 – 1.5 μm) layer of aluminum metallization, practically all the aluminum was consumed to form an intermetallic alloy. This may cause problems if the parts are used at elevated temperatures (more than 125 °C) for a long period of time, due to the possible formation of Kirkendall voids along the periphery of the bonds.

Figure 24. Optical view of a wire-to-die ball bond showing intermetallic at the bond interface, SN 75. (1000X)

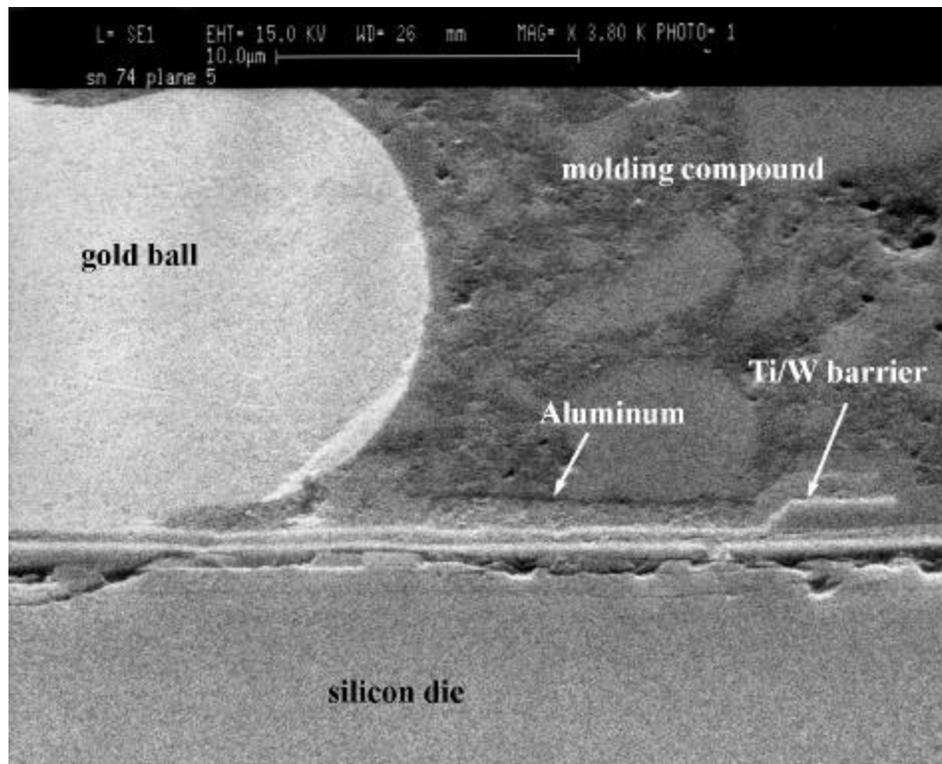
Figure 25. SEM view of the ball bond-to-die cross section.
