NASA ELECTRONIC PARTS & PACKAGING (NEPP) PROGRAM

EEE Links

March 2000, Vol. 6 No. 1

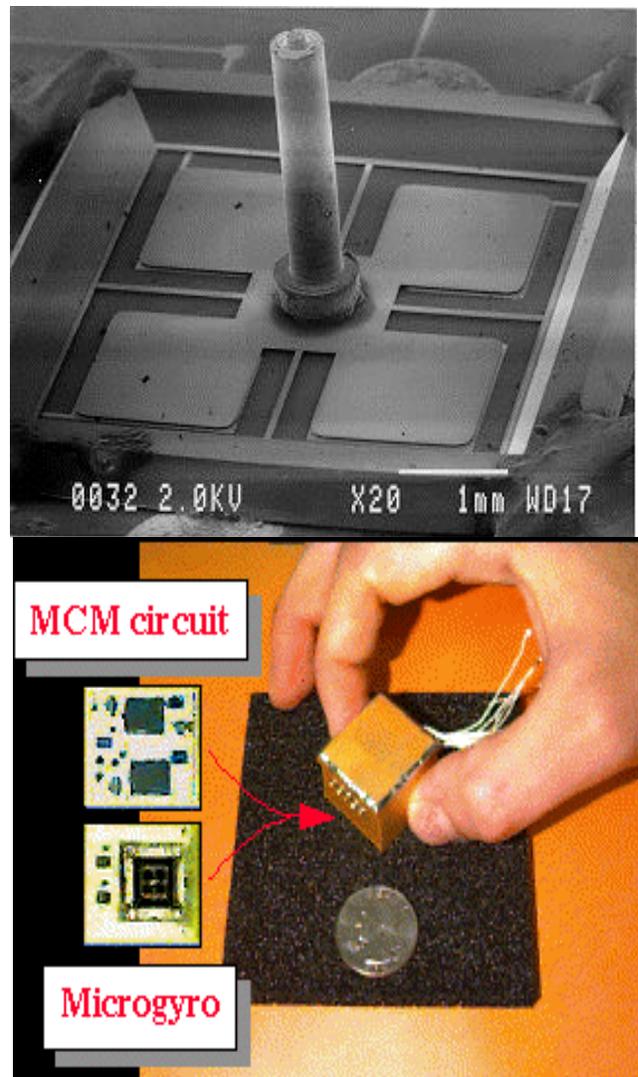
Figure 1. Packaging and Interconnect Development of JPL developed MEMS devices for Space Applications (Courtesy: Tony Tang, MDL/JPL)

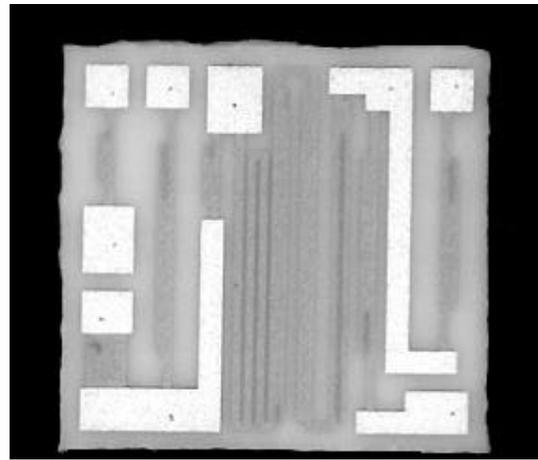
Figure 1. Overall view of the Hubble resistor network.

This investigation into the sensitivity of thin-film resistors to damage from electrostatic discharge (ESD) began as a result of a failure investigation². A hybrid electronic module for the Hubble Space Telescope gyro assembly failed during ground-level testing. The failure was isolated to a single 1500-ohm resistor within a thin-film resistor network chip, shown in Figure 1, that had developed an open circuit. This particular resistor had been connected between an isolated pin on the hybrid package and ground, and it was used as a precision reference resistor. Visual examination showed damage in the form of apparent cracks in the resistive film, in this case nichrome. These "cracks" (shown in Figure 2) were perpendicular to the major axis of the resistor and were crowded together in areas where the trace width was a minimum.

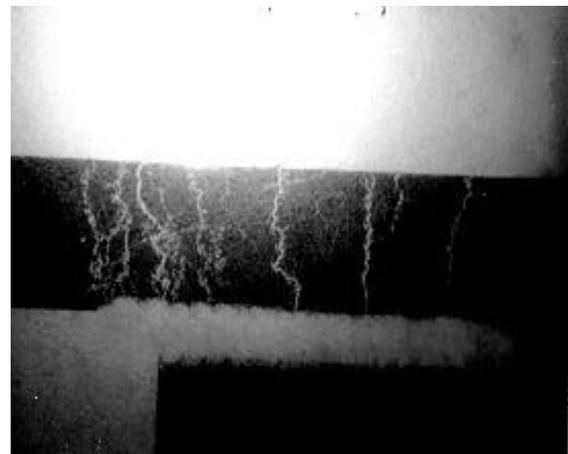
Figure 2. Close up vicinal view of the damage to the Hubble resistor.

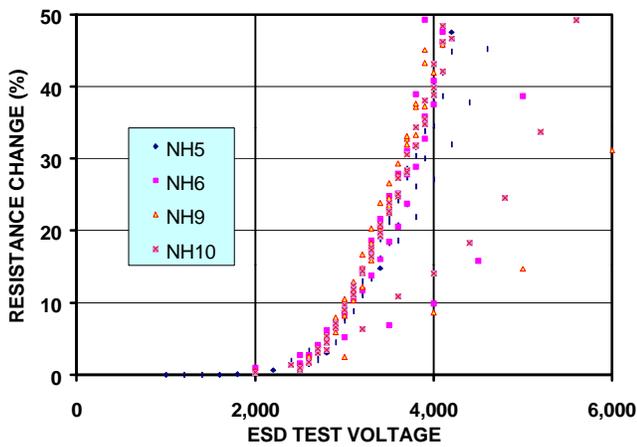
Figure 3. Typical reaction to ESD for nichrome resistors such as these 1250 ohm resistors

There was a general trend among all samples that the damage threshold was proportional to the resistance of the trace being tested. As a rough rule of thumb, the damage threshold was approximately 1 volt/ohm. Multiple identical samples exhibited similar behavior, but the response was not perfectly predictable as shown in Figure 3. Initial intent was to measure physical dimensions of the resistor elements and attempt to relate these dimensions to ESD sensitivity. In fact, it was soon found that the simple effects of dimensional variation were overshadowed by the effects of configuration features in the resistor trace patterns, particularly serpentine and laser trims.

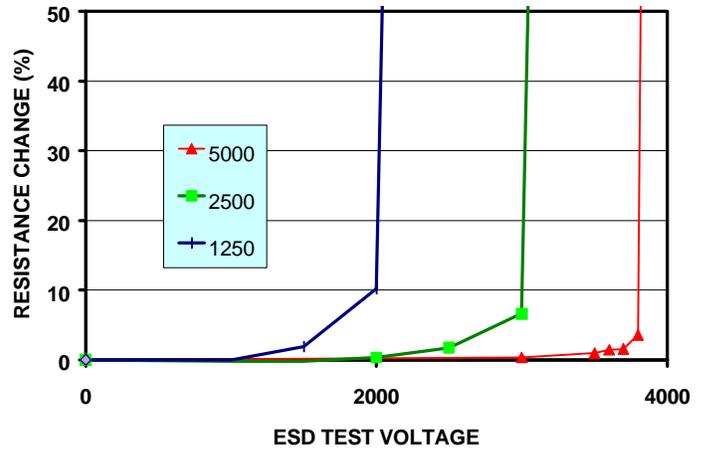
Figure 4. One pattern with polymer coating over the resistive elements showed this dramatic reaction to critical voltages.

A polymer coating (assumed to be polyimide) on two of the test samples produced some interesting results. At low ESD voltage, the polymer apparently acted as an insulation blanket, preventing heat flow out of the resistor trace, especially in corners. As a result, these samples exhibited much heavier localized damage, wider cracks in the nichrome traces, and very predictable response as shown in Figure 4. At higher voltages, the coating apparently produced a carbon surface track during arcing events. Development of this stable arcing path protected the resistor from further degradation during repeated high-voltage ESD events.

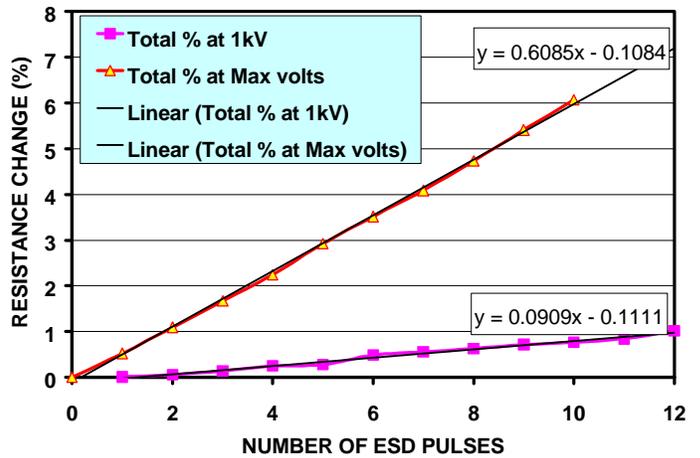
Figure 5. Pattern ND showed a linear reaction to repeated pulses at fixed voltages of 1kV and at 15.5kV

A few resistors were exposed to repeated ESD pulses at the same voltage, with resistance measurements between pulses. Plots of these data (see Figure 5) show that the resistance increase was basically linear, with a slope proportional to the imposed ESD voltage.

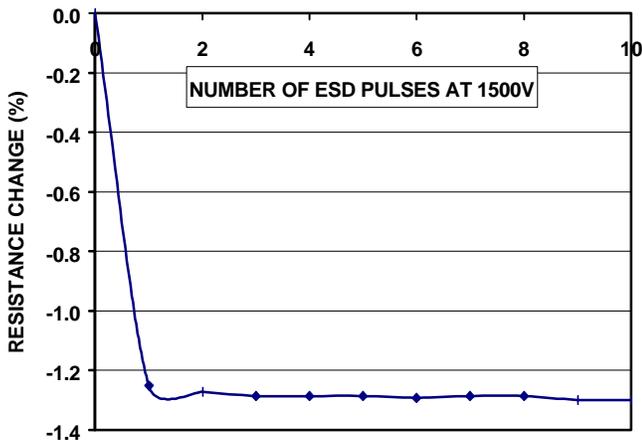
Figure 6. Significant resistance decrease exhibited by tantalum nitride pattern TF.

from 100 to 15,500 volts in steps ranging from 100 to 1000 volts. In all cases, the resistance decreased after each pulse until approximately 3500 volts, at which point it increased rapidly. The maximum resistance changes measured were approximately 3.8 percent negative and 25 percent positive. Figure 6 shows the typical ESD-induced resistance decrease for a tantalum nitride resistor. One group of resistors was tested at opposite polarity, with close correlation of the parts within each test condition. Those tested with the high potential connected nearest the laser trim experienced larger resistance shifts (both positive and negative) than the resistors tested with the low potential near the laser trim. It is unclear what importance this may have, and further investigation is planned. Additional testing on tantalum nitride resistors in general is planned for the next phase of this study.

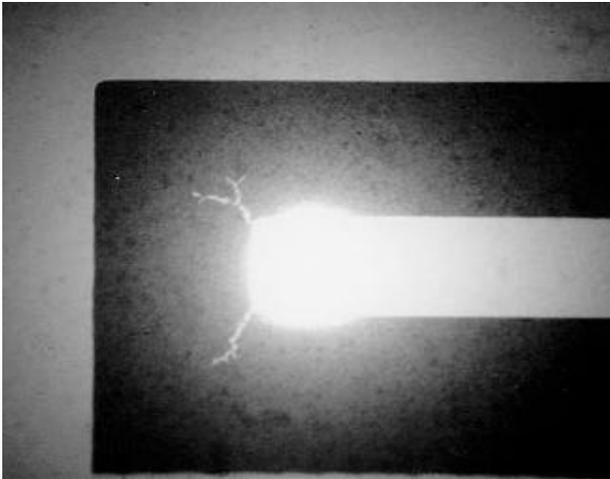
Figure 7. Vicinal illumination view of corner crowding induced damage.

The damage associated with the lowest voltage (and therefore lowest energy) pulses above the damage threshold involved the appearance of “cracks” in the resistive trace at corners and the tips of laser trims. These features resembled the branches of trees in that they split into numerous smaller paths as they developed at higher voltages. It is believed that these features were not actually cracks in the truest sense of the term because they were most likely thermally generated and not strictly mechanical in nature, but the term “crack” best describes their appearance. Vicinal-illumination inspection confirmed that the opaque resistive material was missing within these crack features. Their appearance and location suggest that the cracks result from higher current density around corners in the resistive trace (current crowding). Hagedorn and Hall¹⁸ have shown that the maximum current density in a right-angle turn with a radius of 1% of the trace width (a relatively sharp bend) is more than six times the current density in the straight portion of the resistive trace. Figures 7 and 8 show examples of corner-crowding-induced cracks. In some cases, cracks were observed across the entire width of the resistive trace, but often crack growth was suspended by the transition to internal or external arcing, which shunted the current, preventing it from flowing through the portions of the resistor that exhibited corner cracking. This transition was heavily influenced by the increase in resistance associated with the corner-cracking mechanism.

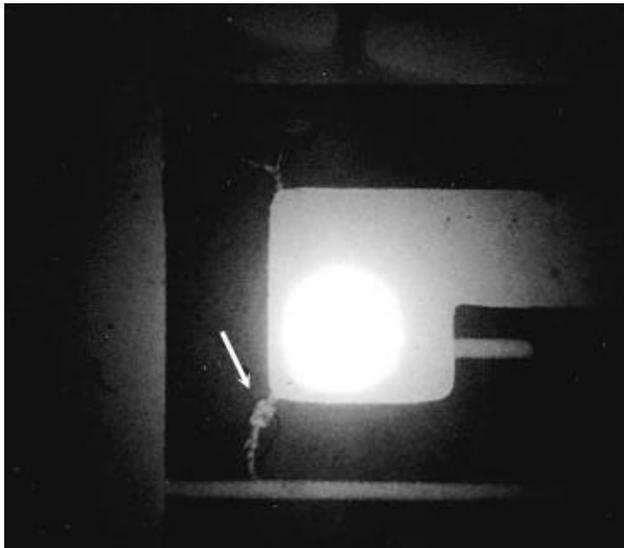
Figure 8. Typical corner crowding damage in a polymer coated resistor.

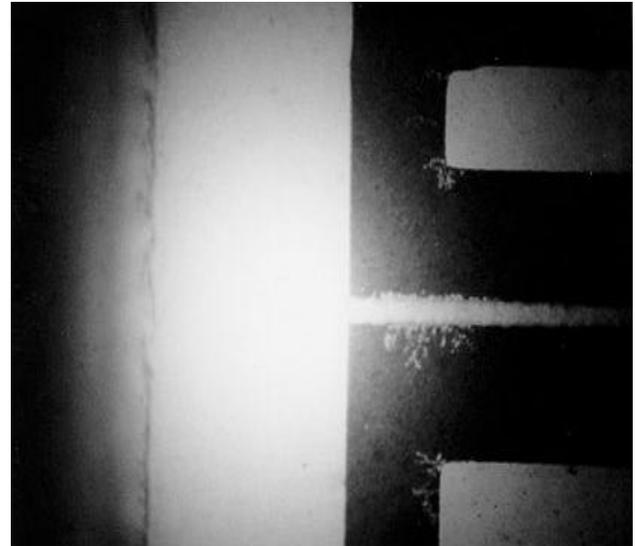
Figure 9. Vicinal illumination view of internal arcing damage.

the resistance change evidence, vicinal-illumination inspection revealed a distinctive appearance for the damage resulting from internal arcing. The low-potential side of an arc always exhibited a branched crack structure extending into the trace from an edge, and the high-potential side exhibited only a few small chunks of nichrome missing from the edge of the trace. Examples of the damage caused by internal arcing are shown in Figures 9 and 10. During some

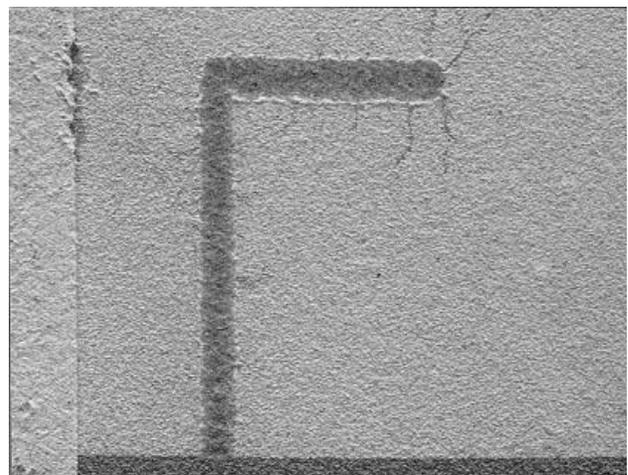
Figure 10. SEM view of ESD damage in a tantalum nitride resistor. Note the internal arcing damage to the left of the laser kerf.

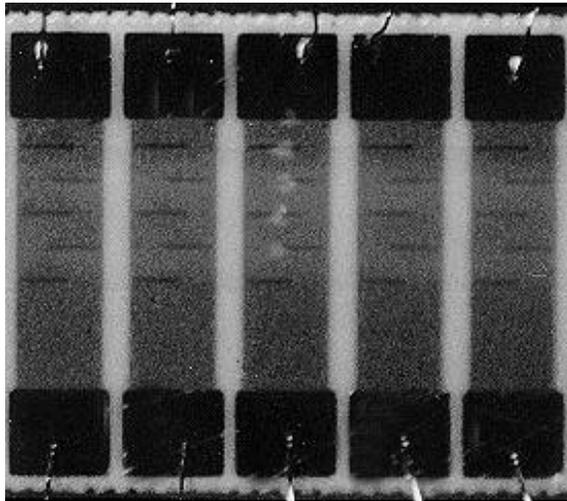
Figure 11. A photograph taken during an ESD induced arc event. Note the location of the arc on the center resistor.

what higher-voltage ESD pulses, arcs were observed directly using a stereomicroscope. Several of these arcs were photographed (see Figure 11), recording locations of the arcs. Internal arcing was often accompanied by the transverse cracks first observed in the Hubble failure (see Figure 12). It is believed that these cracks were the result of increased current density along thin areas of the nichrome, exacerbated by the low effective resistance experienced by the arc, producing higher current flow. At higher ESD voltages, external arcing tended to predominate.

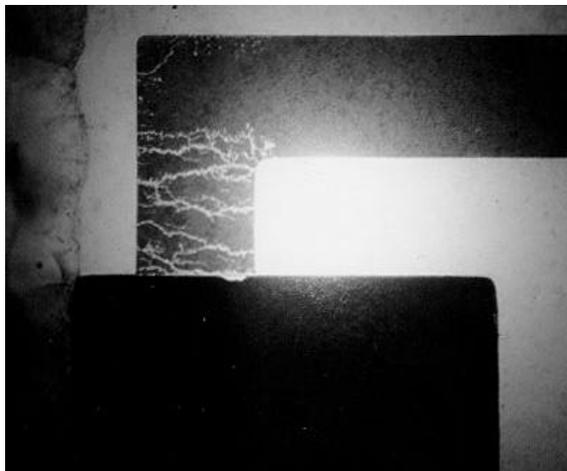
Figure 12. Vicinal illumination view of transverse cracking typical of relatively high voltage ESD damage.

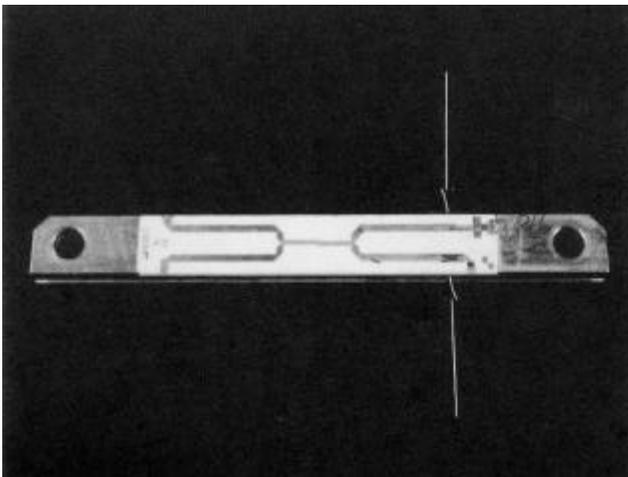
Figure 1. An overall view of a cracked amplifier substrate.

Electrical testing of a high frequency amplifier for use on the TOPEX satellite revealed that several thin film microwave substrates had cracked during mounting into the chassis. A nondestructive method of screening was required to ensure that the remainder of the substrates in the chassis did not contain any latent defects. Standard visual inspection was not considered reliable, and the use of dye penetrant would have contaminated the space flight hardware. A bright field microscope was fitted with a long working distance lens from a macro camera for the inspection. A video camera and large screen television were added to reduce eye strain and allow several people to inspect the samples simultaneously. Each of approximately one hundred substrates was inspected around the perimeter, and through the center of the substrate. No additional cracks were observed in electrically functional areas, and the amplifier was flown with a high level of confidence. This amplifier is still in operation today.

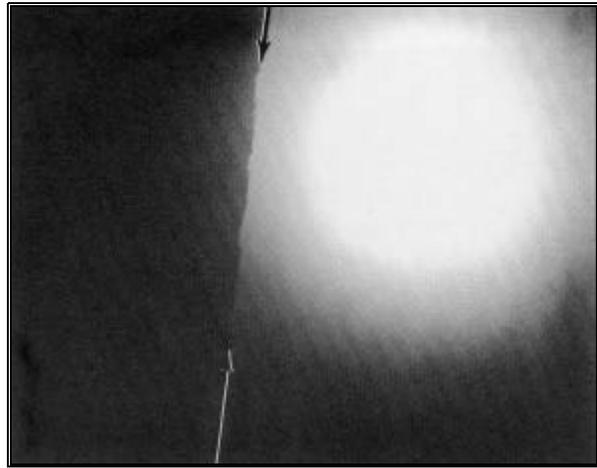
Figure 2. A vicinal illumination close-up view of the crack indicated by the arrows.

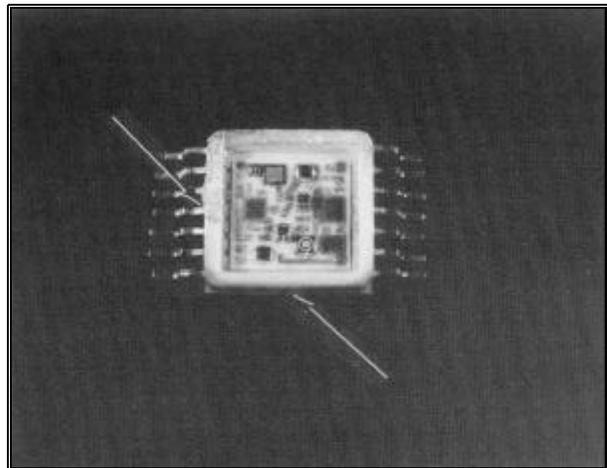
Figure 3. An overall view of the hybrid package.

A hybrid microcircuit used in the POLAR spacecraft failed electrically during testing. The package, which was made from thick film substrate material, was inspected using bright field light scattering, which revealed a crack across one corner. This technique was also able to show the shape of the crack. From this information the crack initiation site was traced to one of the package leads. It was subsequently discovered that moisture leaking through the crack had caused dendritic growth within the package, leading to the electrical failure. This failure was associated with a lack of hermeticity in the ceramic package.

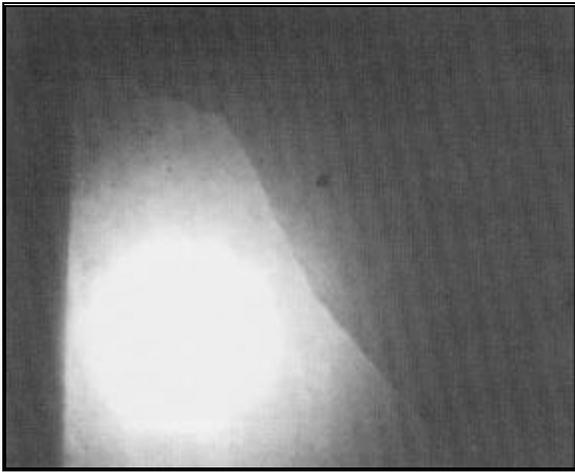
Figure 4. A vicinal illumination close-up view of the crack which resulted in a leak path. Vicinal illumination was used to trace this crack across the entire corner of the package.

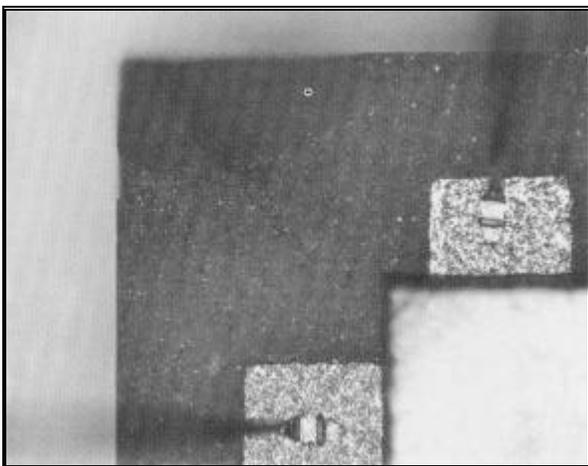
Figure 5. An overall view) of a chip-out in a multichip module.

Bright field inspection of a multichip module showed a small chip-out in one corner of an alumina substrate. The chip-out seemed to be isolated from any electrical circuitry, and not a reliability risk. Vicinal illumination, however, revealed a crack extending from the chip-out toward an electrical connection, which could eventually result in device failure during use. The existence of this crack underscores the need for careful handling and inspection during the processing of advanced components.

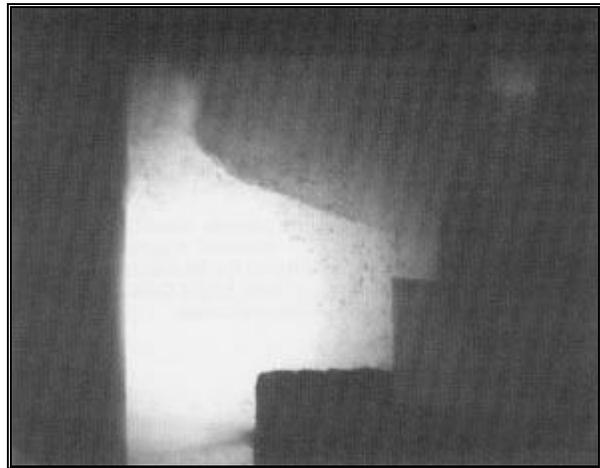
Figure 6. A vicinal illumination view of the same area. Vicinal illumination revealed a crack extending from the chip-out toward active circuit metallization.

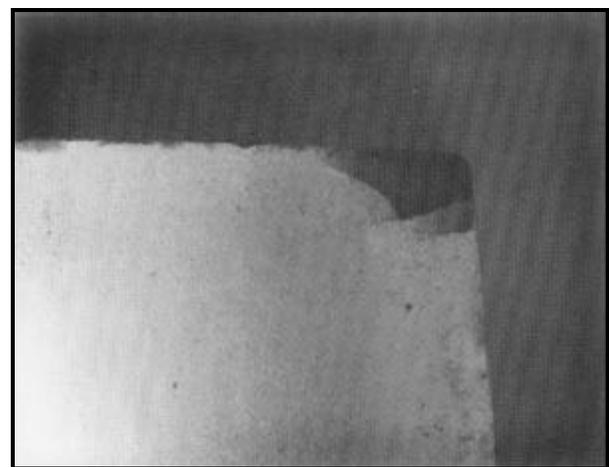
Figure 7. Dark field light scattering photograph showing damage to the corner of an aluminum nitride substrate.

Several five inch square aluminum nitride substrates were evaluated to determine their suitability for use in multichip module packages for space flight use. Throughout the evaluation, dark field light scattering inspection was used to determine the mechanical integrity of the samples. Following a thermal cycling test, one chip-out and several secondary cracks were observed in one corner. During subsequent tests, the status of the cracks was closely examined, and no further crack propagation was observed.

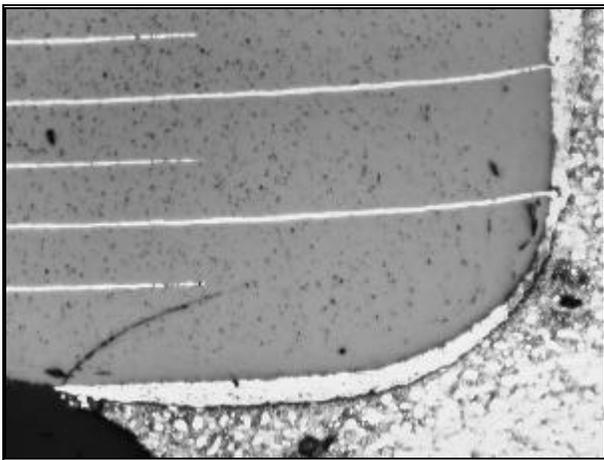
Figure 8. Bright field view of a multilayer ceramic capacitor.

Multilayer ceramic chip capacitors are prone to fracture during manufacture and also during soldering operations. When such a fracture occurs across opposite plates a current leakage path can be formed, resulting in unacceptable electrical performance. The two cracks shown in this example are currently benign since one crack extends through the cover plates to a single conductor plate and the other extends through two common conductor plates. Such cracks can, however, develop into moisture leakage paths or catastrophic mechanical failures.

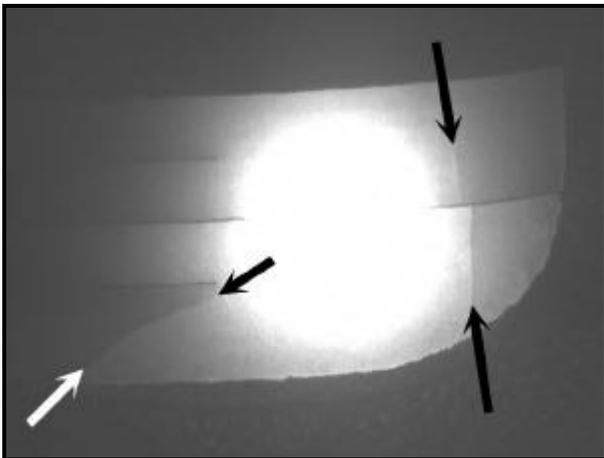
Figure 9. Vicinal illumination view of the same capacitor. Note the crack to the right of the light spot which was revealed only using vicinal illumination.

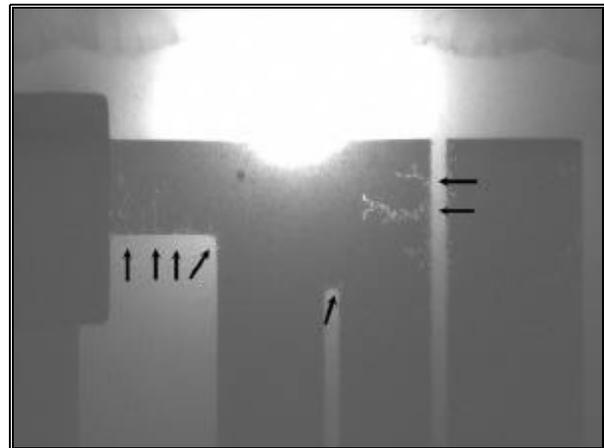
Figure 10. Vicinal illumination photograph showing electrostatic discharge damage on a thin film nichrome resistor within a resistor network.

An investigation of an open circuit failure in a hybrid for the Hubble Space Telescope indicated that the resistor had failed as a result of electrostatic discharge (ESD) damage. A study was then conducted to determine the pertinent design characteristics for ESD susceptibility. In the course of this study many resistor networks using different patterns, materials, and resistance values were intentionally exposed to ESD pulses. The vicinal illumination technique was used to examine each resistor and determine the location and nature of the effect on the resistive elements. The examples shown include high voltage transverse cracks, corner cracking, and internal arcing over laser kerfs.

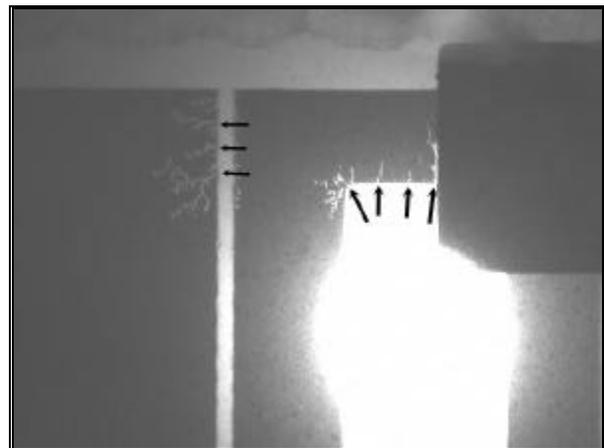
Figure 11. Vicinal illumination photograph showing electrostatic discharge damage on a thin film nichrome resistor within a resistor network. This damage was completely invisible using standard lighting.

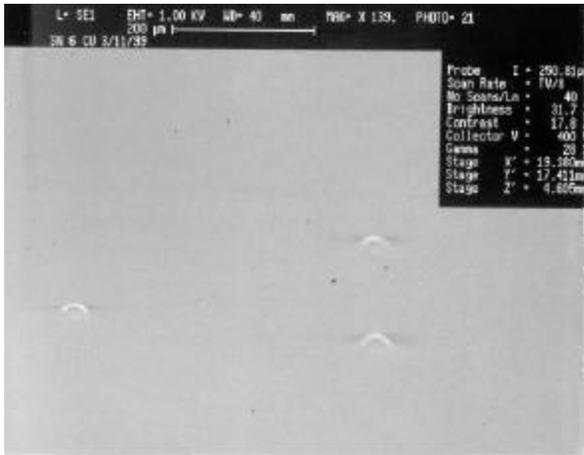
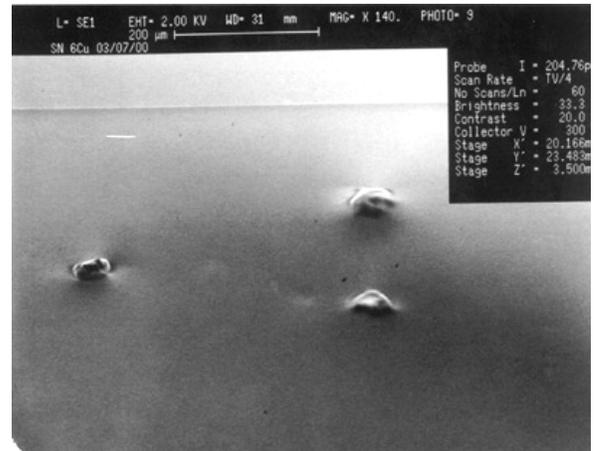
A. Picture taken on 3/11/99

Figure 1. Whiskers forming under coating

The latest observation indicates that tin whiskers under the conformal coat are pushing their way outward causing dome shapes in the coating. As time progresses, these dome shapes become larger and narrower at the top, which suggests that the whisker tips are beginning to penetrate the tough skin of the conformal coat. Figure 1A and 1B show whiskers at the same location taken a year apart. Similarly, Figures 2A and 2B are SEM photos taken at another site six months apart.

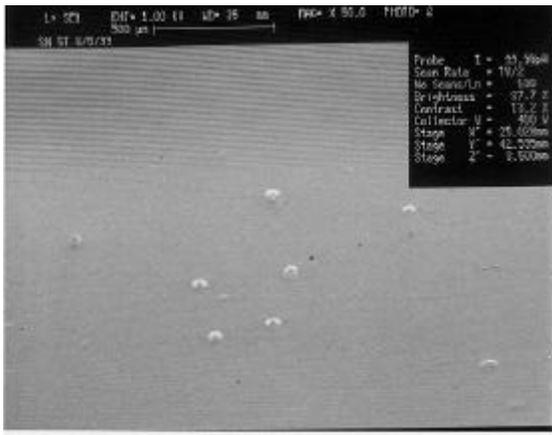
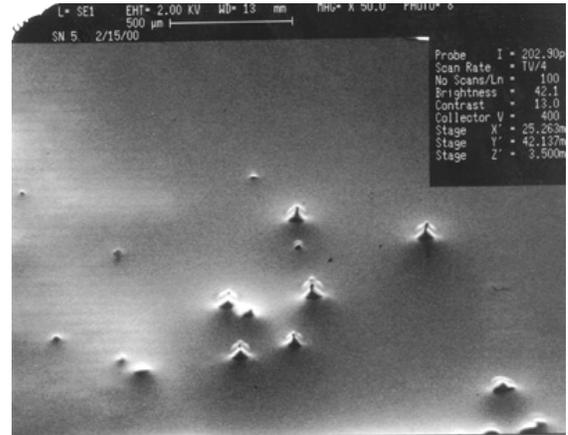
A. Picture taken on 8/5/99

Figure 2. Whiskers forming under coating

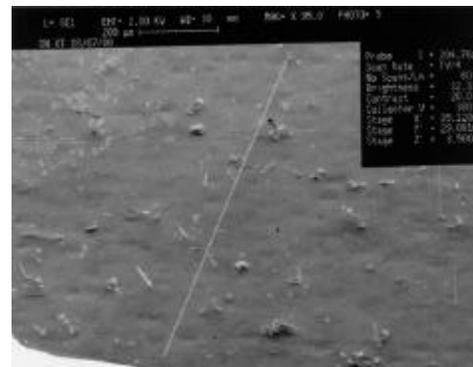
Figure3. Whiskers from uncoated side

Among 14 samples, only 3 samples show these dome shapes. Two of these samples are kept at room temperature; one is copper flashed and the other is pure tin over a brass metal substrate. Figure 3 shows whiskers from a bare metal surface, without coating, and some whiskers are growing a lot faster than others. This one particular whisker is estimated to be 0.8 mm in length. This is, of course, relatively small to cause any short circuits. However, other experimenters have recorded tin whiskers on the order of 1 cm or more.

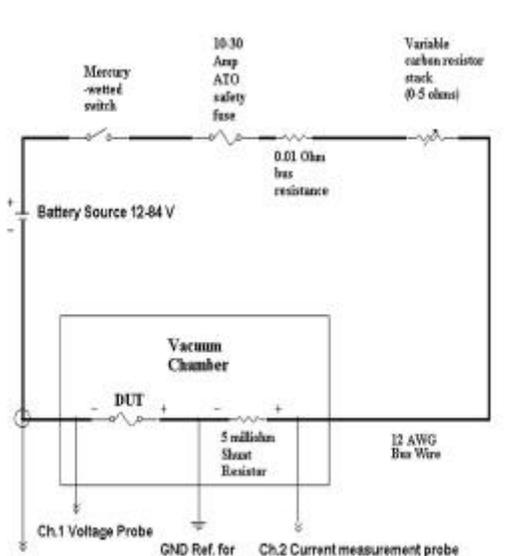
Figure 2. Electrical schematic of the test station used to overcurrent the fuses.

$I^2 \cdot t = 1050 \text{ A}^2 \cdot \text{s}$), a 5.00 m Ω current shunt, an adjustable carbon stack power resistor, and a fuse holder. Short straight lengths of heavy gauge wire were used to minimize stray inductance (measured to be less than 10 mH) and excessive resistance. The total resistance of the circuit, exclusive of the resistance of the fuse, is called the ballast resistance; it can be adjusted to be as low as 0.10 Ω . The voltage across the fuse, the voltage drop across the shunt resistor, and the voltage delivered by an active clip-on current probe were monitored using a digital oscilloscope. The equivalent circuit is shown in Figure 2.

The ballast resistance was set (using the adjustable carbon stack power resistor) so that the maximum current was 100 A, simulating a dead-shortened fuse. The actual current flowing through the fuse before its filament melted depended on the current rating of the fuse and on the voltage chosen for the run, and was sometimes much lower than 100 A. For example, the cold resistance of a 1/8 A fuse is $2.1 \Omega \pm 10\%$ and its hot resistance is $8.0 \Omega \pm 15\%$. Therefore, at 37.3 volts (three batteries), the maximum current available is 17 A at the start of the overcurrent, dropping to less than 4.6 A as the filament melts, when the ballast resistance is set to its minimum value of 0.10 Ω .
