# RED PLAGUE

P. L. Anthony  
and  
O. M. Brown  
*Autonetics  
Anaheim, California*

Describes "red plague" corrosion on silver-plated copper electrical wire insulated with Teflon. Though not a quantitative problem, this corrosion causes serious reliability problems in aerospace electronics and similar applications. Gives details of program to determine cause and mechanism of corrosion. Describes method for initiating and sustaining corrosion plus lab tests which clarify conditions necessary for the corrosion process. Includes study of the galvanic cell properties of the copper-silver couple.

## on silver-plated copper wire

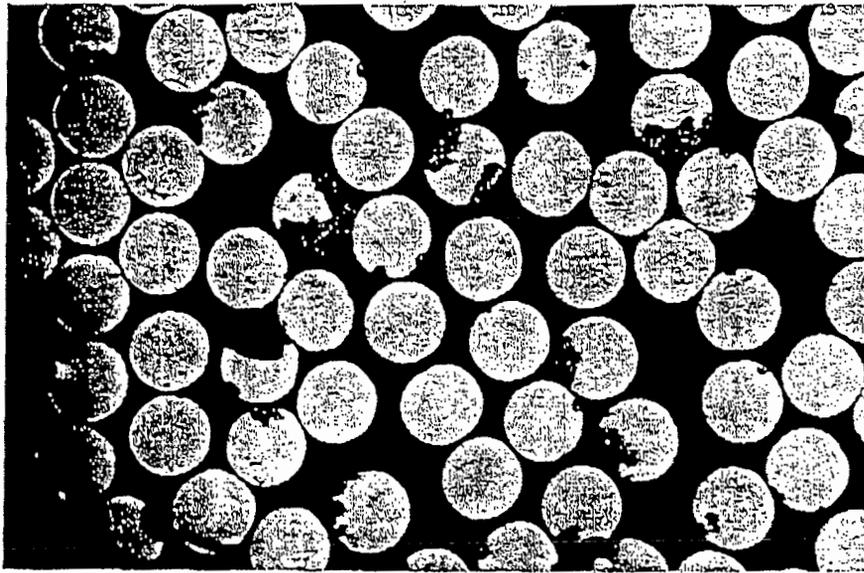
The extent of corrosion damage to the wire conductor strands can be assessed in metallographic cross sections. Figure 3 shows a typical section through a wire specimen which exhibited moderate amounts of external corrosion products. Figure 4 is an enlargement of the heavily corroded strand in the upper right quadrant of Figure 3. It is apparent from these figures that, regardless of the external appearance, corrosion damage occurs within the upper cores of individual conductor strands.

As can be seen in Figure 3, a high percentage of the strands are affected and, in many, corrosion of the copper has progressed sufficiently to seriously impair the electrical conductivity and mechanical strength. Figure 4 illustrates the copper corrosion under the silver plate. A break in the silver plate such as was invariably found to be associated with each region of underlying copper corrosion can also be seen in Figure 4, as well as indications of corrosion products which have apparently "crept" outward from the break over the surface of the strand.

Figure 3—Photomicrograph (36X) of metallographic cross section through a corroded wire conductor.

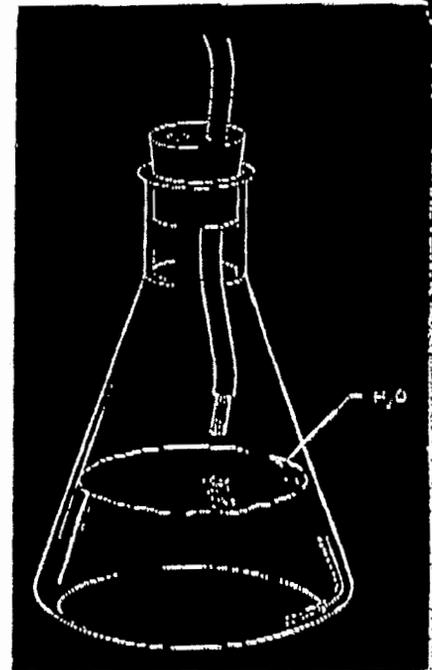
Figure 5—Apparatus for vapor diffusion environment to produce "red plague" corrosion in silver-plated stranded copper electrical wire.

The environmental system which was ultimately successful for artificially promoting "red plague" corrosion in Teflon insulated silver-plated copper stranded wire is shown in Figure 5. This particular arrangement was chosen to provide a continuous exposure of the wire conductor to moisture and air by a natural vapor diffusion process.

For this test, wire sections used were approximately three feet in length with 1/2 to 3/4 inch of the insulation removed from each end. The wire was inserted into one hole of a two-hole stopper, and the stopper then fitted into the neck of a glass flask partially filled with water, as shown in Figure 5. Length of the wire within the flask was adjusted so that the lower end was slightly above the water surface. The other end of the wire was supported directly above the flask. The second hole in the stopper was left open to the atmosphere. Thus, there is a slow but constant diffusion of water vapor and air upward through the interstices in the wire conductor strands from the flask where the relative humidity is virtually 100 percent to the top end of the wire where the relative humidity is the laboratory ambient, approximately 50 percent.

Wire specimens which were susceptible, i.e., had breaks in the silver plating, developed noticeable corrosion within 48 hours when subjected to this test. The corrosion was confirmed by analysis to be identical to the naturally occurring "red plague." Furthermore, microscopic examination before and after test indicated a definite correla-

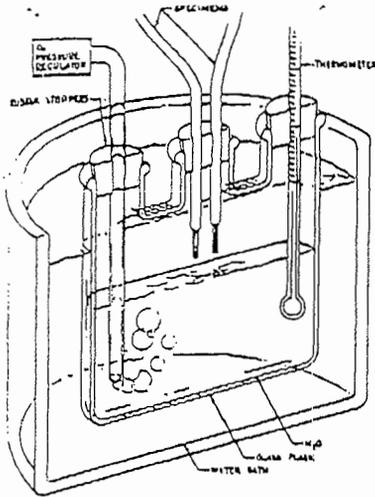
Figure 6—Apparatus for wire corrosion susceptibility test.

pressure of 1 to 2 psig were used. The temperature was maintained by placing the flask in a water bath, and oxygen was metered to the flask at a rate to balance the flow out through the wire sample being tested. This combination of elevated temperature and forced flow of moist oxygen through the wire accelerated the process sufficiently to readily differentiate between the corrodability of various wire specimens within the 24-hour exposure. The apparatus for the corrosion susceptibility test is diagrammed in Figure 6.

A considerable increase in the corrosion rate can be obtained by raising the temperature and introducing pure oxygen under slight pressure to the flask as described above. As a standard corrosion susceptibility test, a temperature of 140 F (60 C), and an oxygen

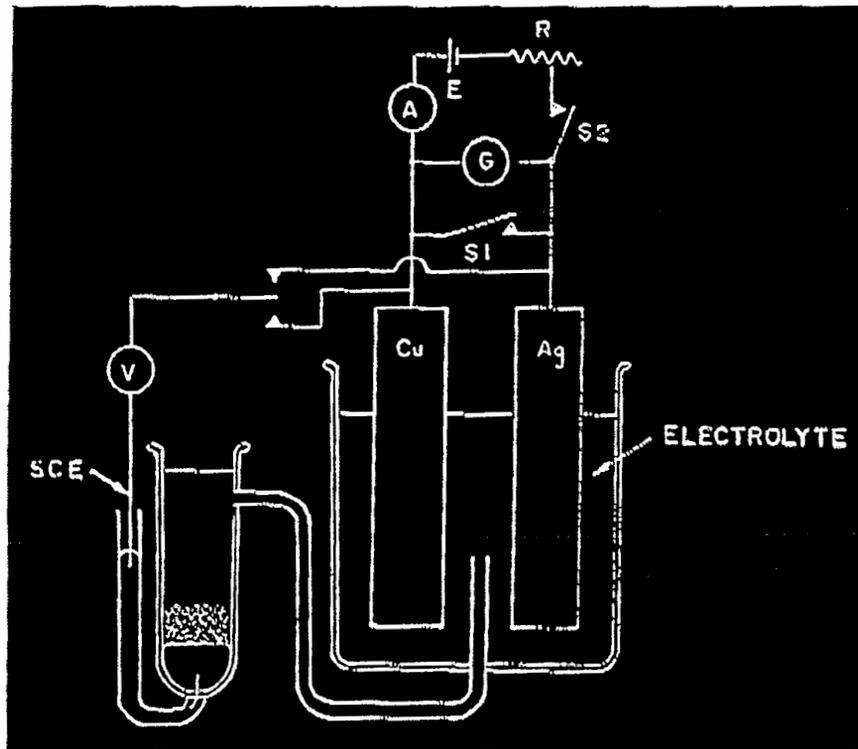
Figure 7—Diagram of copper-silver cell with saturated calomel electrode (SCE) for solution potential measurement and zero-resistance ammeter circuit for galvanic current measurement.

To further clarify in chemical terms the wire corrosion phenomenon observed to occur naturally and in the vapor diffusion tests, a series of experiments was conducted with the copper-silver galvanic cell. The galvanic behavior of the copper-silver couple was studied by conventional electrochemical cell techniques. The individual electrode solution potentials relative to a saturated calomel reference electrode, as well as the open circuit cell potentials, were measured in each electrolyte to provide an indication of the cell reaction mechanisms. The galvanic current in the cells was determined as a function of time with the zero resistance ammeter circuit.<sup>1</sup> A diagram of the circuit arrangement used is shown in Figure 7.

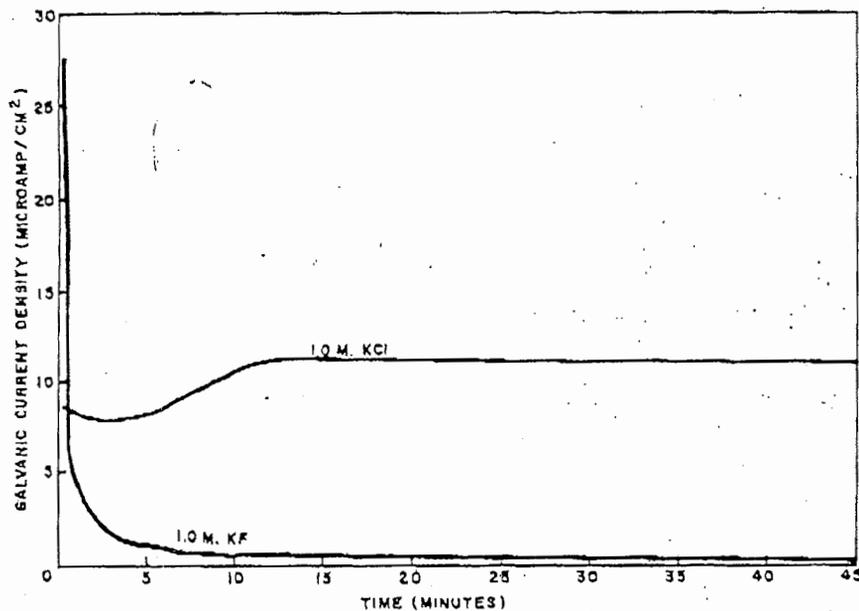
Figure 8 provides a direct comparison of the galvanic currents as a function of time for the copper-silver couple in molar KCl and KF solutions. Characteristics of the current-time curves for the two electrolytes are strikingly different. In the chloride solution, the galvanic corrosion current changes little with time. After a slight drop from its initial value, the current actually increased, probably due to an increase in electrolyte conductivity and pH as the cell reaction proceeds and more ions are formed. In the fluoride electrolyte, however, the initial current, although substantially higher, dropped rapidly to low levels. The steady state corrosion current of the copper-silver couple was more than 20 times less in the fluoride solution, even though initial currents were about three times greater than in the chloride solution.

Figure 8—Change of copper-silver galvanic current with time in potassium chloride and potassium fluoride electrolytes.

was started, but the current quickly dropped to almost the same value as before. When helium was introduced to the cells containing KCl electrolyte, the current immediately increased more than twofold and then slowly decreased. Aeration of KCl electrolyte cells caused a rapid and sustained fourfold increase in the galvanic current.
