Failures in Hybrid Microcircuits during Environmental Testing. History cases.

Perot Systems/NASA GSFC, code 562, Parts, Packaging, and Assembly Technologies Office
Alexander.A.Teverovsky.1@gsfc.nasa.gov

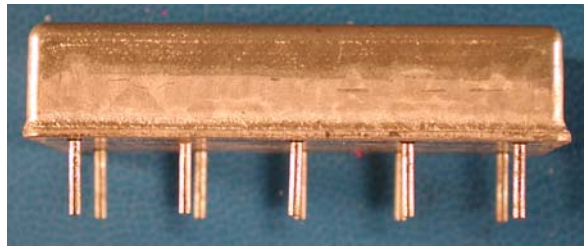
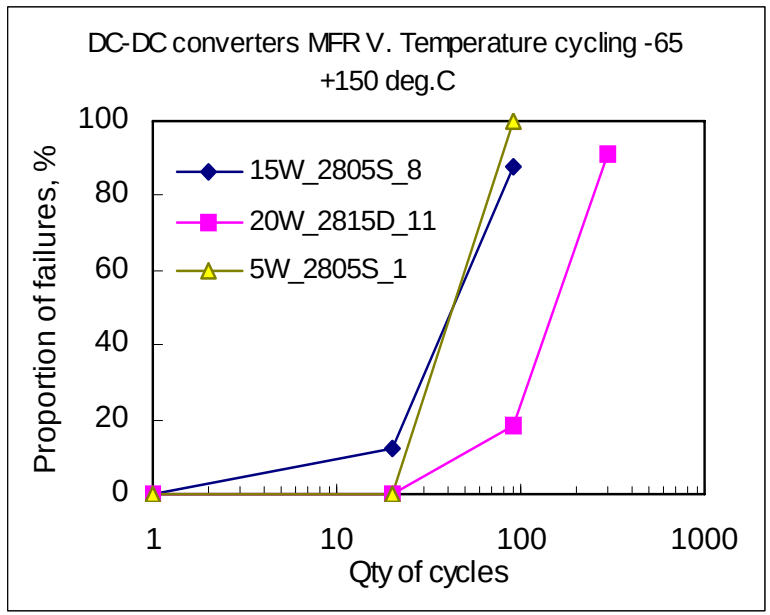
- Hybrid DC-DC converters (5W to 20W) manufactured by different vendors were tested at -55, +25, and +125 ºC after 20, 100, 300, and 1000 TC from -65 ºC to +150 ºC.
- Failures in parts manufactured by one vendor were observed starting 20 TC.
- Out of 20 tested parts 17 parts failed after 300 TC.
- Most parts failed at RT and 23% failed at -55 ºC.

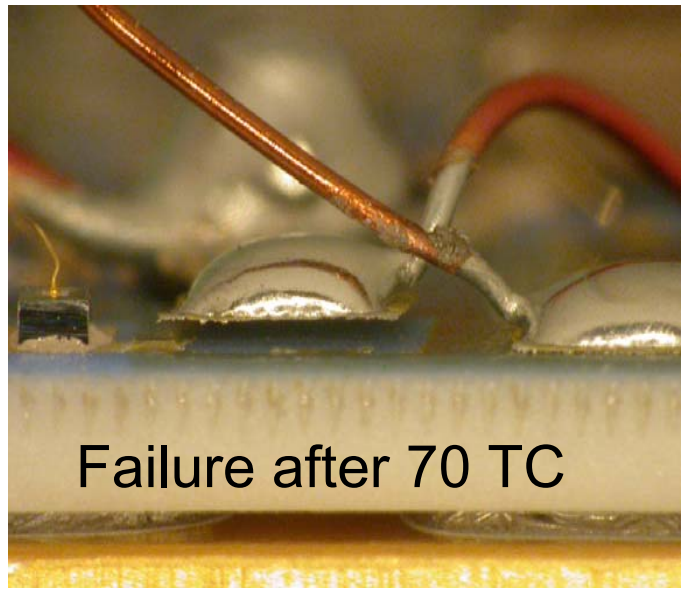
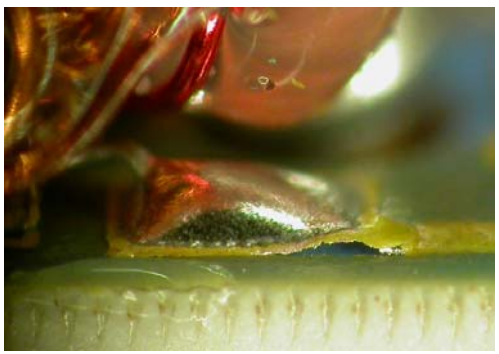
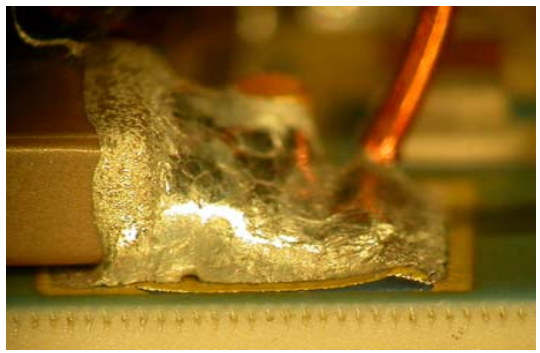
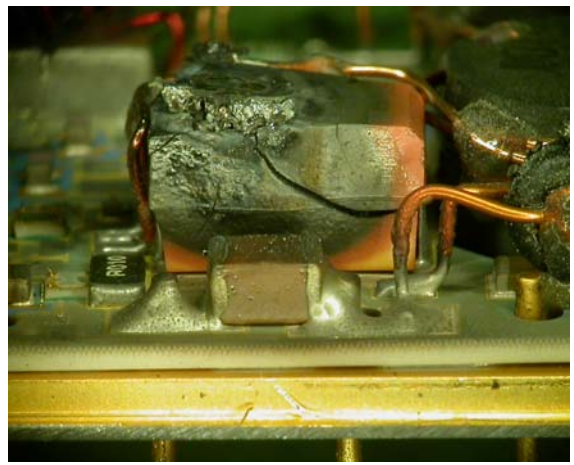
Case I. Results of Failure Analysis.

- Most failures were due to fractured metallization traces on the substrate near solder joints.
- Element and components are evaluated per MIL-PRF-38534.
- Failed Ta capacitor was observed in two cases.
- Capacitor failures might be caused by intermittent contacts.

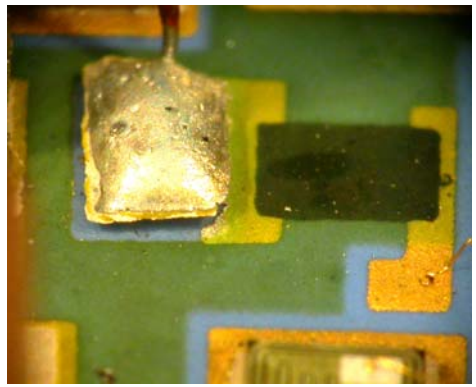
Case I. Deficiencies of Substrate Qualification per MIL-PRF-38534.

- C.3.7… Substrates fabricated …using a qualified process will be exempt from this evaluation.
- C.3.7.5.2.3… Perform film adhesion testing per acceptable industry standards.
- C.3.7.5.2.4… Perform solderability testing if specified in the applicable specification. (The test does not assess the effect of soldering on metallization).

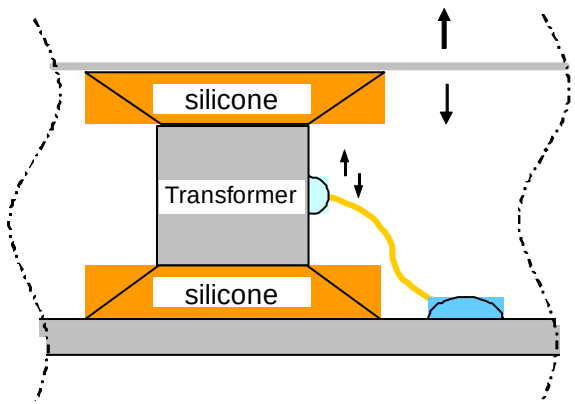
Case II. Flex-Lid-Induced Failures.

- A DC-DC converter failed during box-level testing in a thermo-vacuum chamber.
- The failure was due to a soldered joint fracture.
- Failed wire was secured to the transformer fixed to the lid with silicone.
- Mechanism of failure: low-cycling fatigue caused by deformation of the lid and shifts of the transformer and wire.

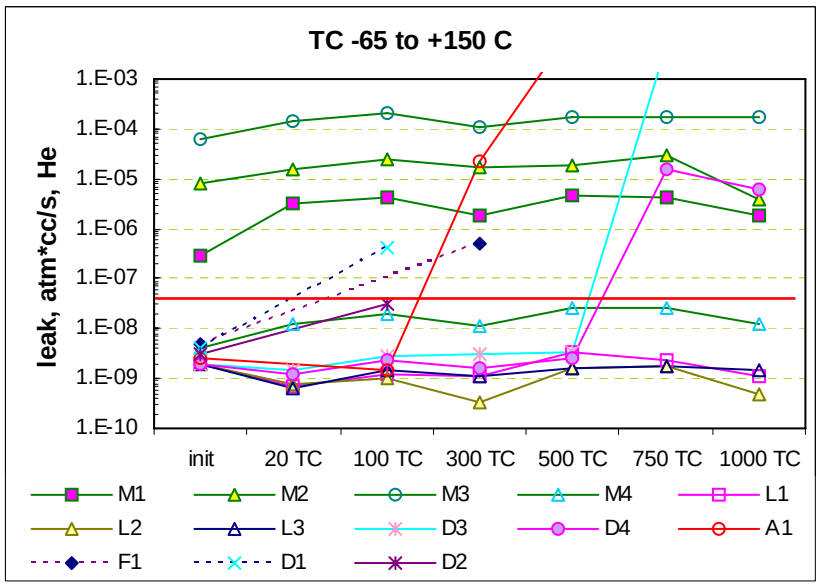
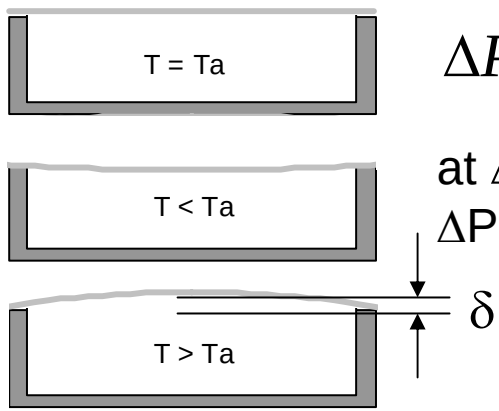
Variations of the Leak Rate with TC

- MIL-PRF-38534 requires 3(0) after 15 TS -65 to +150 ^{o}C for package seal evaluation.
- 5 out of 31 hybrids failed after 100 TC -65 to +150 ^{o}C.
- "Leaky" hybrids do not fail: $\tau = P_0 V/L$.

Large-size hybrids might be more susceptible to hermeticity failures

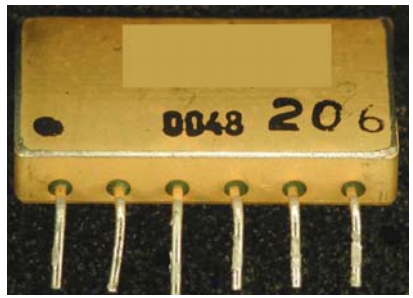
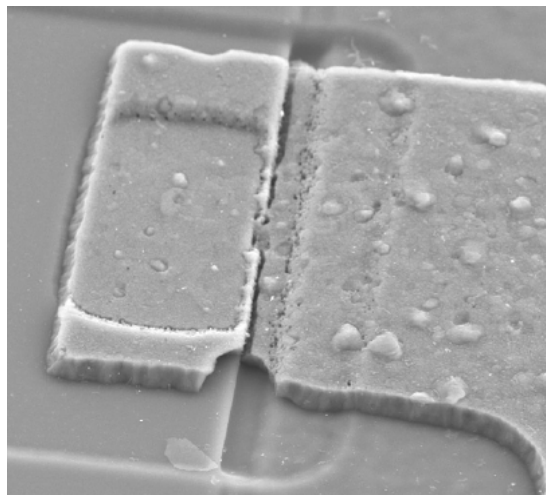
Case IV. Die Metallization Failure during TC.

- DPA has indicated a poor die metallization step coverage.
- Thinning of die metallization is typically considered as a reliability risk due to increased current density and possibility of electromigration failures.
- The parts passed life testing, but one out of 7 hybrids failed after 300 TC between -65 °C and +150 °C.

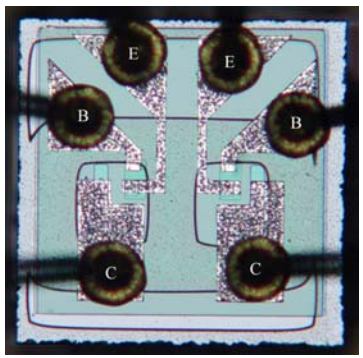
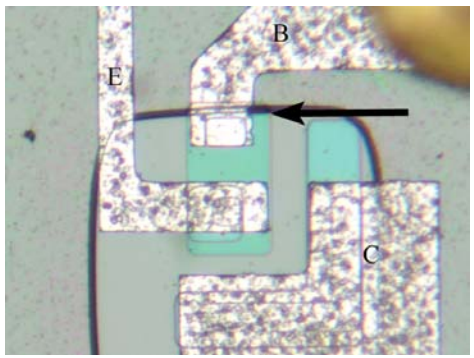
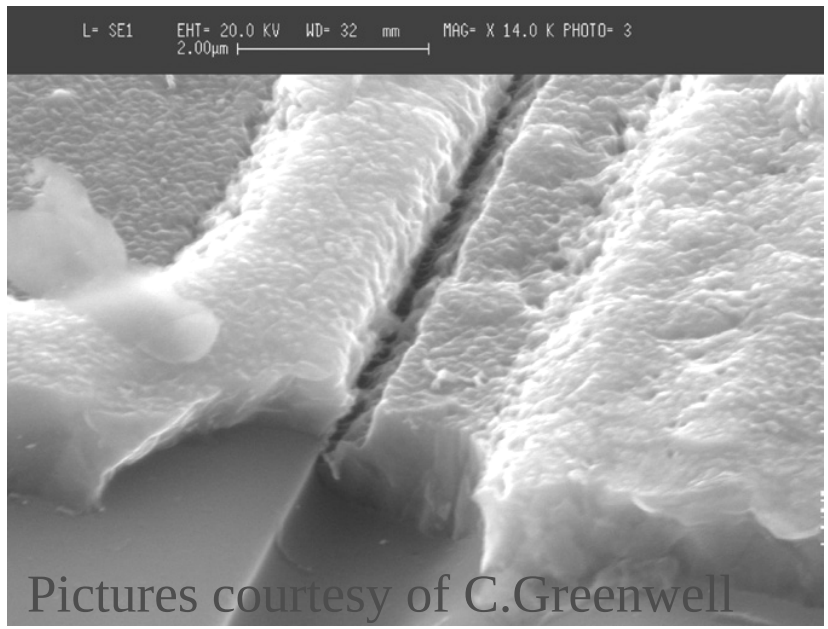
Case IV. Results of Failure Analysis.

- The failure was due to open circuit in the base metallization of a transistor.
- Mechanical stresses during TC resulted in low-cycling fatigue cracking of Al metallization and failure of the transistor.

TC can induce enough plastic deformation in the metallization to cause an open circuit failure in case of poor oxide step coverage.

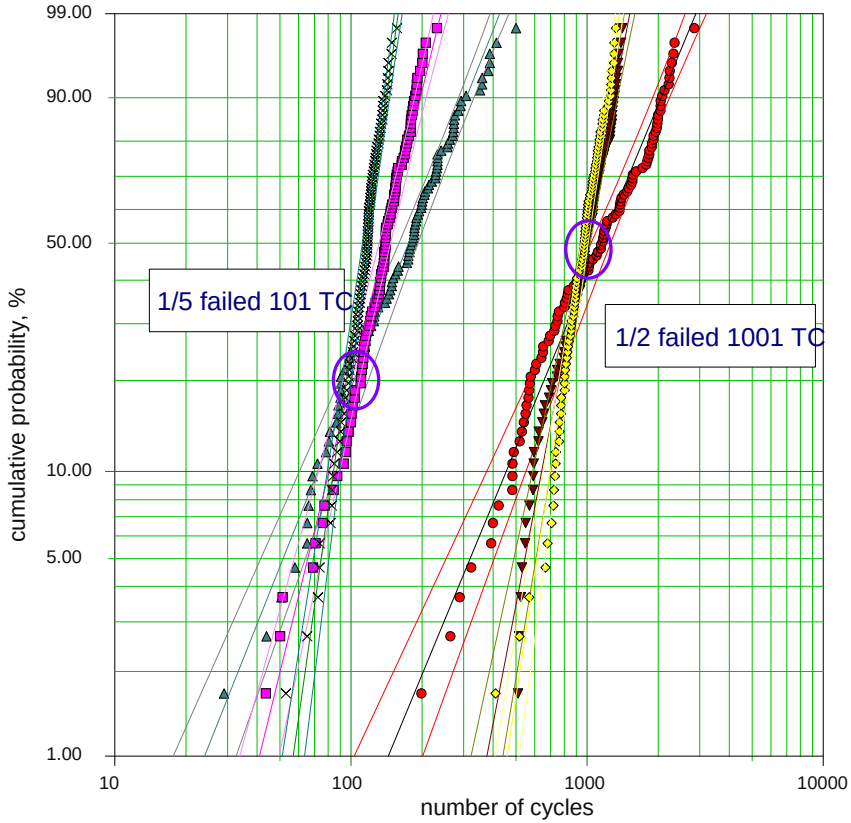
Weibull distributions of the worst case TC simulation (2<β<6)

More confidence can be achieved by increasing the number of test cycles.

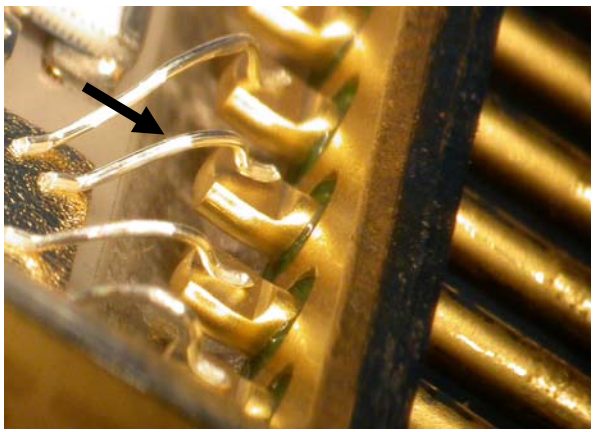
Case V. Wire Bond Failures.

- Five hybrid solid state power controllers successfully passed life testing at 125 ^{o}C during 1000 hours.
- Additional electrical measurements after testing unexpectedly revealed open pins in two parts.
- The failures were caused by lifted 10-mil Al wires.
- Although Al wires are annealed, they are stiff and have built-in mechanical stresses, which might result in failures in bonds with weakened adhesion under minor mechanical disturbances.

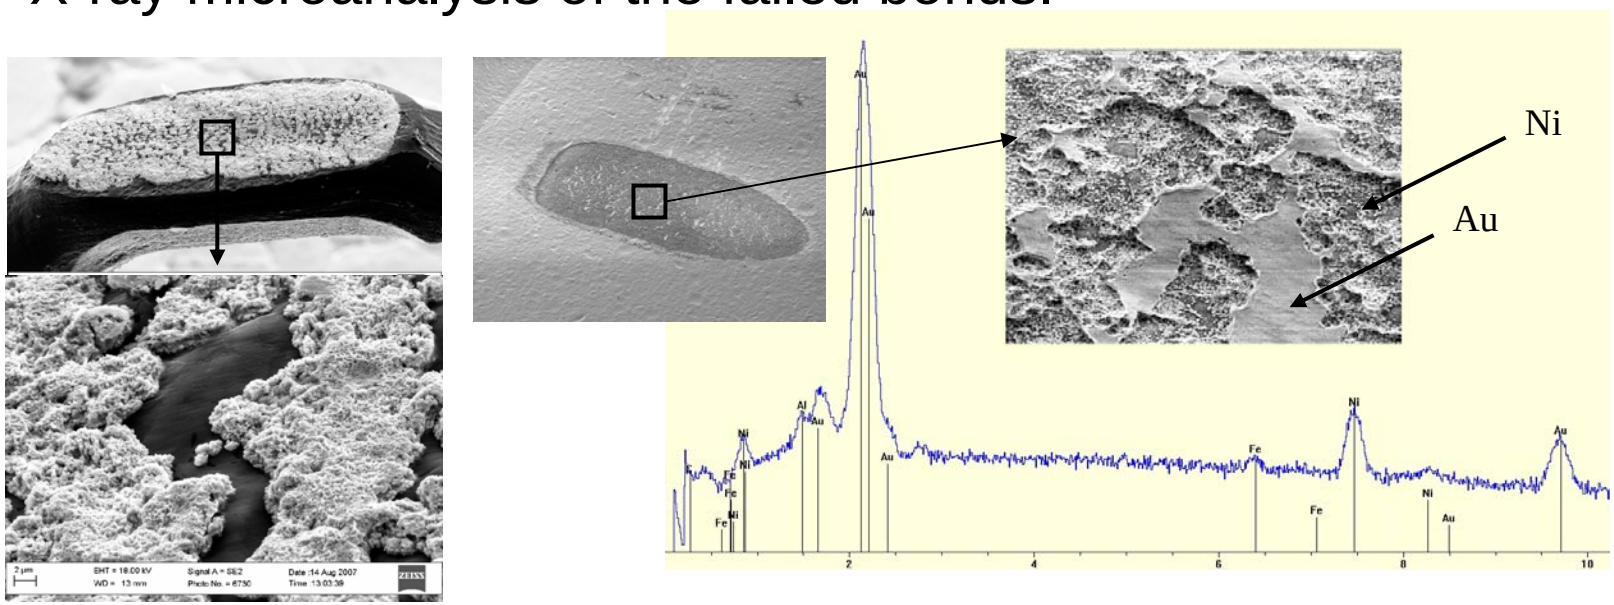
Case V. Microstructure of Failed Bonds.

- Failed WBs were separated mostly along the nickel surface exposing relatively minor areas covered by gold.
- Most Au/Al IMC remained attached to Al wires and mating surfaces were ~80% covered with IMC thus indicating that the WBs were formed properly initially.
- No significant amount of contamination was observed during X-ray microanalysis of the failed bonds.

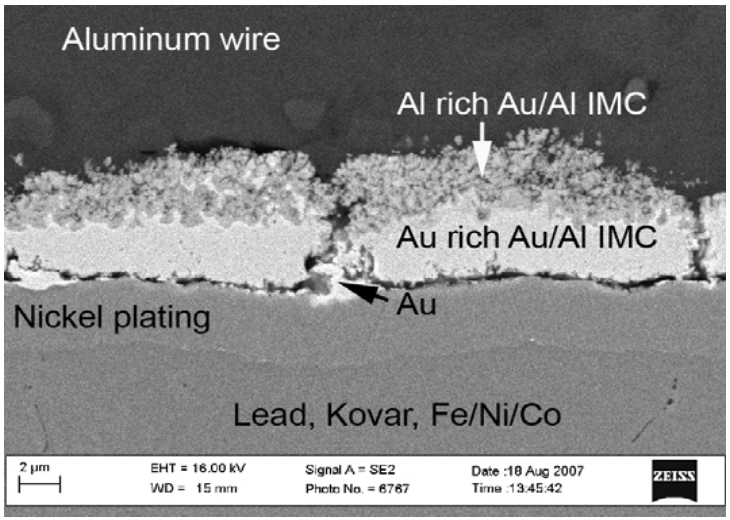
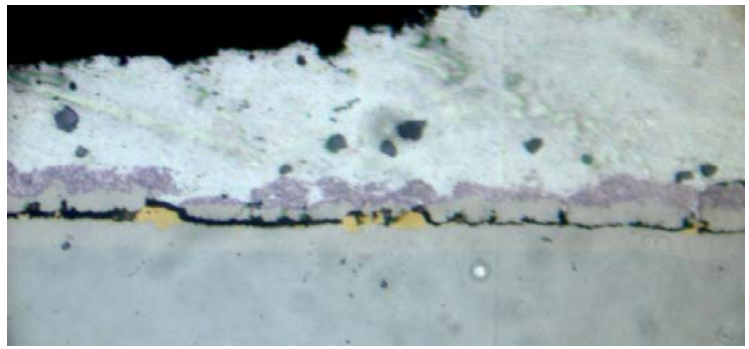
Cross section of Al wire-to-post bond

Purple and tan colors of the Au/Al IMC represent aluminum-rich, $AuAl_2$, and gold-rich, Au_4Al IMC.

- Formation of Au/Al IMC at the Al/Au interface is a normal phenomenon.
- Au/Al IMC grow with time. At 125 ^{o}C all Au plating (~1 μm) is consumed in a few hours and a Ni/IMC contact is formed.
- In the presence of contaminations (Tl, Pb, As) Kirkendall microvoids accumulate resulting in failures (Horsting mechanism).
- Even a very low concentration of contamination (below the level of EDS sensitivity) might be sufficient to cause failures.

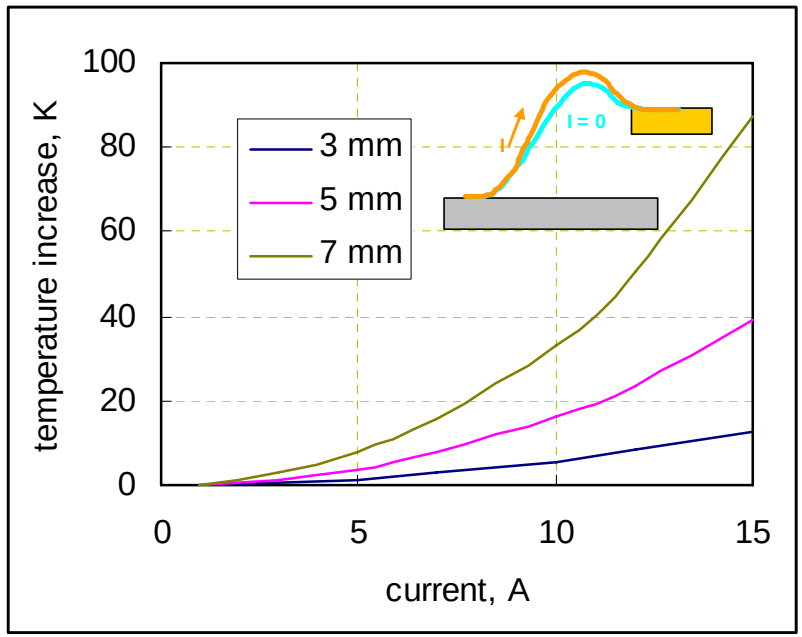
Tmax in wires of different length

- In power hybrids the risk of WB failures increases due to self-heating of wires.
- Overheating of wires causes deformation and stress in the bonds.
- Estimations show that for 5 mm long 10-mil Al wire at I = 15 A the temperature might rise on 40 K, which would increase the wire length on ~ 4 μm.
- Power cycling might cause low-cycling fatigue in wire bonds.

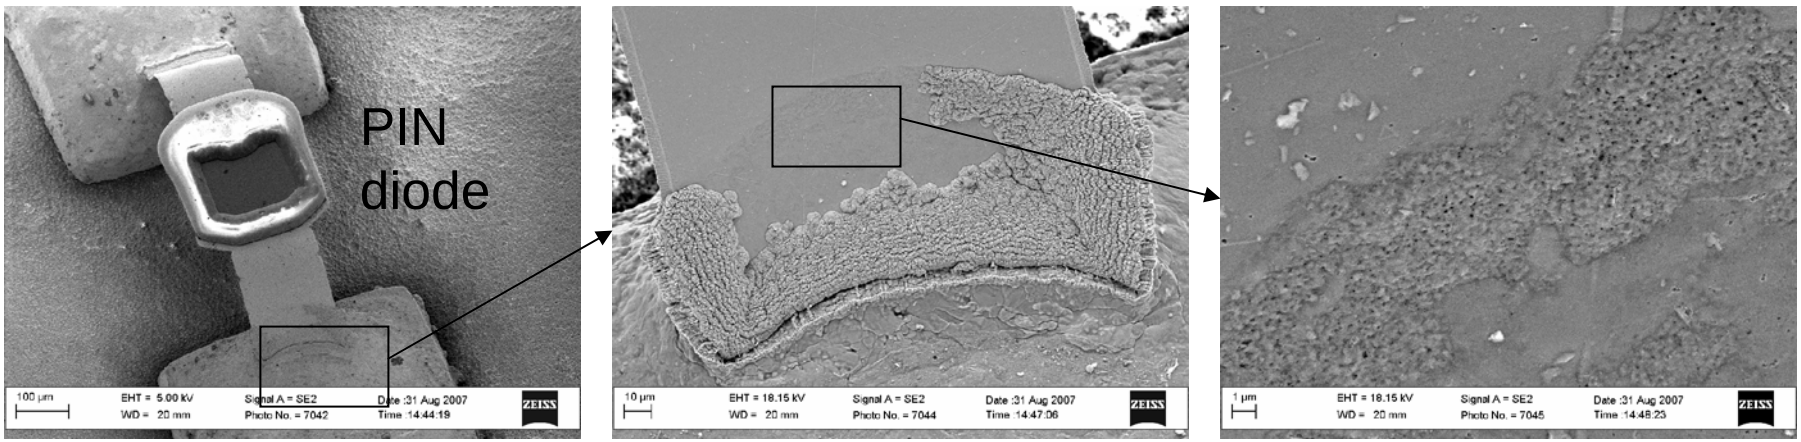
Case VI. Solder-induced Au/In IMC

- Microwave hybrids passed qualification testing including HTOL at 90 ^{o}C for 600 hrs.
- PIN diodes with gold beam leads (170 μm X 5 μm) are installed using an indium-base solder, 80In/15Pb/5Ag.
- To evaluate the effect of In/Au IMC growth on mechanical strength of solder joints, the diodes were pull tested before and after HTS at 125 ^{o}C for 110 hrs.

Growth of IMC after 600 hrs at 90 ^{o}C occurs by diffusion of Au and In atoms across the thickness of the gold beam lead.

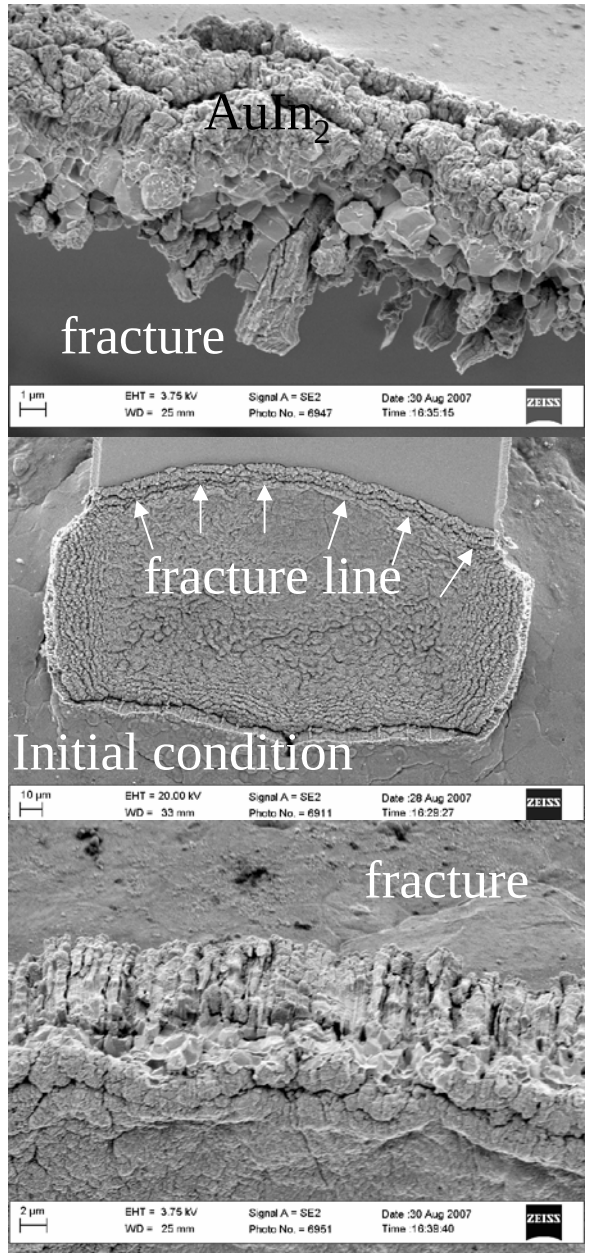
Case VI. Pull Test.

- Fractures occur along IMC growth.
- 3 out of 7 diodes failed after HTOL and 5 out of 7 diodes after HTS.
- The central area of the Au leads was completely converted into a grainy and fragile $AuIn_2$ composition.

Note: the calculated strength of the Au beams is ~13 g-f and the failure criteria is 4 g-f.

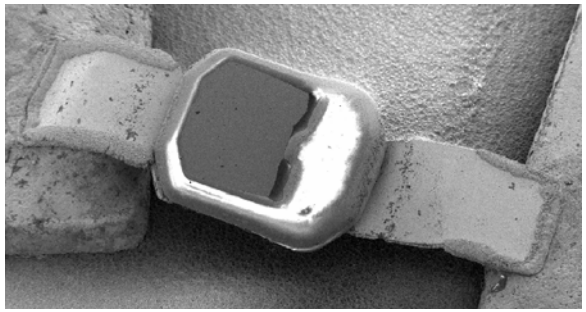
A diode in an initial condition and after HTS testing.

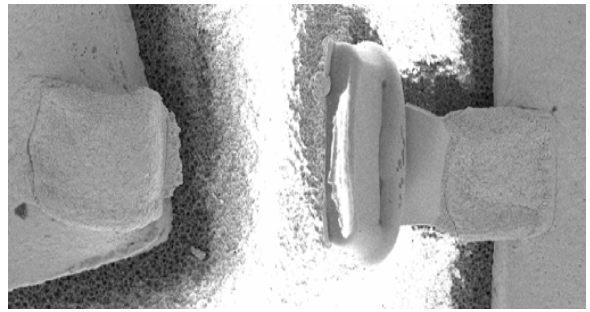
Pull test failure at 0.26g after HTS

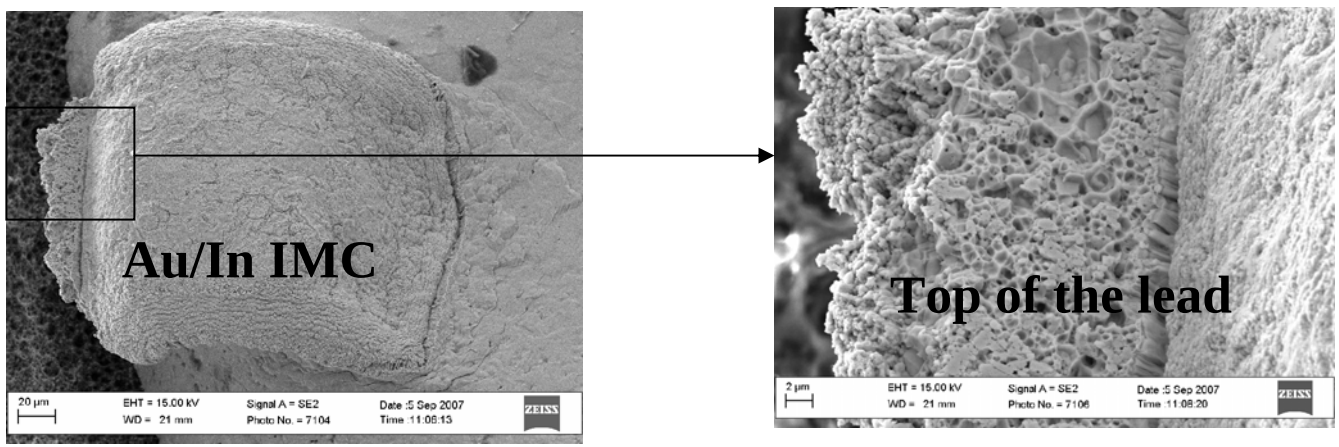
Close-up views of the fractured lead. The gold lead is completely converted into Au/In intermetallics after 110 hrs at 125 ^{o}C.

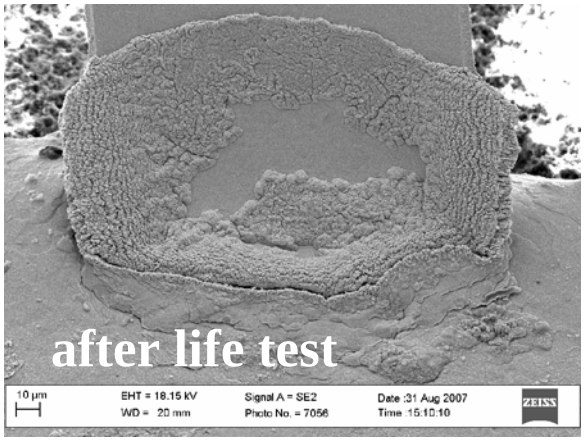
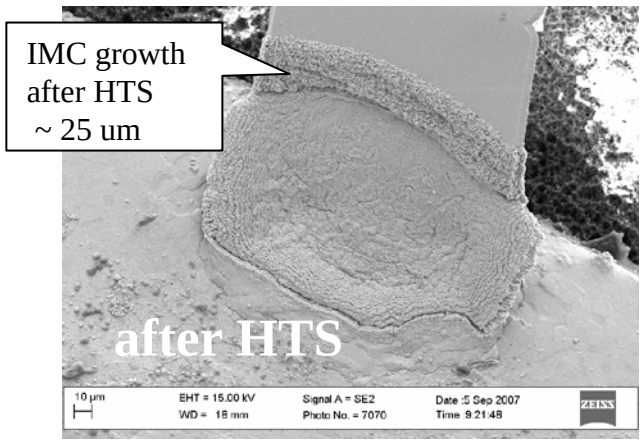
Case VI. The Rate of IMC Growth.

IMC growth on beam leads was estimated at RT, 90 °C, and 125 °C

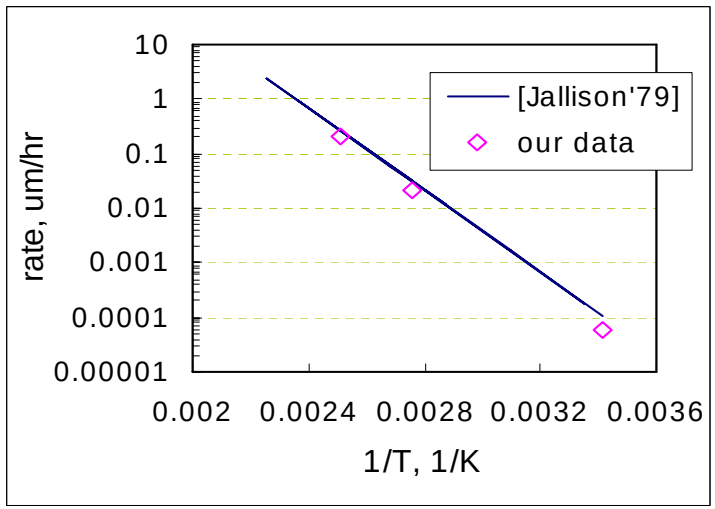
$$r = \beta \times \exp\left(-\frac{E_a}{kT}\right)$$

For pure Au/In system [Jallison'79]:
β = 6.9E8 μm/hr, Ea = 0.72 eV

- Results of this experiment (Au - In/Pb/Ag solder) are in agreement with literature data.
- Time to convert a gold beam of a thickness *h* into Au/In IMC is *t = h/2r.* At RT t = 1.6 year.

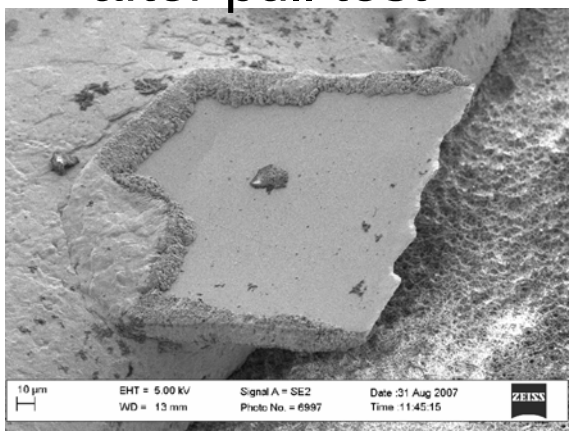
after pull test

A beam-lead fractured at 11.7 g.

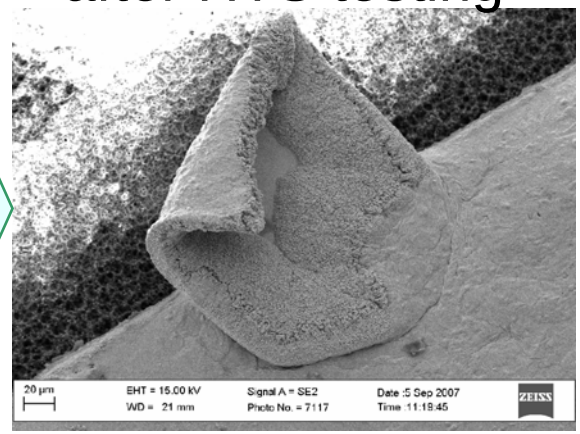
after HTS testing

Significant deformation is caused by IMC growth

- Au/In IMC are electrically conductive, but fragile and have reduced strength -> high risk of failure due to TC and/or mechanical disturbances (shock, vibration, etc.)
- A substantial volumetric changes caused by IMC growth (~4X) result in built-in stresses and can cause failures even without external mechanical distortions.
