Thermo-Mechanical Characterization of Motorola MMA1201P Accelerometer Test Report

**MOTOROLA MMA 1201P ACCELEROMETERS FAILURE
AND CONSTRUCTION ANALYSIS REPORT**

Motorola Accelerometers (MMA1201P) Failure and Construction Analysis Report

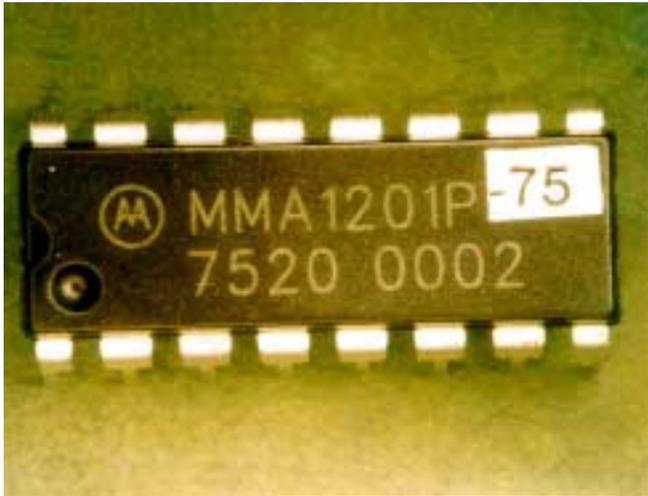
Figure 1. An external top view of the accelerometer manufactured by Motorola. 5X

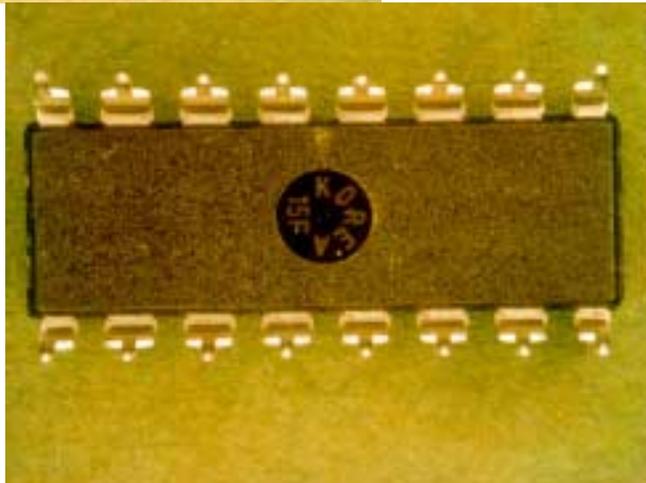
Figure 2. An external bottom view of the accelerometer. 5X

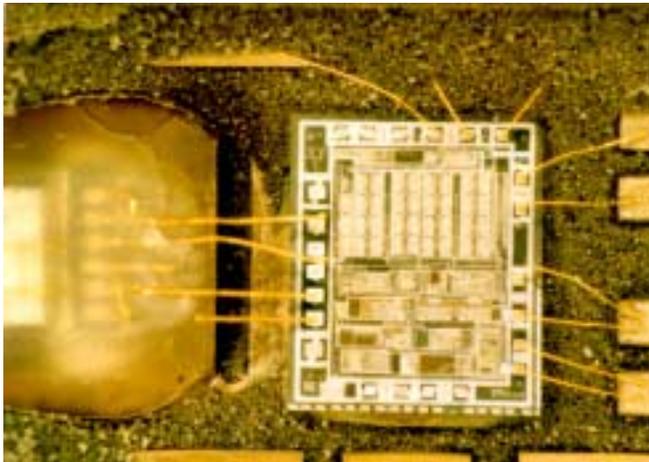
Figure 9. Internal view of the accelerometer with the plastic encapsulation chemically removed, causing some bending of the wires. The sensor is seen on the left in this view, under a glop of silicone made translucent by chemical action. 13X

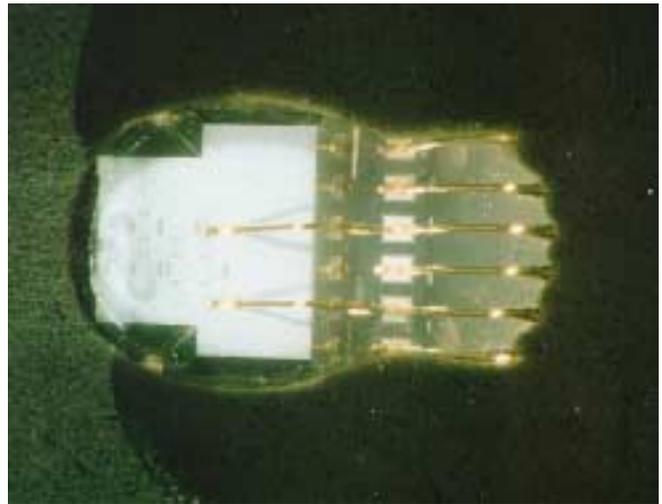
Figure 16. SN281 was submitted for construction analysis. Note that the wires of the device, as manufactured, appear unbroken and smooth. 16X

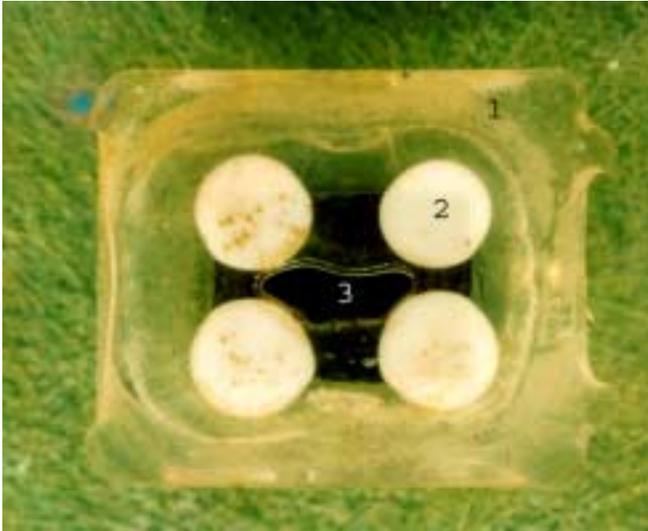
The nature of the damage suggested that the silicone had shrunk and expanded under multiple temperature cycles and, while doing so, the silicone had pulled anisotropically on the gold wires, leaving them damaged after testing. Multiple temperature cycles caused the wires to kink and break at the bond pads, and caused Poisson necking at the silicone/plastic interface. A gap was also seen between the silicon and the plastic, indicating lack of adhesion between the plastic and the silicone.

Figure 17. Inverted view of sensor (3), showing the silicone (1), and four white, apparently polymer glue feet (2). 16X

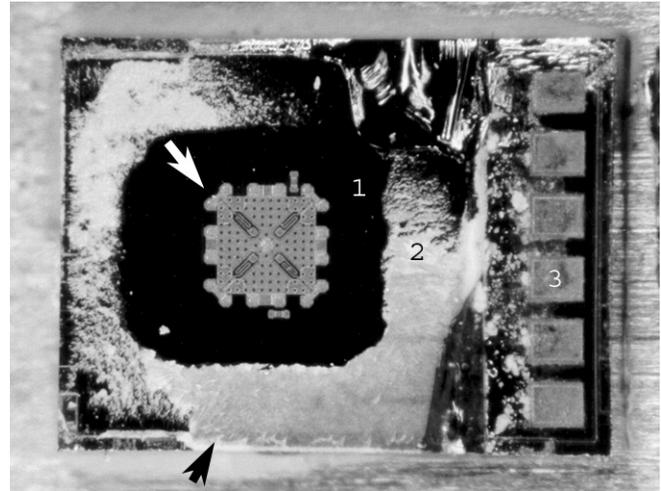
Figure 18. Black arrow indicates silicon substrate in this view of the sensor after destructive opening. White arrow indicates the actual accelerometer. (1) Cavity. (2) Lead bonding material. (3) Bond pads. 32X

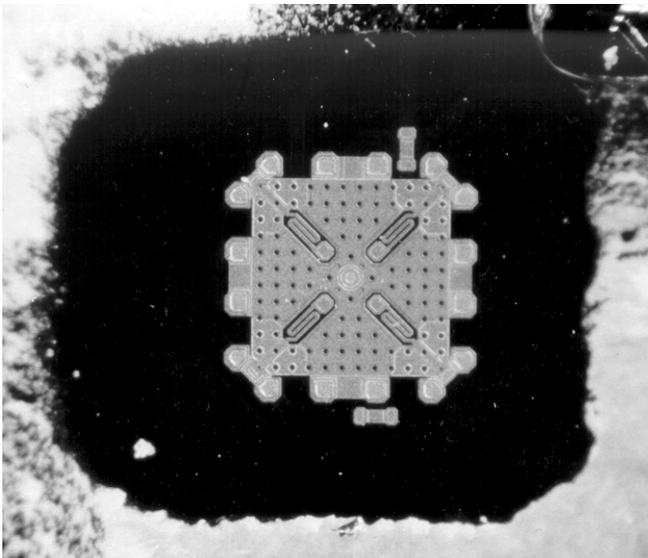
Figure 19. Optical view of accelerometer sensor inside cavity. 64X

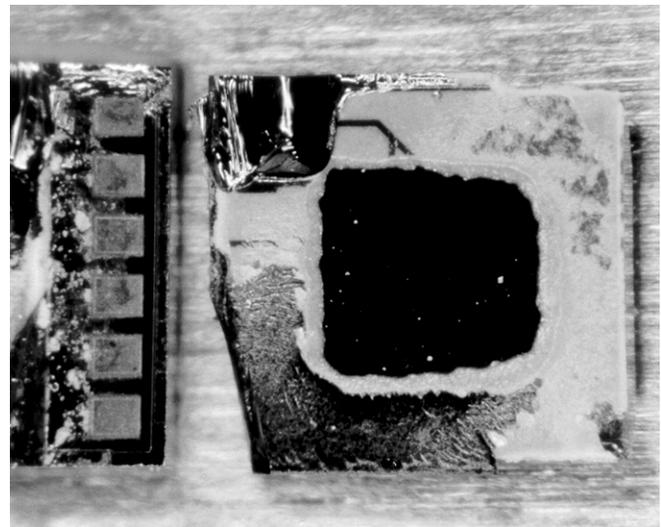
Figure 20. The lid of the sensor is shown on right. Note that an electrical trace appears to connect with the dark surface, which is presumably conductive. 32X

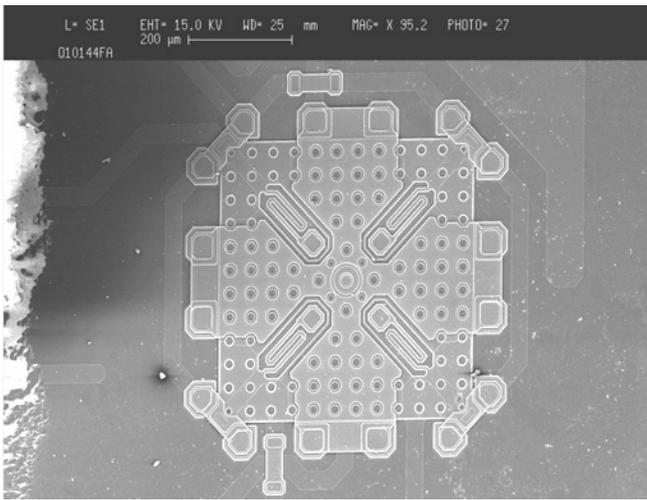
Figure 21. SEM view of sensor inside cavity. 95X

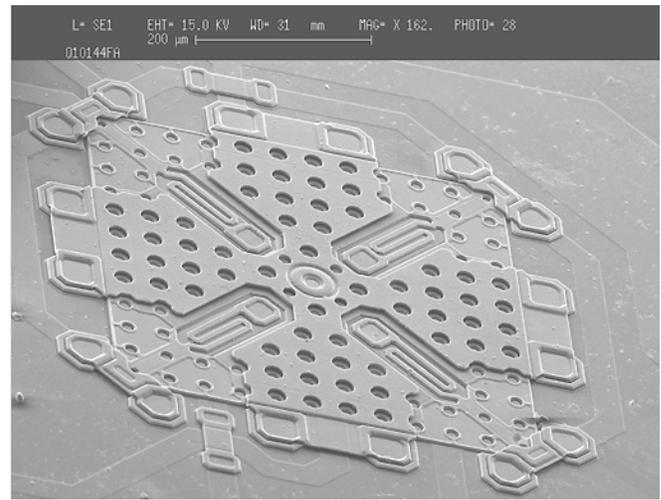
Figure 22. Tilt SEM view of sensor. Note the two bridges on opposite sides of the sensor, and the faint, apparently diffused traces. 162X

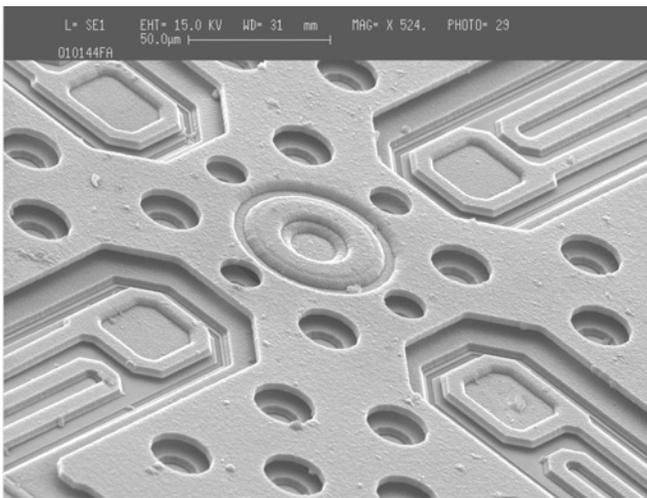
While the cause of failure for the shock-tested parts has not yet been determined, it is suspected that shock in the z-axis direction may have caused damage to the unsupported silicon membrane.

Figure 23. The center of the sensor appears to be a suspended membrane. Four pads on the lower level are also seen. 524X

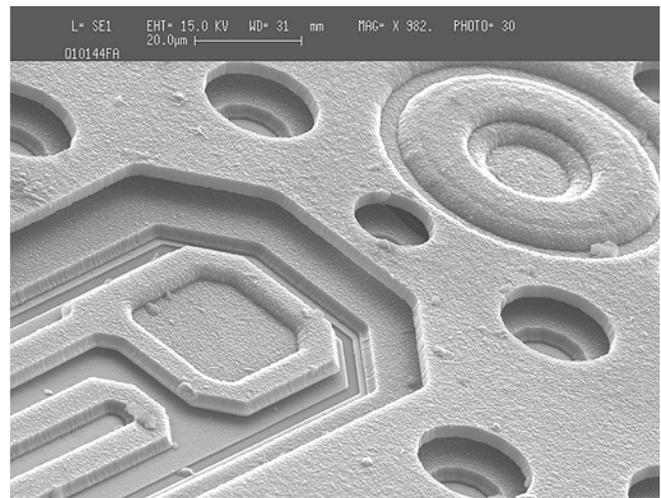
Internal SEM and EDS inspection revealed that the accelerometer sensor consists of a silicon membrane supported at four corners. This membrane stands above another silicon layer on the substrate. The sensor apparently works because of capacitance changes as the membrane deflects under acceleration. The lid of the cavity appears to form one plate of the capacitor. Also the substrate may form another plate. Four serpentine resistors and pads were observed on the substrate near the center of the transducer. A long integration EDS of the membrane indicated virtually pure silicon with a trace of cobalt.

Figure 24. The membrane is clearly elevated in this view. Round holes on both the upper and lower levels, may be intended for the etching process, and also to make the membrane more flexible. EDS showed that the membrane was silicon with a trace of cobalt. 982X

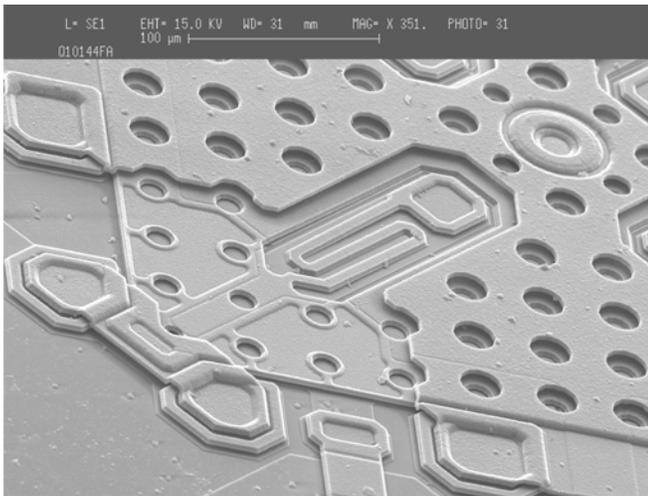
Figure 25. A corner view of the sensor. EDS indicated that the lower level was also composed of silicon. Serpentine path appears to be a resistor connecting to a pad. 351X

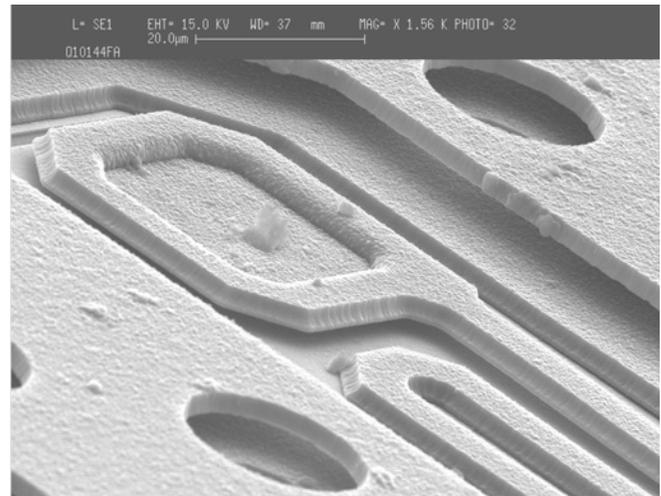
Figure 26. Close-up of the pad. The membrane appears suspended in this high-angle view. 1560X

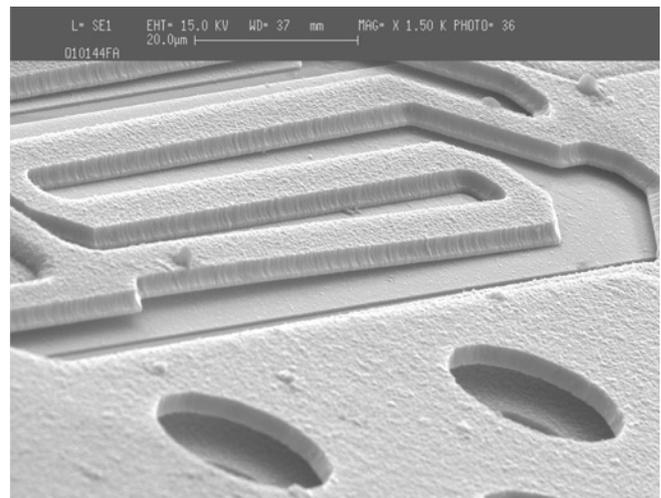
Figure 28. Close-up of resistor. An edge of the membrane is in the foreground. Note the slope on the resistor, while the pad, itself is intimate with the substrate. 1500X

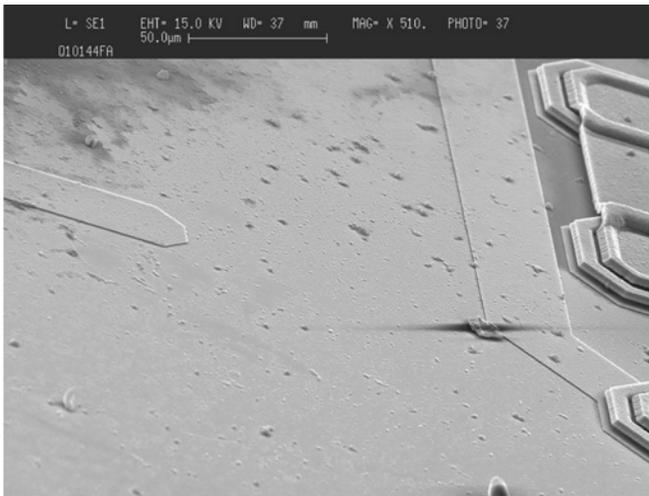
Figure 29. The trace at the upper left appears to go nowhere. 510 X
