# SEE and TID Characterization of an Advanced Commercial 2Gbit NAND Flash Nonvolatile Memory

**Abstract**—An advanced commercial 2Gbit NAND flash memory (90 nm technology, one bit/cell) has been characterized for TID and heavy ion SEE. Results are qualitatively similar to previous flash results in most respects, but we also detected a new dynamic failure mode.

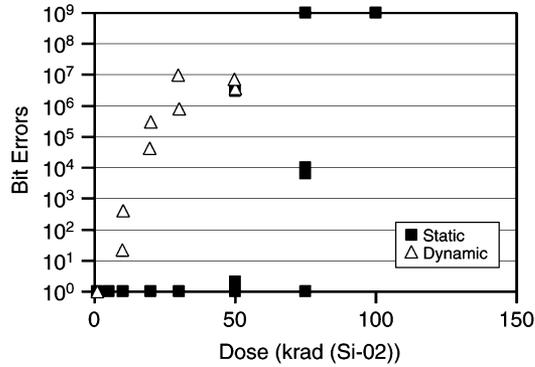
Fig. 1. Dynamic and static error rates compared, with dynamic errors starting at much lower doses.

The results of the dynamic testing were that there were no errors in either part before irradiation. Results after irradiation are shown in Fig. 1. There were a few errors, even at the first exposure level, but the number of dynamic errors increases rapidly with dose, to several million before failure. These numbers were stable through multiple cycles, and also with slower clock speeds. At every level, however, the bits could be read correctly if the commands were given manually, as we have already explained. We will discuss the reasons for this result later.

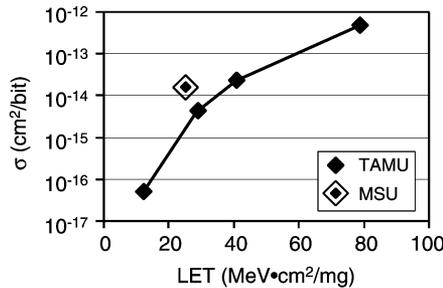
Fig. 2. Static SEU cross-section.

Even for the unbiased and static cases, in Fig. 2, bit errors and Page/Block errors were evident in the patterns of upsets observed. By page and block errors, we mean that all or most of the bits in either a page or a block were detected as errors. It is likely that the Page/Block errors arise due to upsets in configuration registers in the memory array, rather than upsets of the individual bits. For this reason, the page and block errors have been removed from the bit error cross-section in Fig. 2. In these tests, the sample was read only before and after the exposure, but not during the exposure. For this reason, it could not be determined exactly when the errors occurred. It is likely that a small fraction of the individual bit errors were obscured by page and block errors, so cross sections are approximate for unbiased and static error modes.

cally have (only) a 7–10 nm tunnel oxide, which would explain rapid annealing, by the usual tunneling process [20]. Although the failure of the charge pump for the erase process is the limiting factor in the TID environment, it is not the only failure mechanism. In Fig. 2, two parts have about  $10^4$  bad bits in an initial static read at 75 krad. However, a bit error map for one of these is shown in Fig. 6, and the errors are concentrated in certain rows. The page address is also the row number, which is the same as the word-line number. This suggests that these errors are due to the peripheral circuits for these rows, and not due to the failure of individual bits.

intermittent, meaning that they disappeared at the next higher dose. Our view is that these were probably not due to radiation, but it is possible to get errors of both polarities in the TID test. We note that these chips do not have built-in error correction, but the manufacturer recommends that error correction be used (off chip), because it is difficult to keep the error rate below one part per billion without it, even in the absence of radiation. Error correction would be expected to eliminate most of the single bit static errors, which is the main effect in Fig. 2.

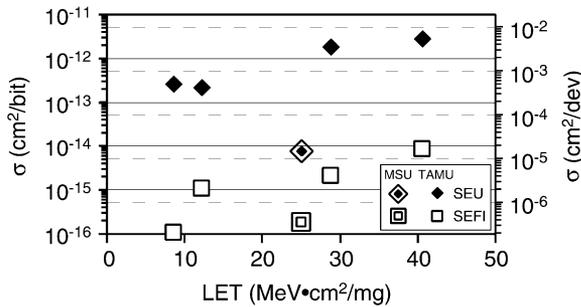
Fig. 3. Dynamic read error cross section. SEU cross sections are on the left axis, SEFI cross sections on the right.

For the Dynamic Read condition, in Fig. 3, the parts exhibited other Single Event Functional Interrupts (SEFIs) in addition to the bit and Page/Block errors. (Page and block errors are counted as SEFIs in Fig. 3–5, but there were also other kinds of SEFIs. In general, SEFI is used to mean any non-destructive interrupt—something stopped working, but operation was eventually restored.) Here, and in the following discussion, SEU cross sections will be given in cm<sup>2</sup>/bit, while SEFI and destructive event cross sections will be normalized on a per device basis. For Dynamic Read/Write, in Fig. 4, and Dynamic Read/Erase/Write, in Fig. 5, functional failures (destructive events) were observed that made it impossible to Erase or Write to the memory. Page/Block and SEFI errors were not identified in some cases, because of the functional failure of the device. Generally, SEFIs and functional failures occurred at roughly comparable rates. SEFIs that were detectable (because the chip survived) are plotted in Figs. 3–5. We were not able to do destructive physical analysis (DPA) to determine the

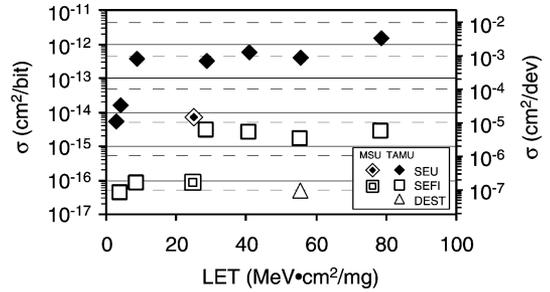
Fig. 4. Dynamic Read/Write error cross-section, for single bit errors, SEFI, and destructive effects (SEU on the left axis, other effects on the right).

In the heavy ion SEU testing, errors were seen for all LETs and all bias/operating conditions. Results are shown in Figs. 2–5. In all cases, the All-0's was found to be the worst-case pattern, so after the first few runs, all subsequent runs were carried out with this pattern.

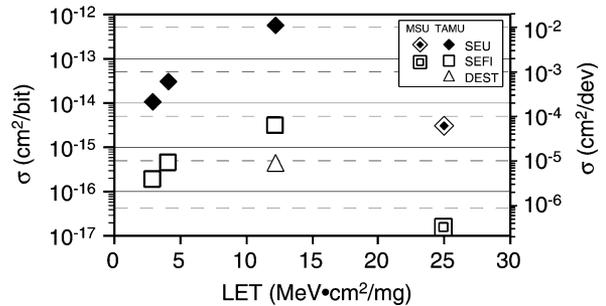
Fig. 5. Dynamic Read/Write/Erase error cross section, for single bit errors, SEFI, and destructive effects (SEU on the left axis, other effects on the right).

In the SEE results in Figs. 2–5, a number of error mechanisms are reported, with cross sections. These errors are qualitatively similar to previous reports. For example, the same mechanisms are reported in [16] for older technology, but the cross sections in Figs. 2–5 are generally two or more orders of magnitude

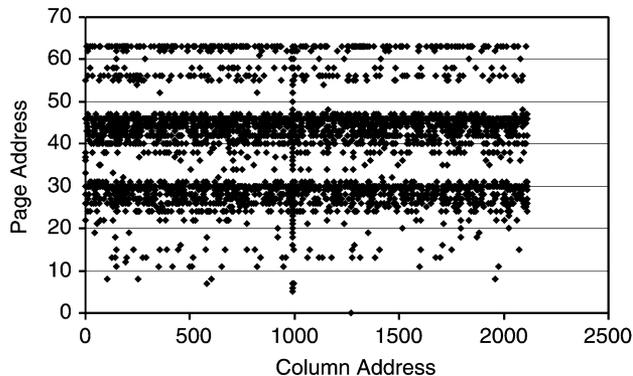
Fig. 6. Bit error map for initial static read, at 75 krad ( $\text{SiO}_2$ ). Non-random distribution indicates problems in peripheral circuits, rather than individual bits. Page address is also the row number.

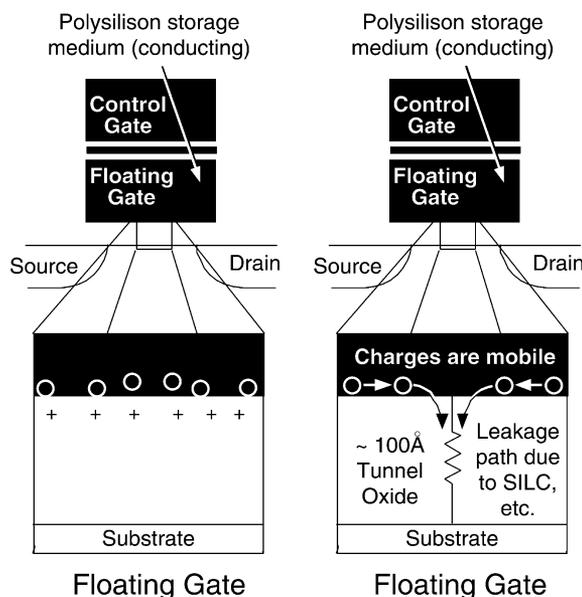
Fig. 7. Radiation damage mechanisms: (a) positive oxide charge; (b) oxide damage along an ion track, leading to a conducting path in the oxide.

The most common error in heavy ion testing is a single bit error, zero turned to one, when the ion passes through the floating gate. Positive oxide trapped charge, compensating the negative charge on the floating gate, is indicated schematically in Fig. 7(a), which is an attractive idea because of its simplicity. However, the actual physical charge loss mechanism, in a heavy ion strike, is more complicated, and it has been described in a number of previous reports [23]–[25]. Oxide damage from the ion strike, leading to a low resistance leakage path, as illustrated in Fig. 7(b), has been reported previously [24], [25], but it is not the focus of this work.
